STRUCTURAL ENGINEER'S REPORT

Barn Building
adjacent to
46 Glossop Road, Charlesworth

Ref. 12918.002

Date: 06 July 2010

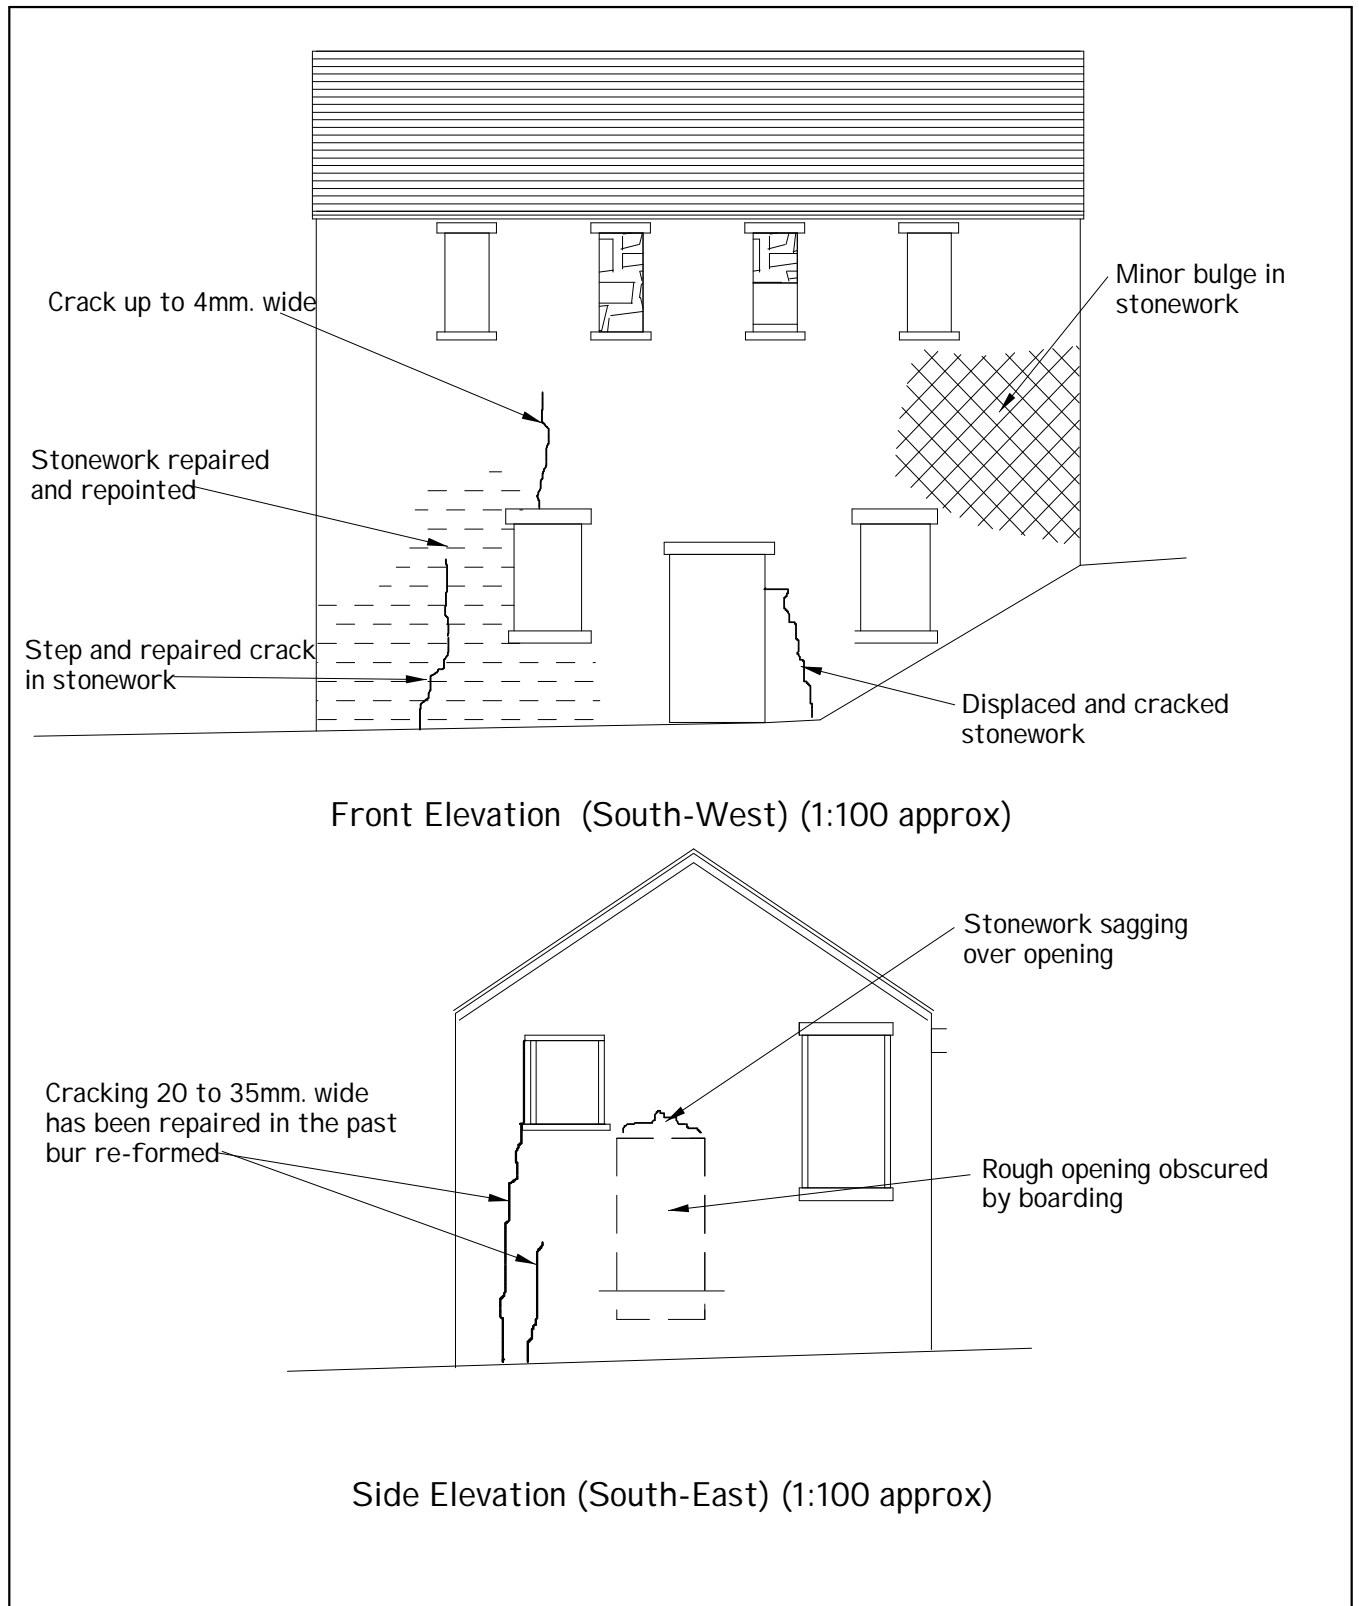
- 5.2 There is some significant cracking of the stonework at the front of the right hand gable, and this has resulted in bulging of the stonework on the adjacent front elevation. The cause of this cracking is not clear, but it is suspected that it is a combination of delamination of the stonework layers combined with differential thermal movement between soil retaining and exposed areas of stonework.

- 6.1 We recommend that the proposed conversion works include crack stitching and stainless steel ties to a new suspended floor, to enhance the lateral stability of the stone walls. Additionally, an inner leaf of blockwork constructed on an internal concrete raft slab should be constructed and tied to the stonework.

- 6.2 In areas where the exterior of the stonework is delaminating away from the inner skin of stone, stainless steel ties can be inserted internally to prevent any further separation
