# Whitcher Wildlife Ltd. Wildlife Consultants.

# Charlestown Road, Glossop – Report Addendum.

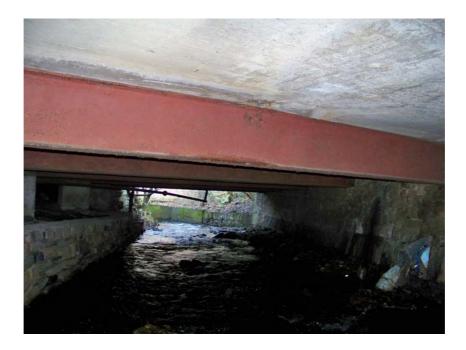
## 2.1. Culvert A.

2.1.1. This was walked and inspected in full. The building above is supported on steel girders suspended over the watercourse supporting a concrete slab, as shown in the photograph below. The culvert walls are a variety of stone walls.

2.1.2. No bat roosting opportunities were identified under this culvert and no nests were identified on the girders or in the walls of the culvert.

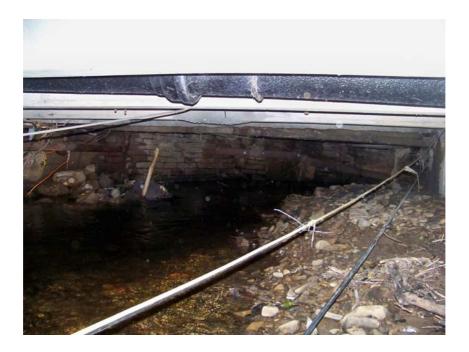
#### 2.2. Culvert 2.

2.2.2. It was deemed to be unsafe to enter this culvert. However, the photograph below shows the outlet end to the west of the main road. This shows that the deck comprises concrete beams and a concrete deck with no suitable bat roosting opportunities.

2.2.3. Within the culvert there was an accumulation of debris that suggests that the water depth in the culvert will rise at times of high flow making the walls unsuitable for roosting or hibernating bats.

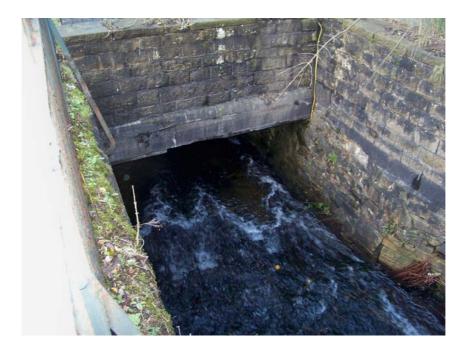
2.2.4. It was deemed unsafe to enter the inlet end of the culvert, shown in the photograph below.

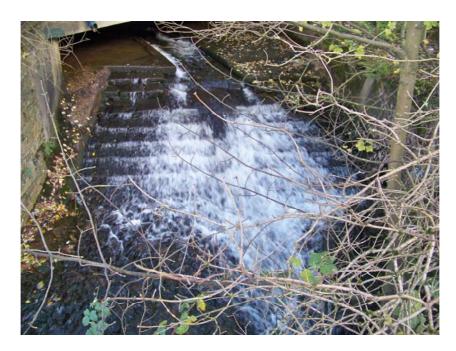
## 2.3. Culvert 3.

The photograph below shows the outlet end of Culvert 3. It was not possible to access this culvert for safety reasons. However, it appears that the culvert has cast concrete walls and a concrete beam and deck and this does not provide any bat roost potential.
