# BUXTON CRESCENT AND SPA

### SCHEDULE OF CONDITION

### THE PUMP ROOM

Prepared by Nicholas Jacob Architects

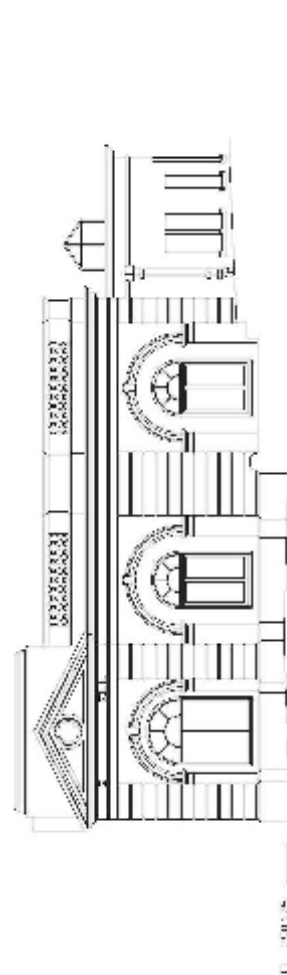
Buxton crescent and spa.  
West elevation.

**1.1.1** Bottle balustrade central pier has area of spalling stone approximately 450 x 450mm. This should be removed and the surface exposed examined for further failures. Assuming this is sound, clean off rough surface and re-point joints with lime sand mortar.

One minor area of worn drip on the outside face above window 2. Cut out damaged drip of coping approximately 300mm long by 100mm high and 65mm deep and cut in new section with moulded underside.

**1.1.3** Re-point 7no joints in coping stone with lime sand mortar 1:3.

**1.1.5** Joint between central pier of balustrade and bottle balusters over window 2:- There is an open joint to be filled vertically 1.1 linear meters.

**1.1.6** Joints in cornice below lead cloaking are generally open. Re-point 8no. joints. 0.5 linear meters each.

**1.1.7** Ventilation hole approximately 225 x 150mm below cornice has no grill. Re-instate cast iron grill in this location.
