Subject Buxton Crescent Hotel & Spa**Job No/Ref**

216069-00/SJS

Date 5 April 2011**Page 1 of 10**

Sound insulation

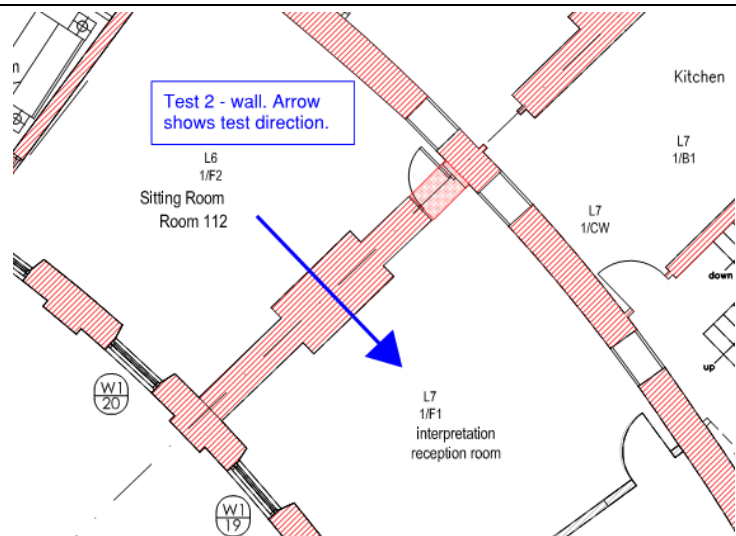
Test 2 (wall) - 2nd floor (front)

This wall appeared to be solid brickwork (approximately 600mm thick), plastered on both sides. It had back to back fireplaces, the fireplace on the 'source' room side of the wall was open and the fireplace on the 'receiver' room side of the wall had been enclosed.

Both walls tested appear to have a general construction of around 600mm plastered brickwork, with back to back fireplaces. The results of the tests suggest that this basic construction is capable of achieving the proposed standards, and so no specific upgrading measures are likely to be required. However, it will be important to maintain the integrity of these and the other walls by making sure that any holes/cavities are filled with brickwork and mortar to the full depth of the wall and any surface cracks are filled plaster etc.

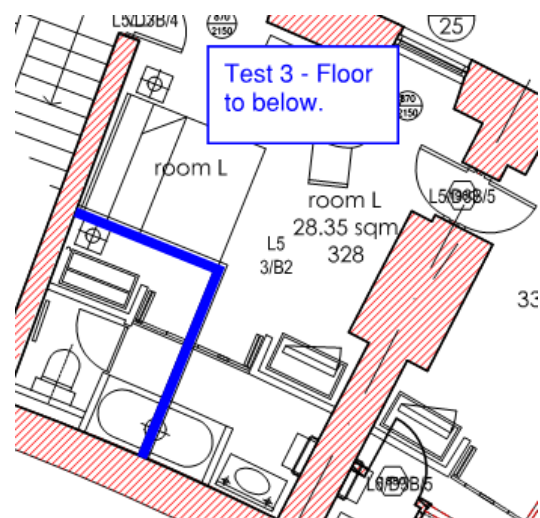
**Test 3 (floor) - 3rd floor (rear)**

Office-type carpet (approx 4mm thick), 22mm floor boards on joists. Cavity of around 300mm and a lath and plaster ceiling (approx 25mm thick) supported on separate joists.

This section of floor significantly failed to achieve the proposed standard, although its performance is roughly what we would expect for our understanding of its construction. This suggests that the floor's basic construction is not capable of achieving the proposed standards and so will need to be upgraded. The two key options for this are to either add an independent plasterboard ceiling (as discussed above) or perhaps adding a layer of pugging on boards may be sufficient. The latter option would bring the construction of this floor more in line with the construction of the 1st / 2nd floor (front) floors, which appear to be achieving the requirements.

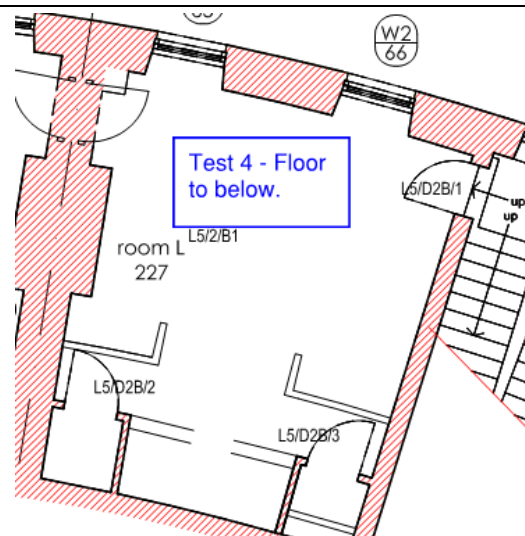
**Test 4 (floor) - 2nd floor (rear)**

Office-type carpet (approx 4mm thick), 22mm floor boards on joists. Cavity of around 190mm and a lath and plaster ceiling (approx 25mm thick) supported on separate joists.

This section of floor only marginally failed to achieve the proposed standard (ie R'_{w55}) and so specific upgrading works may not be necessary. It will however be necessary to determine the actual construction of this floor to set a benchmark for works to the other areas of 2nd floor (rear).

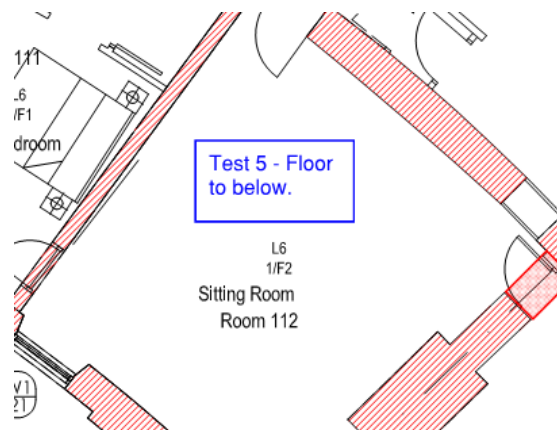
Test 5 (floor) - 1st floor (front)

Office-type carpet (approx 4mm thick), 22mm floor boards on joists, approx 25mm of plaster pugging between the joists on 10mm timber boards. Cavity in excess of 1m and a lath and plaster ceiling (approx 25mm thick) supported on separate joists.

The front section of this floor achieves the standard proposed between Guestrooms (ie R'_{w55}), but does not achieve the standard required between Guestrooms and other areas such as the bar, restaurant, retail units etc (ie R'_{w60}). In ideal conditions we would expect this floor construction to achieve a higher sound insulation than we measured (ie it is a double construction with a cavity in excess of 1m), and so in the first instance we recommend that it is inspected to determine whether any of its key elements have been removed (ie the pugging). If this is the case, then these need to be replaced and the floor retested.

However, if the floor is found to be intact, then the best method to increase its performance would be to add an independent ceiling (refer to Section 3.2.1). If this is not possible then the measures discussed in Section 3.2.3 would need to be considered.

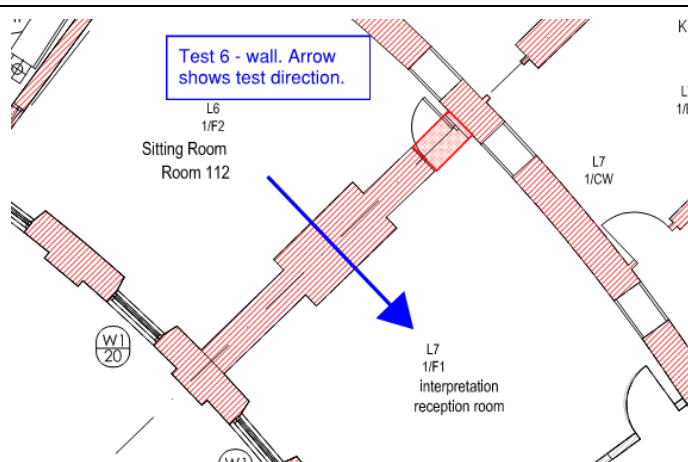
**Test 6 (wall) – 1st floor (front)**

This wall appeared to be solid brickwork (approximately 600mm thick), plastered on both sides. It had back to back fireplaces, the fireplace on the ‘receiver’ room side of the wall was open and the fireplace on the ‘source’ room side of the wall had been enclosed.

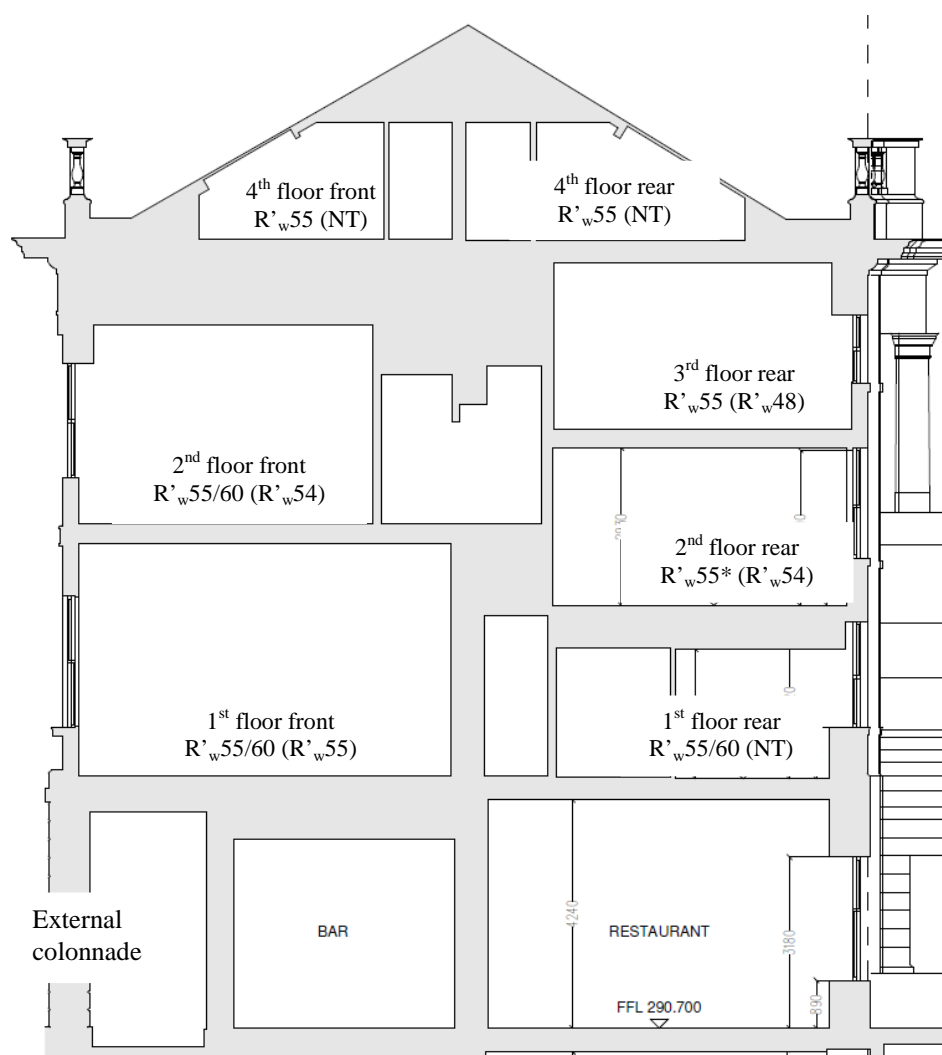
Figure 1 – Sound insulation criteria and test results (shown in brackets), NT= not possible to test

The results of the tests, together with the relevant criteria, have been marked on Figure 1 below. As can be seen from this figure, some of the floors tested achieve or are very close to achieving the proposed standards. Some of the results are roughly what we would expect for our understanding of the construction, and some are not. For example, the 2nd floor (rear) test achieved a significantly higher sound insulation than the 3rd floor (rear) construction, but the drawings suggest that their constructions are very similar.

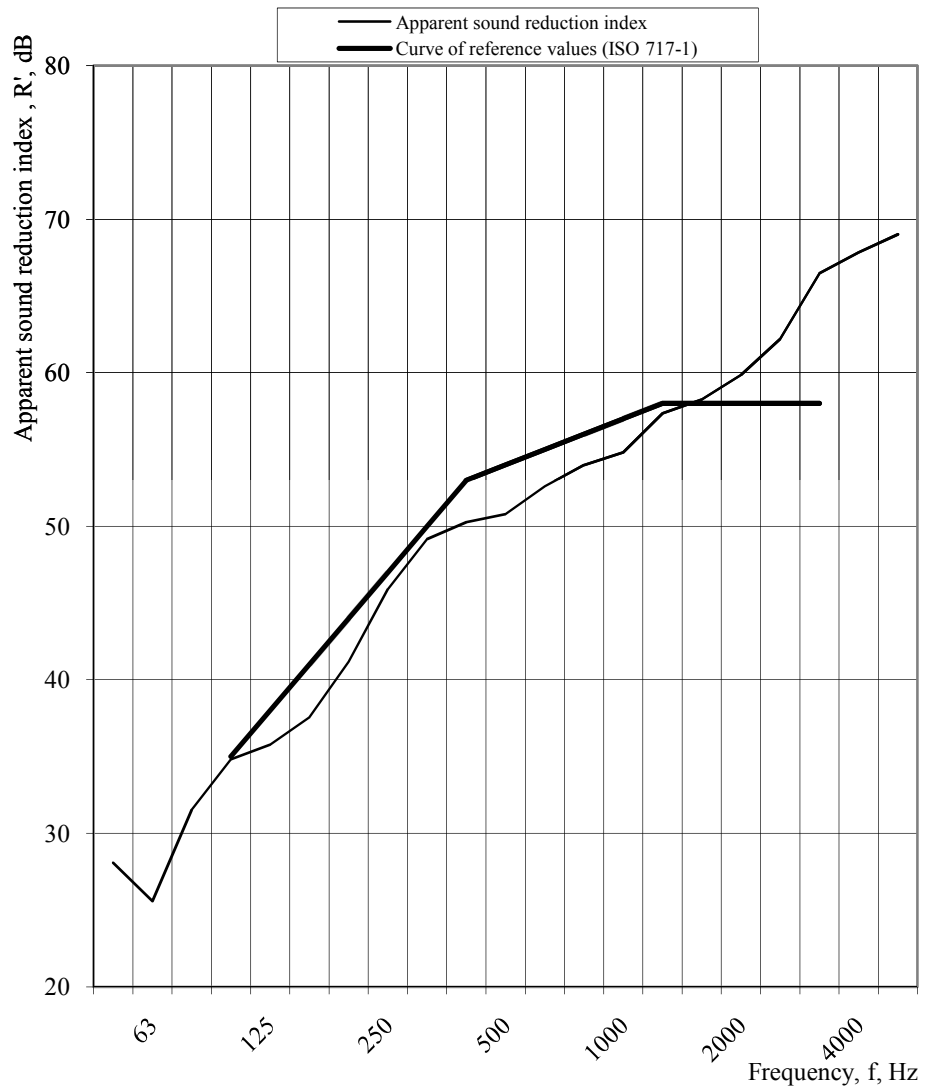
Test 1 - Floor, 2nd floor (front)

$R'_{w} (C; C_{tr}) = 54 (-1; -6) \text{ dB}$ $C_{50-3150} = -2 \text{ dB};$ $C_{50-5000} = -1 \text{ dB};$ $C_{100-5000} = 0 \text{ dB}$

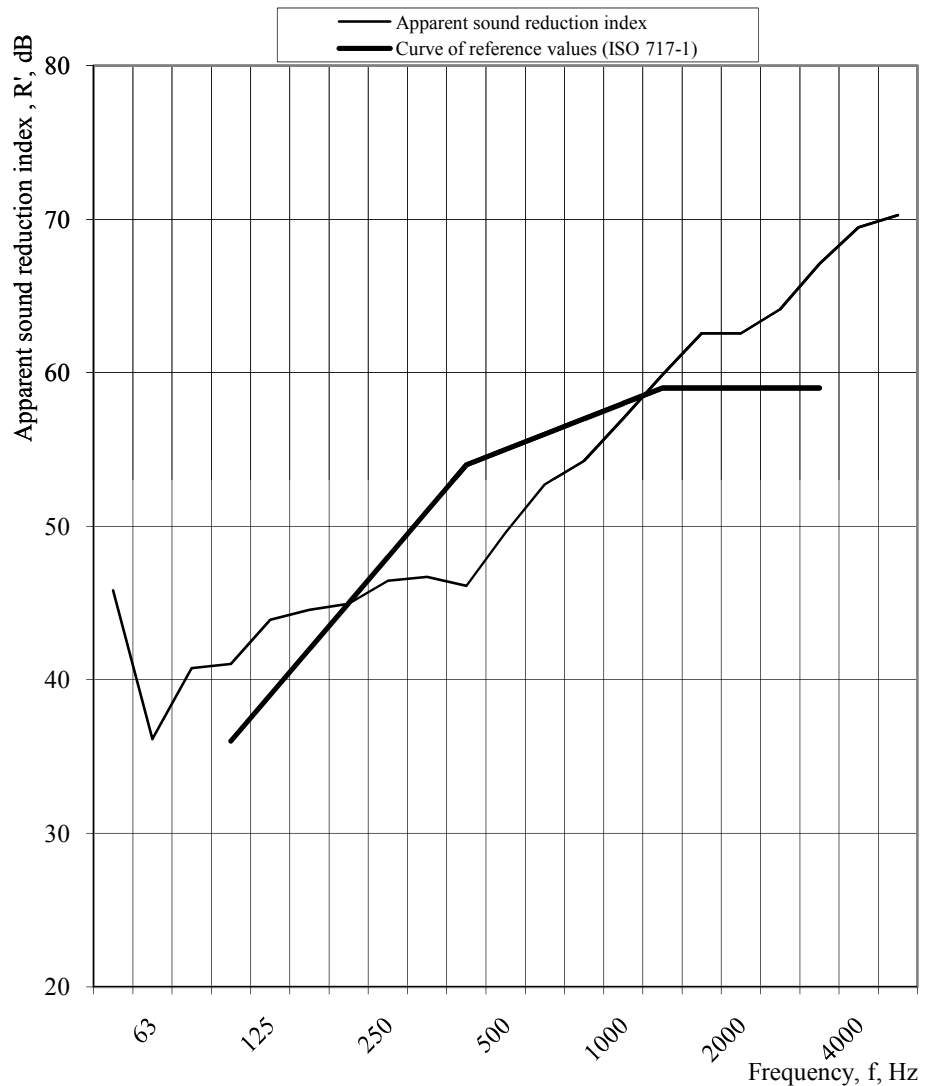
Test 2 - Wall, 2nd floor (front)

$R'_{w} (C; C_{tr}) = 55 (-1; -4) \text{ dB}$ $C_{50-3150} = -1 \text{ dB};$ $C_{50-5000} = 0 \text{ dB};$ $C_{100-5000} = 0 \text{ dB}$

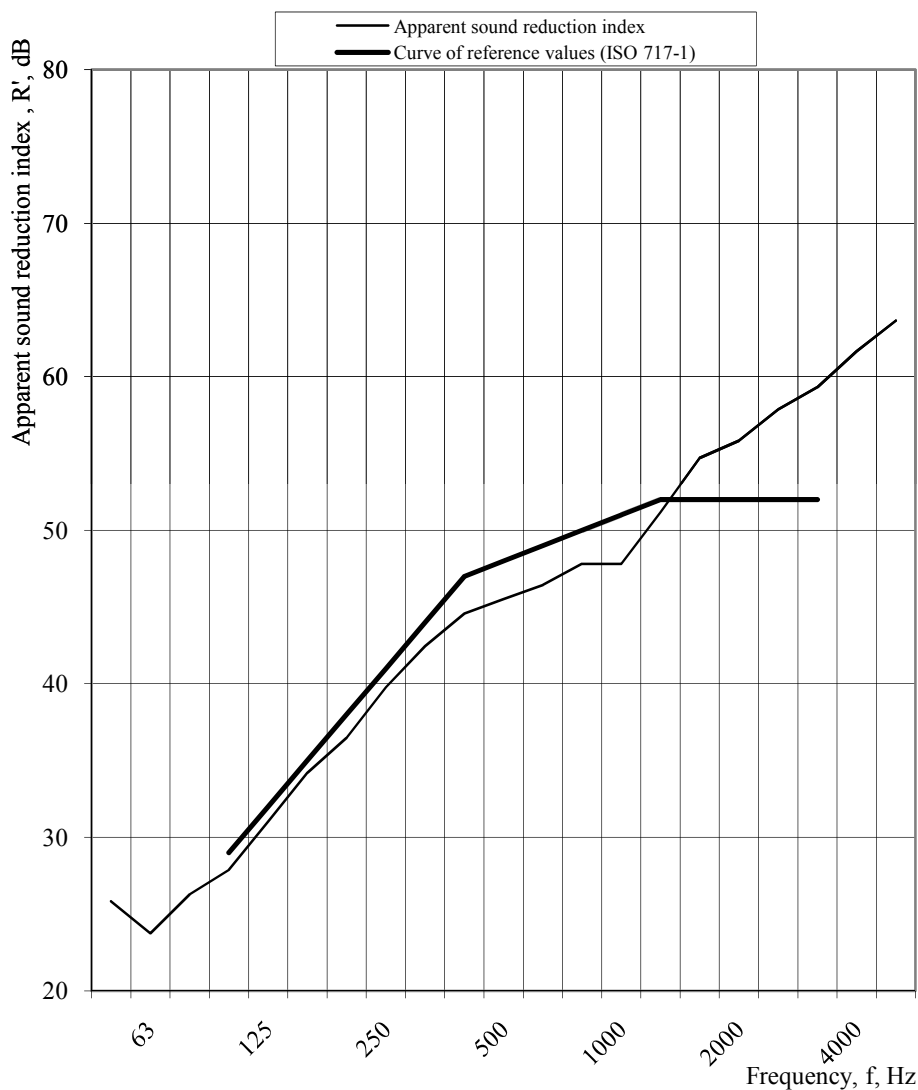
Test 3 - Floor, 3rd floor (rear)

$R'_{w} (C; C_{tr}) = 48 (-1; -5) \text{ dB}$ $C_{50-3150} = -1 \text{ dB};$ $C_{50-5000} = 0 \text{ dB};$ $C_{100-5000} = 0 \text{ dB}$

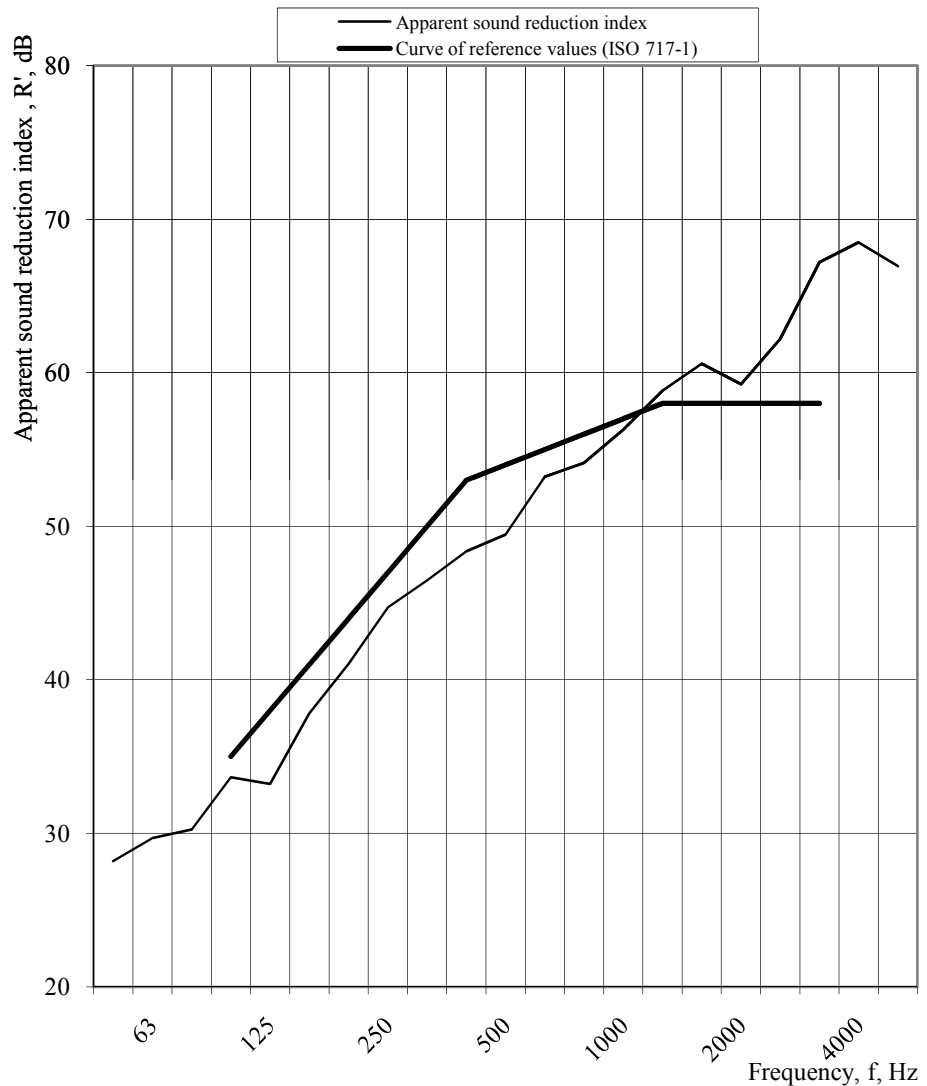
Test 4 - Floor, 2nd floor (rear)

$R'_{w} (C; C_{tr}) = 54 (-2; -7) \text{ dB}$ $C_{50-3150} = -3 \text{ dB};$ $C_{50-5000} = -2 \text{ dB};$ $C_{100-5000} = -1 \text{ dB}$

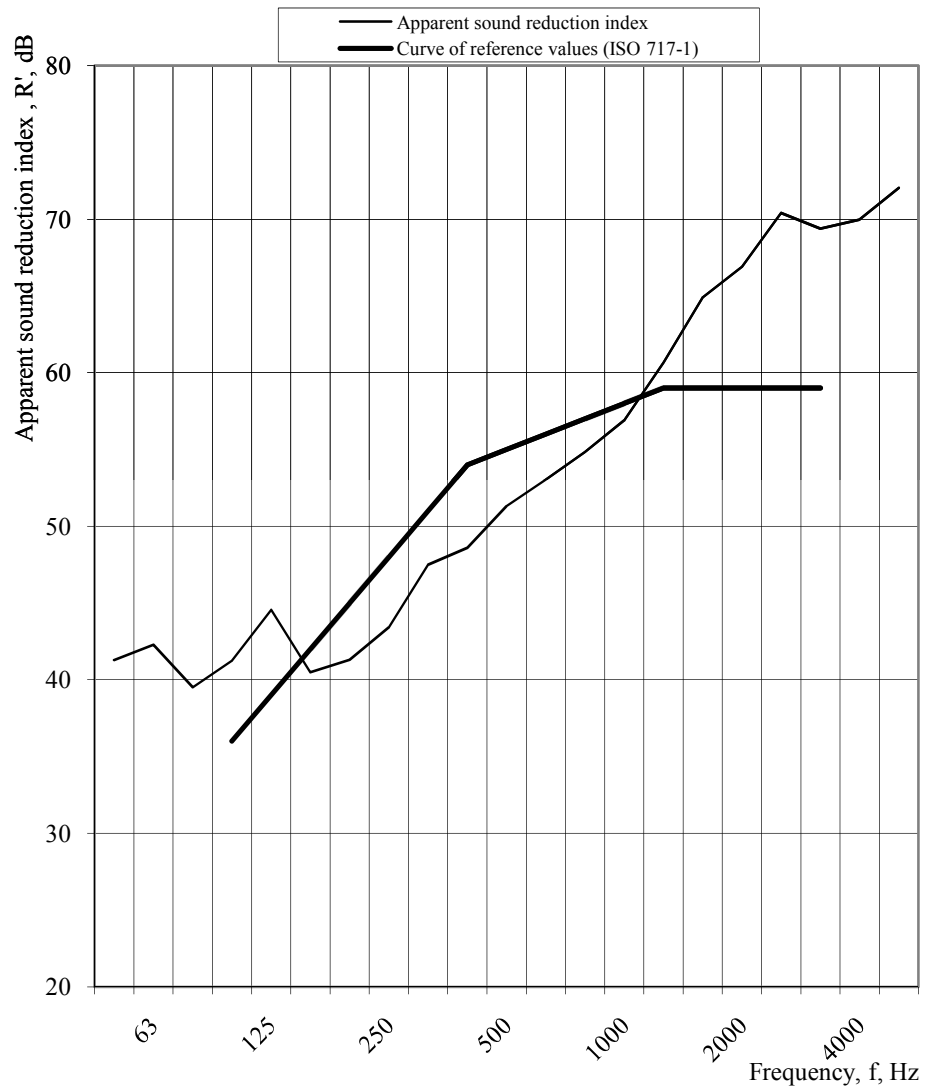
Test 5 - Floor, 1st floor (front)

$R'_{w} (C; C_{tr}) = 55 (-1; -5) \text{ dB}$ $C_{50-3150} = -1 \text{ dB};$ $C_{50-5000} = 0 \text{ dB};$ $C_{100-5000} = 0 \text{ dB}$

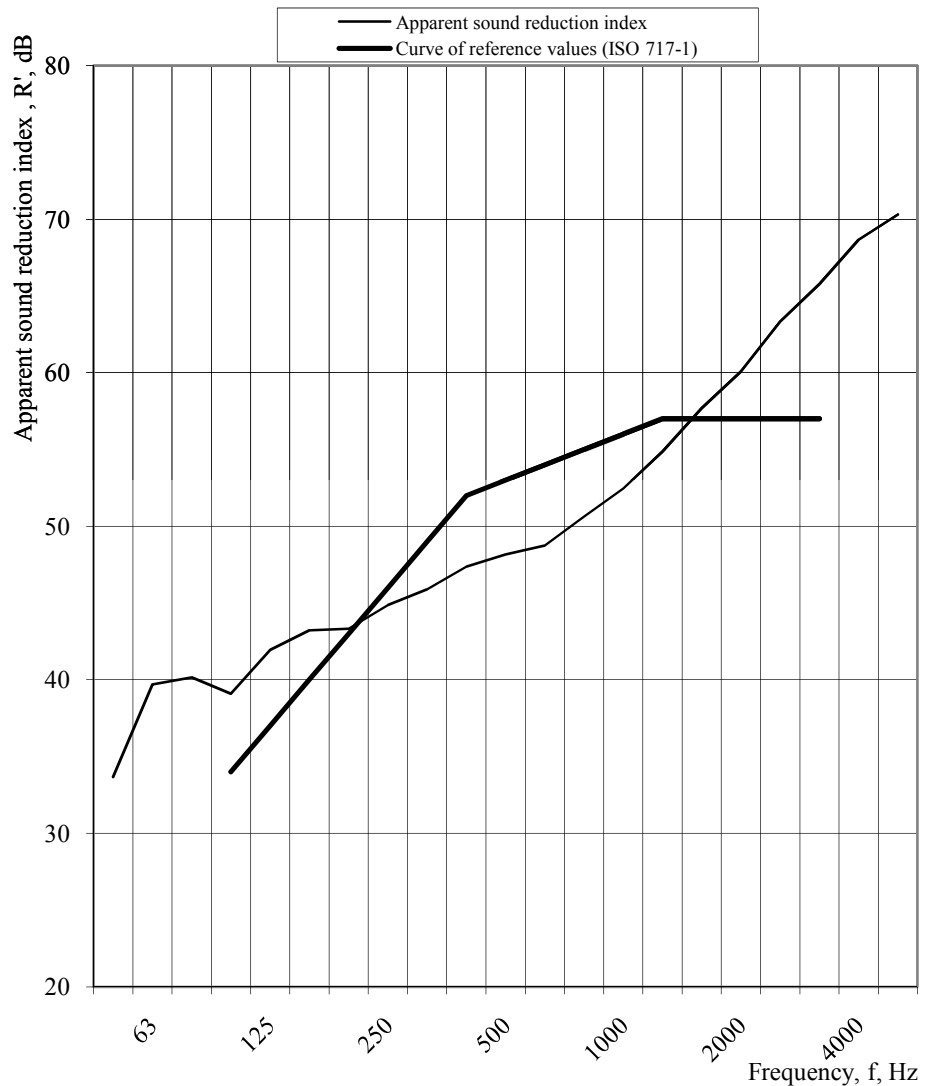
Test 6 - Wall, 1st floor (front)

$R'_{w} (C; C_{tr}) = 53 (-1; -4) \text{ dB}$ $C_{50-3150} = -1 \text{ dB};$ $C_{50-5000} = 0 \text{ dB};$ $C_{100-5000} = 0 \text{ dB}$
