**BAT AND BARN OWL SURVEY  
AT A  
BUILDING OFF MARSH LANE, NEW MILLS,  
DERBYSHIRE  
MARCH 2011**

**RACHEL  
HACKING  
ECOLOGY**

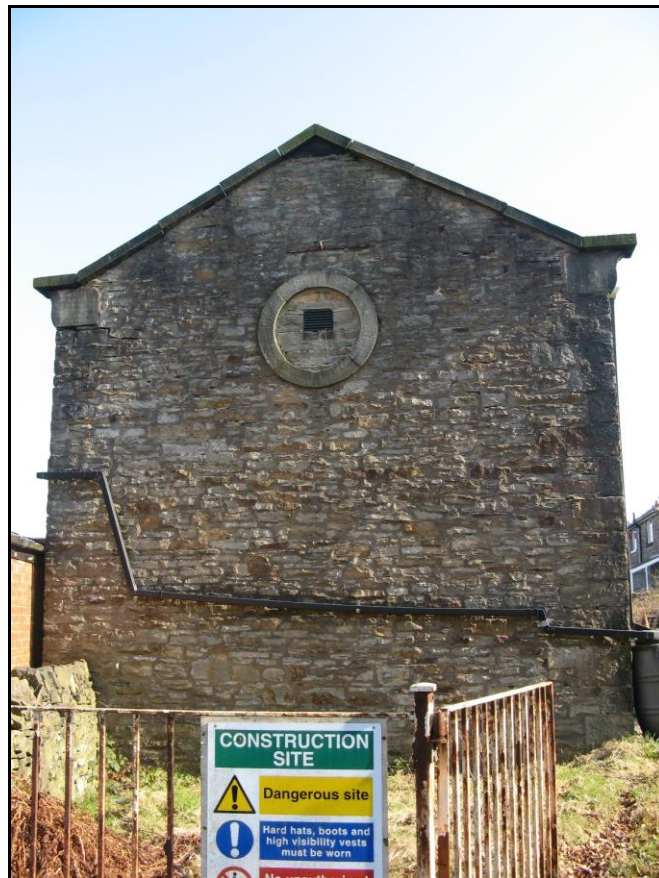
- 3.2 The main part of the barn is stone built with a slate tile roof (see Photograph 1). The ground floor is currently used for storing building materials and is divided into compartments. The first floor is unused. Wooden shutters cover the windows and there are large wooden doors to each compartment. On the western gable end is a ventilation panel (see front cover of report). The whole building is unheated.

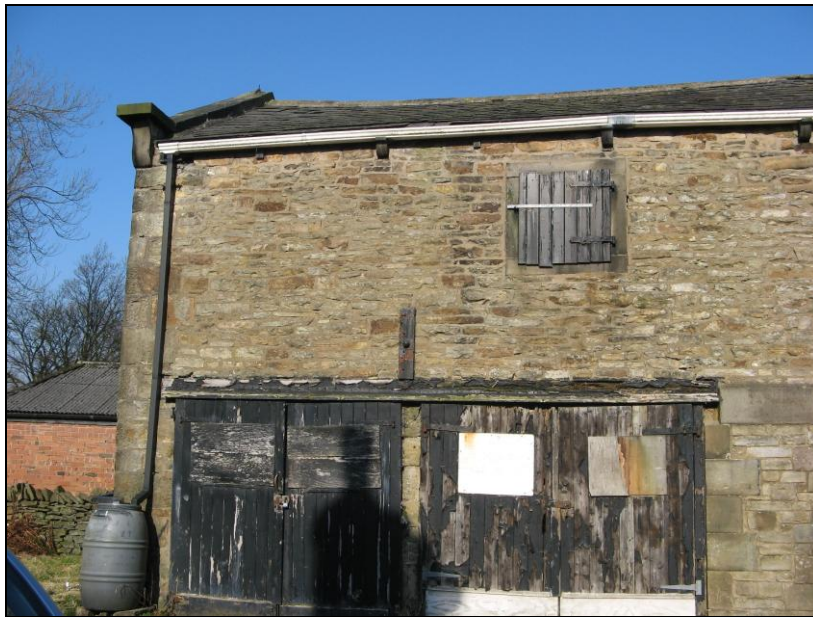
**Photograph 1 showing front of barn**

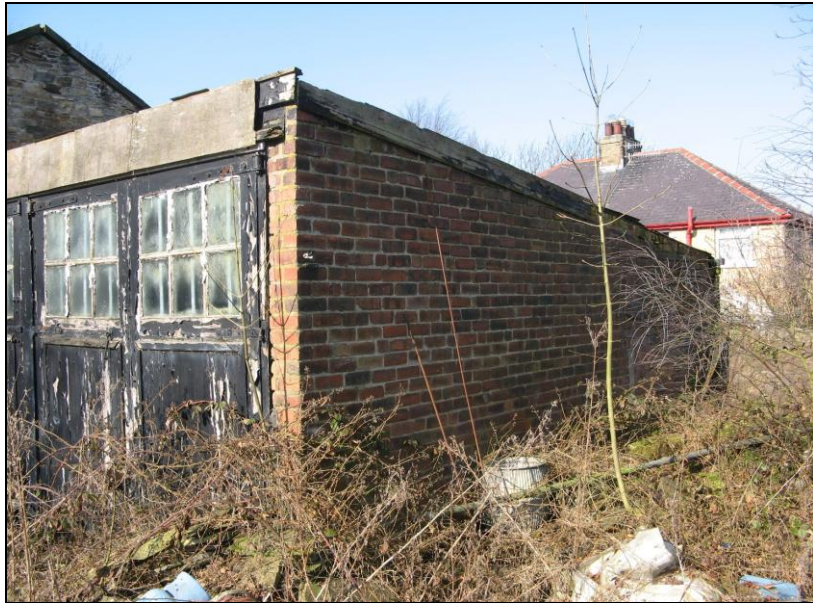
- 3.3 A single storey brick built extension is attached to the eastern gable end (see Photograph 2). This has a sloping roof composed of corrugated metal plates. The extension also has large wooden doors leading to various internal compartments and is also currently used for storage.

**Photograph 2 showing brick built extension**

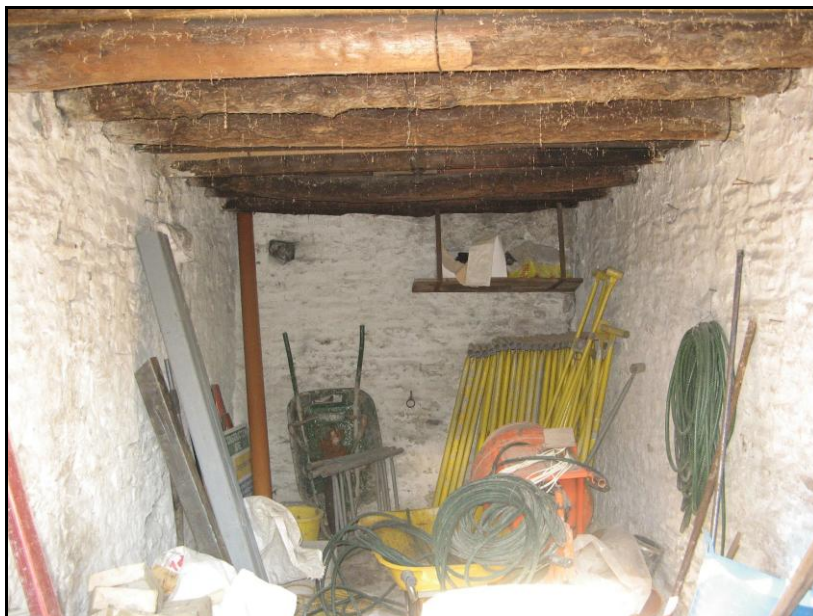
- 3.4 The building was easy to inspect internally for evidence of bat and Barn Owl. The ground floor was divided by brick walls into compartments (see Photograph 3). Light entered the compartments through gaps in the large doors. The compartments were well maintained. The ceilings of the compartments were comprised of wooden beams and panels. These were covered in cobwebs. No bat activity evidence could be located within these compartments.

**Photograph 3 showing one of the ground floor compartments**

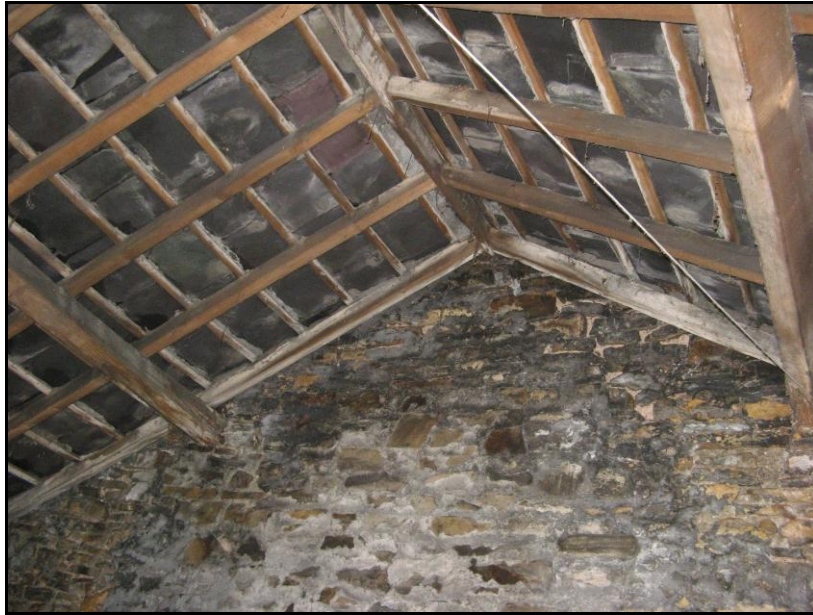
- 3.5 The first floor was accessed by a ladder and had not been used for some time. This part of the building was open to the roof and therefore the roof could be easily inspected. The slate tiles were flush to each other with no roof lining and the timber joists were in a good state of repair (see Photographs 4 & 5). No bat urine staining was located.

**Photograph 4 showing roof tiles from the first floor**

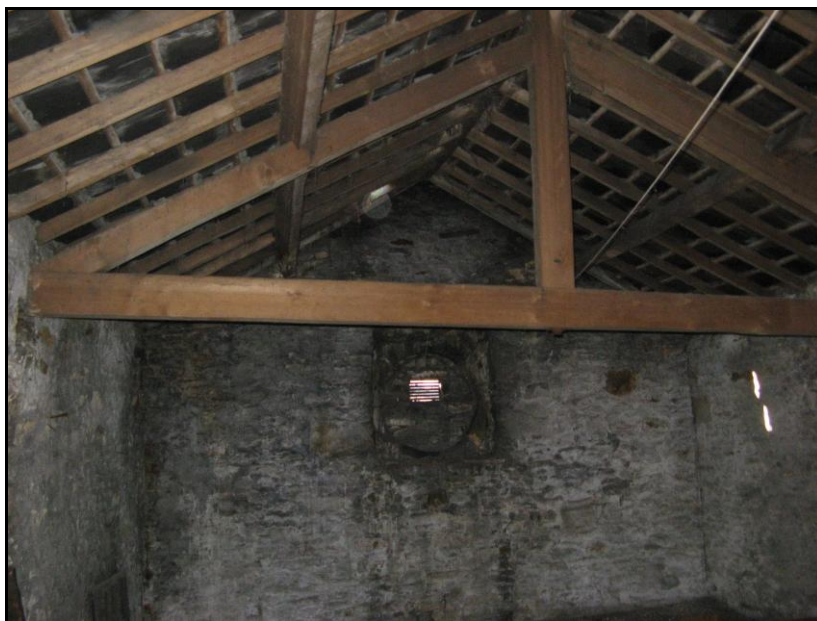
- 3.6 The roof apex was covered in cobwebs. A number of small gaps were evident where tiles had slipped or broken. These could have provided entry and exit points for bats but were covered in cobwebs. Light penetrated through the window shutters and gaps within the roof. The roof space was unheated and draughty.

**Photograph 5 looking towards southern gable end**

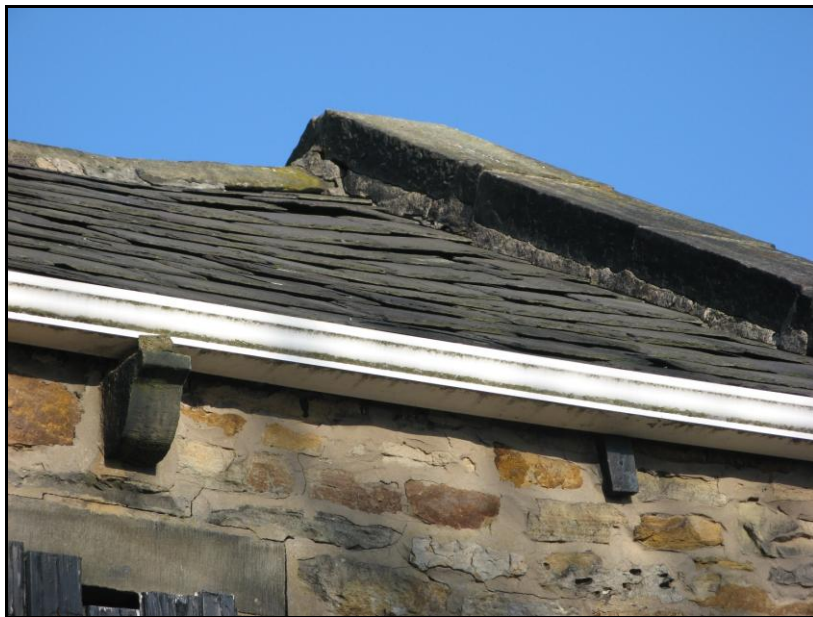
- 3.8 The majority of the slate roof is in a good state of repair. There are small gaps where tiles have slipped (see Photograph 6). During the internal survey, gaps were noted to be covered in cobwebs. The mortar and stonework are in a good state of repair. There is the odd gap in the mortar towards the edge of the walls. These gaps were inspected and found to be covered in cobwebs, indicating no recent usage. No bat droppings were located on the walls.

**Photograph 6 showing a gap between the slate tiles**
