# PEATHILL FARM.

**BAT SURVEY.**

**Ref No:-** 120316.

**Date:** 14<sup>th</sup> March 2012.

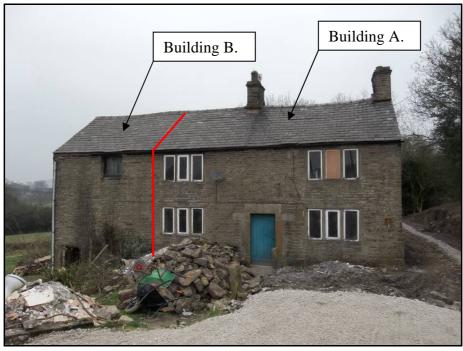
3.3.3.1. The photograph below shows the southern wall of Building A.

- 3.3.3.2. Building A is a two storey house with three rooms on the ground floor and two rooms on the first floor. The walls of the building comprise stone, which is well pointed on the outside and plastered on the internal walls.
- 3.3.3.3. Building A is attached to Building B on the western elevation and Building D on the northern elevation. Building B is integrated into the stonework and roof with no gaps or crevices. Building D is attached with mortar which is mostly in place with only a few areas missing. This is shown on the photograph below.

- 3.3.3.4. The pitched roof comprises a simple rafter and purlin design covered with blue slate and ridge tiles, which are all in place and well pointed. The roof is lined with a Bitumen and Hessian based liner which is tight fitting and fully intact. In places there are raised slates which may allow access into the space between the roof liner and the slates. The inside of the roof can be easily observed as there is no ceiling.
- 3.3.3.5. The windows and doors were all intact and tight fitting with no gaps or crevices leading into the building.
- 3.3.3.6. No bat field signs were identified during the internal and external inspection of Building A.

3.3.3.7. Bird nesting potential was identified within this building. There was a nest identified in the eastern of the two chimneys.

- 5.1. It is recommended that a follow up dusk emergence survey is carried out of Buildings A, B and E. The dusk emergence survey will be in support of this report and will help prove or disprove the presence of bats within the buildings.

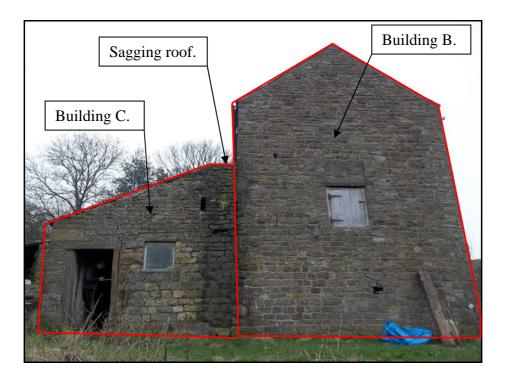
3.3.4.1. The photograph below shows the western wall of Building B.

- 3.3.4.2. Building B is three storey's high with no floors and ceilings between each storey. The walls of the building comprises stone which is well pointed on the external wall and partially rendered on the internal wall providing cavities into the stonework. Building B is attached to Building A on the eastern elevation and Building C on the northern elevation. Building A is integrated into the stonework and roof with no gaps or crevices.

- 3.3.4.3. Building C was attached with mortar on the roof which has broken away and the roof is now sagging causing the roof to pull away from the wall leaving a large gap.

- 3.3.4.4. The pitched roof of Building B comprises a simple rafter and perlin design covered with blue slate and ridge tiles, which are all in place and well pointed. The roof is lined with a Bitumen and Hessian based liner which is tight fitting and fully intact. In places there are raised slates, which may allow access into the space between the roof liner and the slates.

- 3.3.4.5. The windows and doors were all intact and tight fitting with only a few small gaps leading inside.
- 3.3.4.6. No bat field signs were identified on the internal or external inspection of Building B.
- 3.3.4.7. Bird nesting potential was identified within this building as there were droppings and feathers on the floor. There were also two swallow nests identified on top of one of the roof purlins.

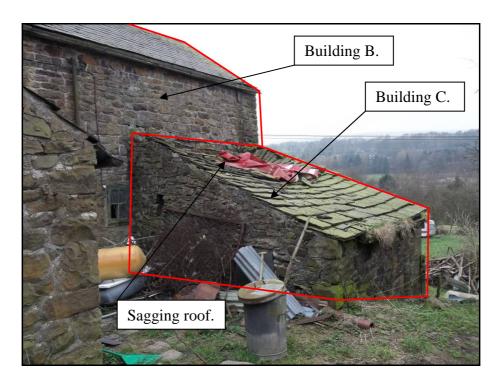
3.3.5.1. The photograph below shows the eastern and northern wall of Building C.

- 3.3.5.2. Building C is single storey in height. The walls of the building comprise stone, which is well pointed on the external walls and partially rendered on the internal walls providing cavities into the stonework. Building C is attached to Building B on the southern elevation.
- 3.3.5.3. Building C was attached with mortar on the roof which has broken away and the roof is now sagging causing the roof to pull away from the wall leaving a large gap.

- 3.3.5.4. The single pitched roof comprises a simple rafter and purlin design covered with stone roofing tiles which are all in place but, due to the uneven shape, leave small gaps. The roof is not lined and can be easily observed as there is no ceiling.
- 3.3.5.5. The windows were all intact and tight fitting although the door is missing providing access into the building.
- 3.3.5.6. No bat field signs were identified on the internal or external inspection of Building C.
- 3.3.5.7. Bird nesting potential was identified within this building. No nests were identified during this survey.

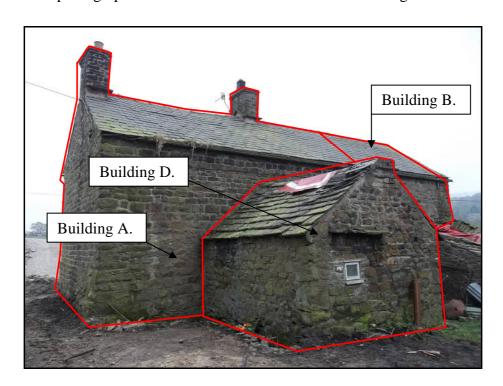
3.3.6.1. The photograph below shows the northern wall of Building D.

- 3.3.6.2. Building D is a single storey in height structure with one room. The walls of the building comprise stone, which is well pointed on the external walls and plastered on the internal walls with no gaps or crevices.
- 3.3.6.3. Building D is attached to Building A on the northern elevation. Building D was attached with mortar, which was mostly in place with only a few areas missing.

- 3.3.6.4. The pitched roof comprises a simple rafter and purlin design covered with stone roofing tiles, which are all in place but, due to the uneven shape, leave small gaps. The roof is not lined and can be easily observed as there is no ceiling.
- 3.3.6.5. The windows and doors were all intact and tight fitting with no gaps or crevices leading into the building.
- 3.3.6.6. No bat field signs were identified on the internal or external inspection of Building D.
- 3.3.6.7. Bird nesting potential was identified within this building. No nests were identified within this building during this survey.

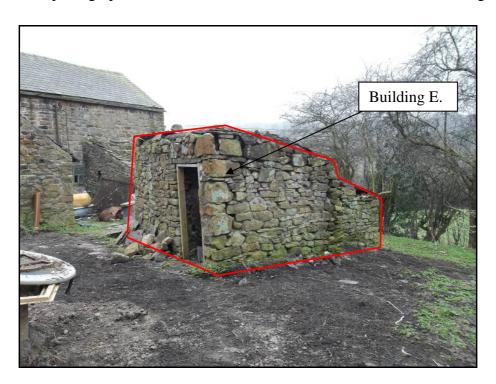
3.3.7.1. The photograph below shows the northern and eastern walls of Building E.

3.3.7.2. Building E is a single storey stone building with two separate rooms. The walls are partially pointed on the internal and external walls of the building. The roof is covered with corrugated metal and cement sheets. There are no doors or windows, allowing open access into the building.

- 3.3.7.3. No bat field signs were identified on the internal or external inspection of Building E.
- 3.3.7.4. Bird nesting potential was identified within this building. However no nests were identified during this survey.

- 4.4. Building E could also provide a suitable habitat for roosting bats as there are numerous cavities which cannot be examined during a visual inspection.
