**BAT SURVEY AT  
PARTINGTON CARE HOME,  
NORTH ROAD, GLOSSOP, DERBYSHIRE  
2012**

**RACHEL HACKING ECOLOGY**

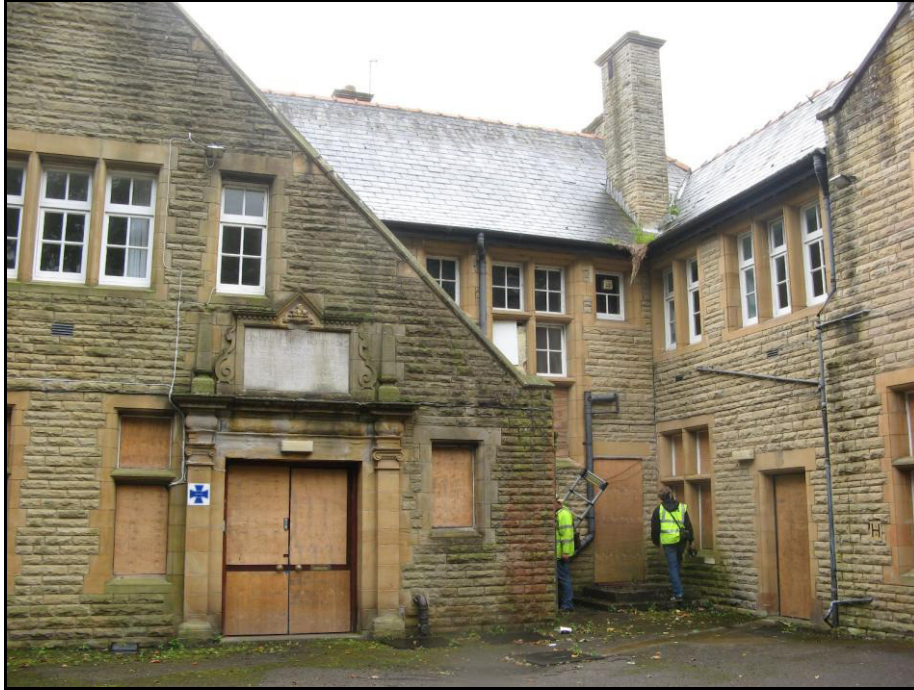
- 3.1 Partington Care Home is a very well maintained building (see Photographs 1 and 2). The walls are constructed of stone brickwork and the roofs are slate-tiled. The windows are all in a good state of repair.

**Photograph 1 showing exterior of the building at the front entrance**

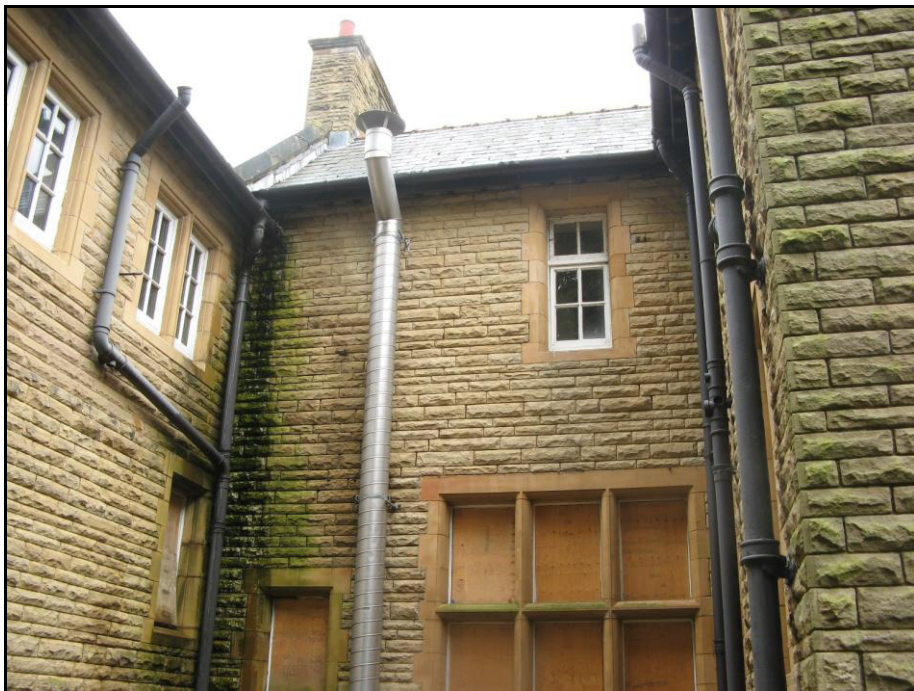
**Photograph 2 showing northern side of building and good condition**

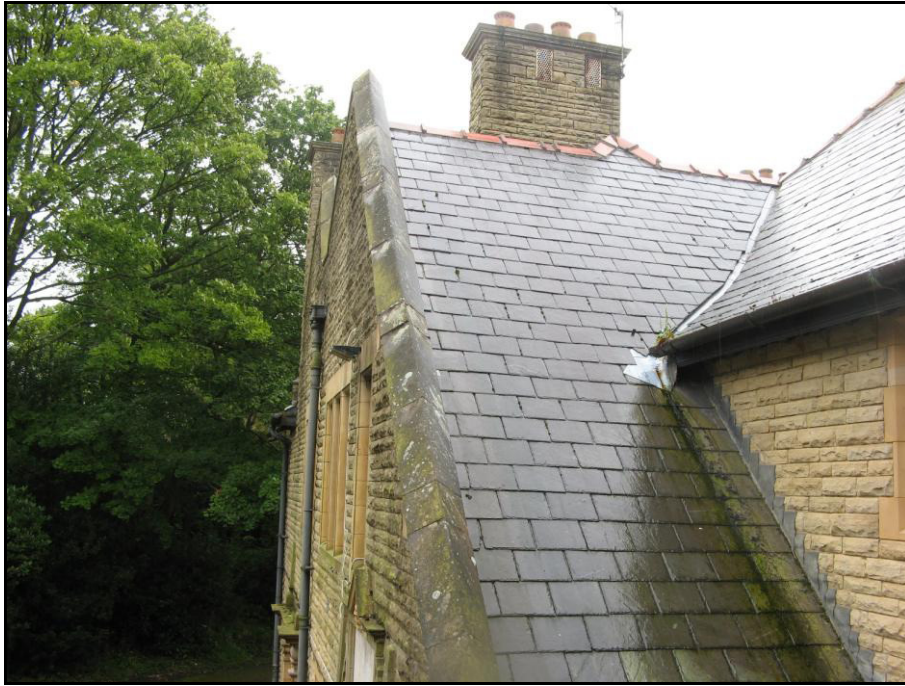
- 3.2 There were limited gaps within the brickwork and mortar. Small gaps exist between the brickwork and the guttering, the roof overhang and the soffit boards. These were covered in cobwebs, indicating no recent use by bats. The chimney breasts are well maintained with no missing brickwork.
- 3.3 The roof is in a good state of repair (see Photograph 3). The tiles are intact with the odd tile having slipped, creating a small gap. The lead flashing is intact and flush to the tiles. The roof apex tiles are all intact.

**Photograph 3 showing the typical condition of the roof**

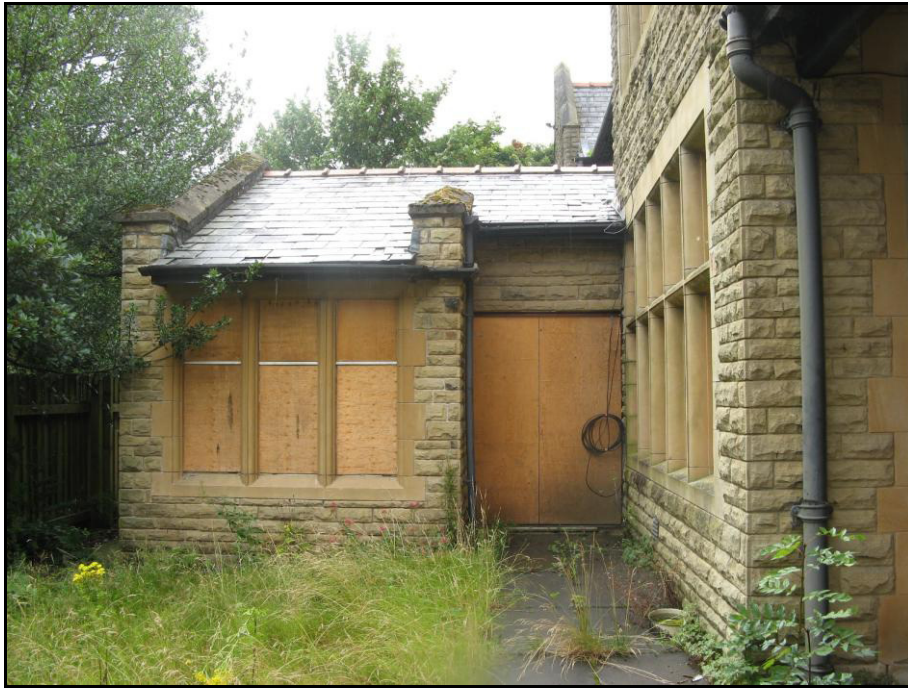
- 3.4 To the rear of the building were small single-storey extensions. These were inspected and found to be in a good state of repair. At the rear are a number of alcoves (see Photograph 4). The wooden sloping soffit boards are flush to the walls here and covered in cobwebs. A number of bird nests were located beneath the eaves here. Two bat droppings were located on the windowsills at the rear of the building.

**Photograph 4 showing single-storey extension to rear and alcove to the right in the picture**

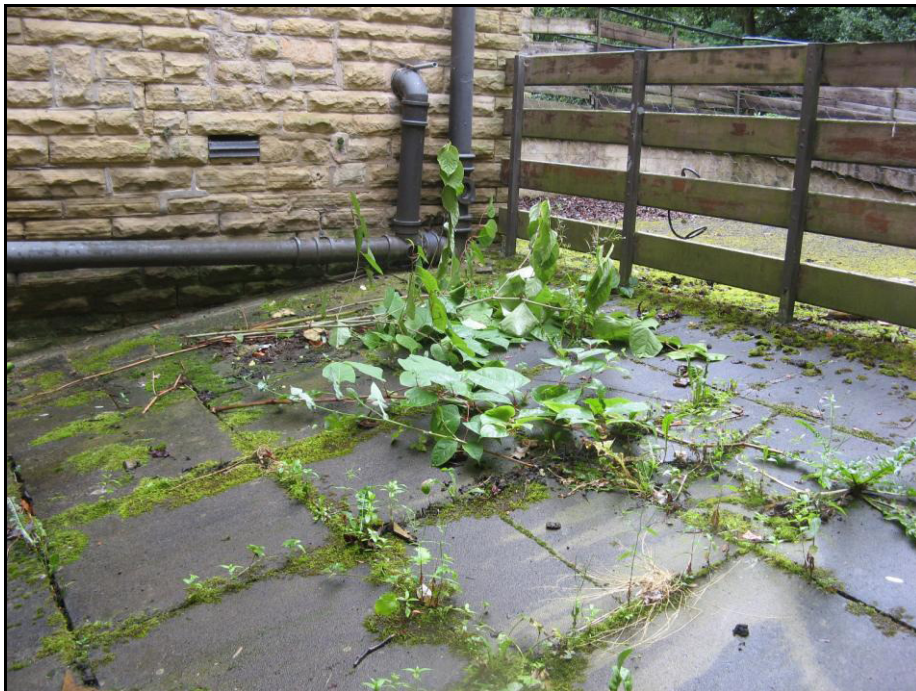
- 3.5 During the external survey, Japanese Knotweed *Fallopia japonica* was located within an alcove outside the western elevation of the building (see Photograph 5). Japanese Knotweed is listed under Schedule 9 of the Wildlife & Countryside Act 1981 (as amended), making it an offence to allow the species to spread into the wild. It is classed as 'controlled waste' under the Environmental Protection Act 1990.

**Photograph 5 showing Japanese Knotweed growing out the flags along the western edge of the building (near to cellar entrance)**

- 4.5 It is recommended that the Japanese Knotweed is removed from the site prior to any building works commencing. It should not be allowed to spread throughout the site. There are many methods to remove Japanese Knotweed, including burial on site, digging out and removal off site or a course of herbicide application. A Japanese Knotweed management plan should be produced.

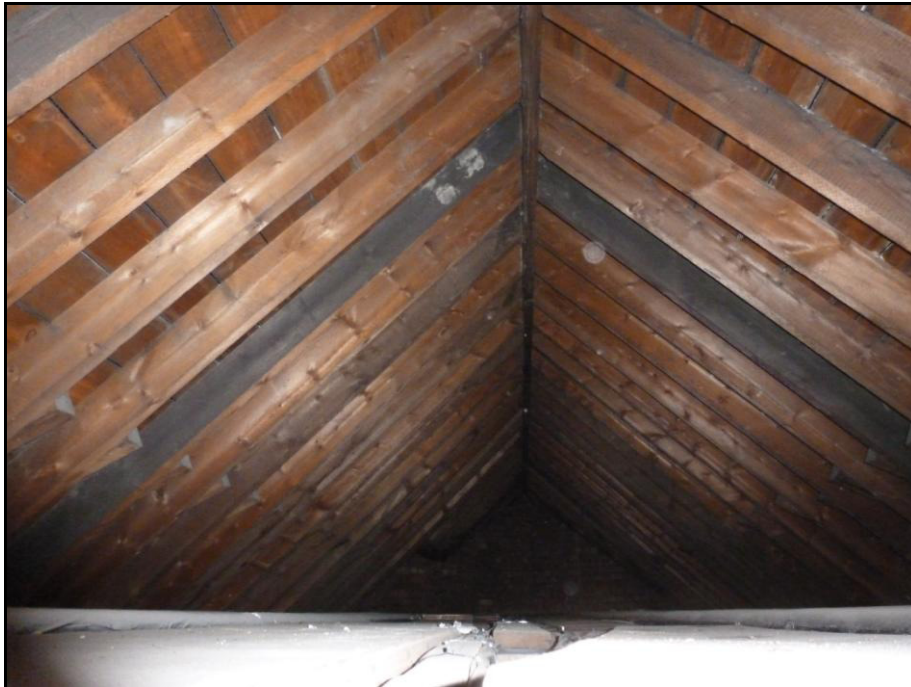
- 3.6 Partington Care Home has a number of roof voids. These were all accessible through loft hatches and were all thoroughly inspected. Some of the roof voids are large with full head height. Others are shallower and smaller. The pitched roofs cover the whole of the building but on the single-storey rear rooms, there are no roof voids.
- 3.7 All of the internal roofs are in a good state of repair (see Photographs 6 and 7). It appears that the timber joists and roof lining are relatively new. The roof lining is either felt lining or timber boards and is flush to the timber joists. There are no tears or gaps in the lining. Insulation is laid to the floor in the roof voids. No daylight could be seen in most of the roof voids. Where ventilation pipes exit through the roof, small gaps were evident but these were inspected and found to be covered in cobwebs.

**Photograph 6 showing internal roof structure in large roof void**

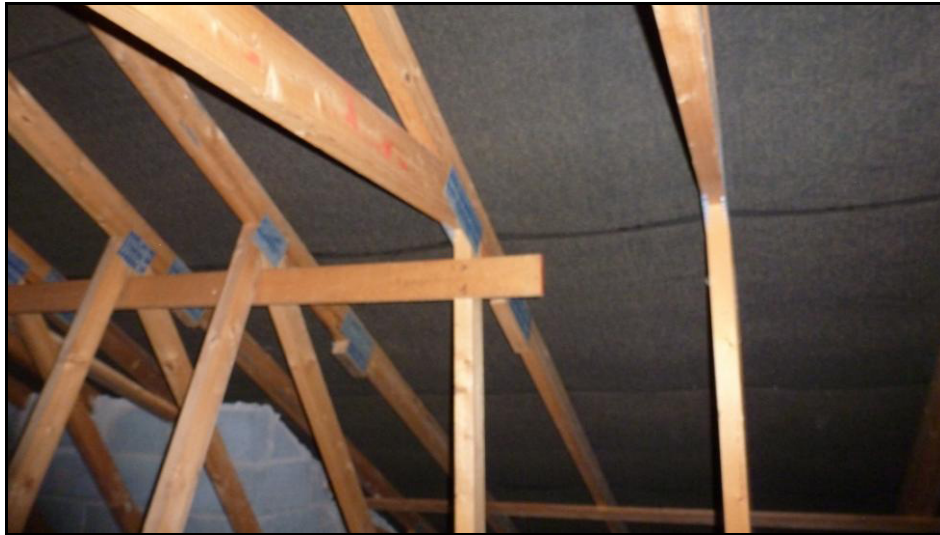
**Photograph 7 showing good condition of felt roof lining and timber joists**

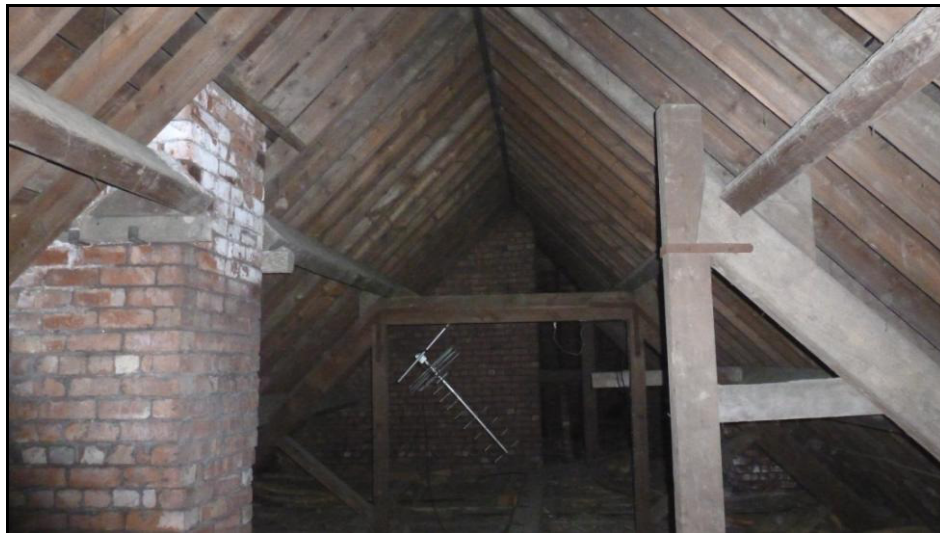
- 3.8 Where the roof joists and main beams meet, the joints were inspected and found to be covered in cobwebs. Exposed brickwork within the larger roof void (see Photograph 8) was closely inspected and found to be covered in cobwebs.

**Photograph 8 showing exposed brickwork in the large roof void**

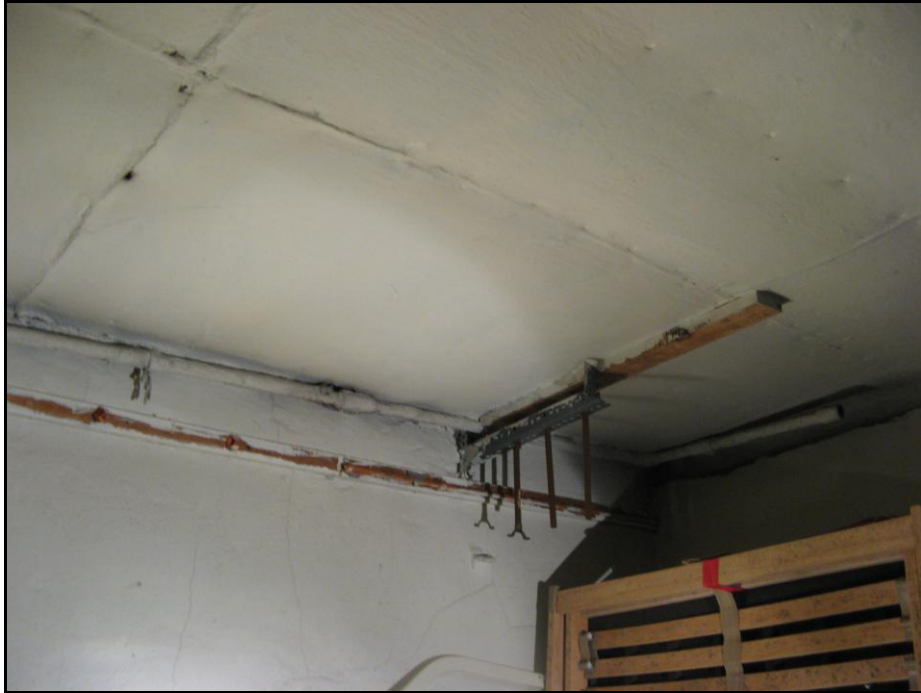
- 3.11 A small cellar exists where the ground drops away along the western edge of the building. This was accessed and found to consist of three small interconnecting rooms which house boilers and pipe-work. The rooms are also used for storage. At the time of the survey, the cellar was flooded due to a burst pipe. The rooms are plastered and well sealed (see Photograph 9). There is very little opportunity for bats to enter the cellar.

**Photograph 9 showing the sealed rooms and ceilings of the cellar**
