## **TREE REPORT**

- (i) No. 976 - Cypress
- (ii) No. 977 - Yew
- (iii) No 978 - Ash
- (iv) No 979 - Elm
- (v) No 980 - Ash
- (vi) No 982 - Ash
- (vii) No 983 - Sycamore
- (viii) No 985 - Holly

11 Lascelles Road  
 Buxton  
 SK17 6RA

- 15<sup>th</sup> December 2012

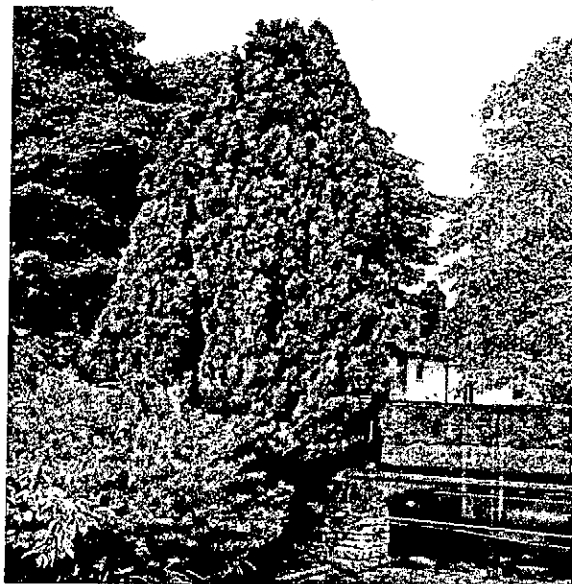
Photo No 1

Leaves are of good colour and normal size for the age of the tree. Density and distribution are normal. Bud numbers are normal. Extension growth is consistent with the age of the tree. The condition, compared to others of the same species in the area is normal.

The branches are evenly balanced and of typical size and formation for a tree of this age and size.

Examination of the base of the trunk using a metal probe and sounding hammer did not reveal any noticeable defects.

The rhizosphere (rooting area) of the tree is next to and partially covered by the public footpath on Lascelles Road and the tarmac driveway of the property. This will, to some extent, have restricted root growth and development.

The tree appears in normal condition for a specimen of this age, size and species. The restricted rooting area does not appear to have affected the health of the tree.

The condition, health and stability of the tree are monitored annually.

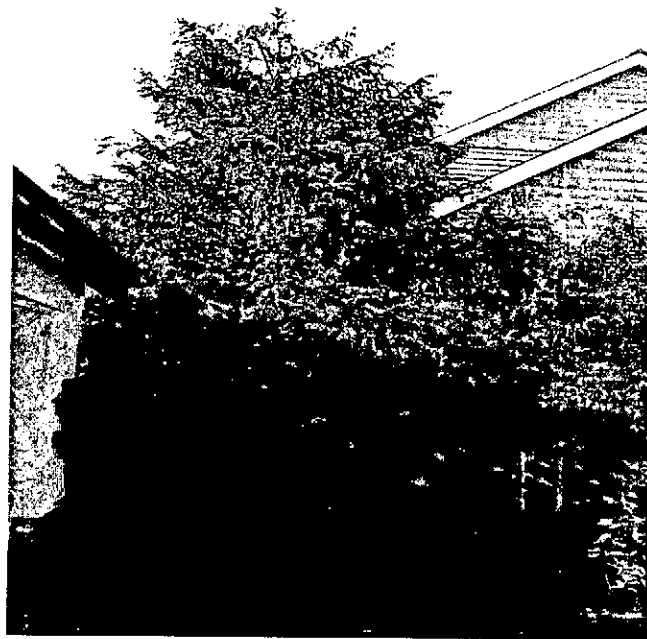
Photo No 2

Leaves are of good colour and normal size for the age of the tree. Density and distribution are normal. Bud numbers are normal. Extension growth is consistent with the age of the tree. The condition, compared to others of the same species in the area is normal.

The branches are evenly balanced and of typical size and formation for a tree of this age and size.

Examination of the base of the trunk using a metal probe and sounding hammer did not reveal any noticeable defects.

The rhizosphere of the tree is next to and partially covered by a brick built garage and the tarmac driveway of the property. This will, to some extent, have restricted root growth and development.

The tree appears in normal condition for a specimen of this age, size and species. The restricted rooting area does not appear to have affected the health of the tree.

The condition, health and stability of the tree are monitored annually.

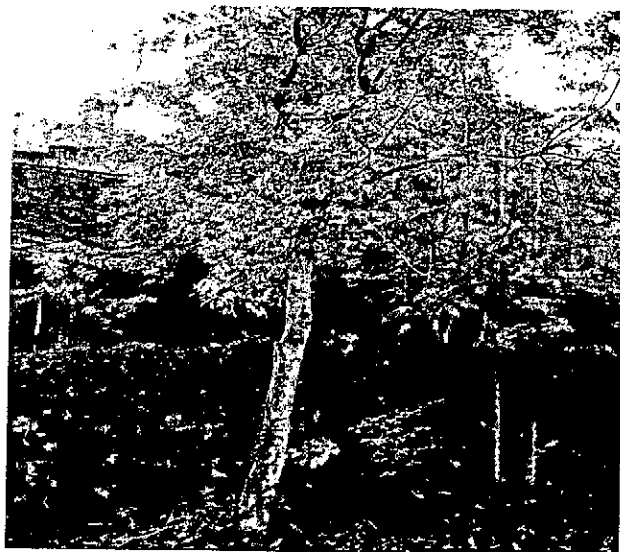
Photo No 5

The tree had shed its leaves due to the season. Bud numbers are normal. Extension growth is consistent with the age of the tree. The condition, compared to others of the same species in the area is normal.

The branches are evenly balanced and of typical size and formation for a tree of this size and age.

Examination of the base of the trunk using a metal probe and sounding hammer did not reveal any noticeable defects.

The tree appears in normal condition for a specimen of this age, size and species. It leans slightly towards the neighbouring property

The condition, health and stability of the tree to be monitored annually.

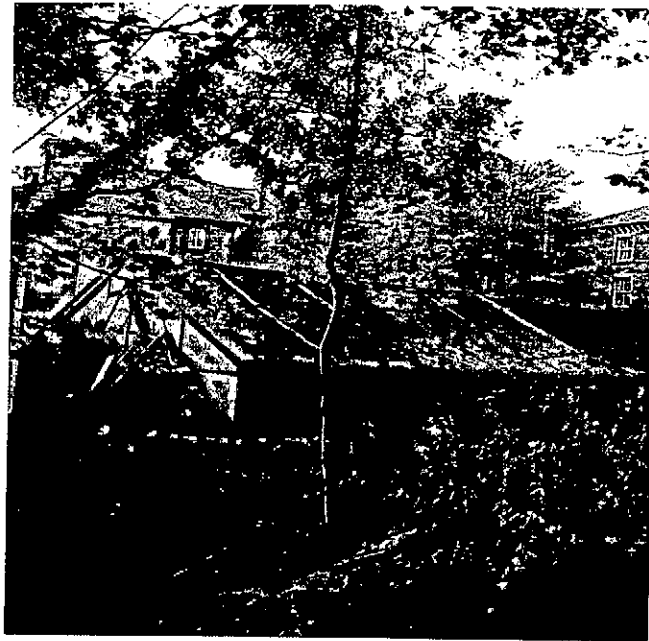
Photo No 6

Branches are evenly balanced at the very top of the tree with none on the lower stem. This has probably arisen when the tree was suppressed by adjacent larger trees, which have been removed.

Examination of the base of the trunk using a metal probe and sounding hammer did not reveal any noticeable defects. The stem shows little natural taper bottom to top and has 'spindly' appearance. This again probably arises as a result of the tree being suppressed.

As there is a lack of natural taper on the stem, affecting strength characteristics, and an uneven weight distribution of branches at the top of the tree, it makes the stem more liable to snap in high winds. Removal of the surrounding trees has also exposed the tree to winds, from which it would have previously been protected.

Residential building development has now taken place on the neighbouring property to within about 2.5m of this tree. In view of this and the problems of possible failure, I recommend the tree is felled.
