SURVEY FOR ASBESTOS CONTAINING MATERIALS

7 High Street West

Glossop
SK13 8AL

Project No: ES/51356

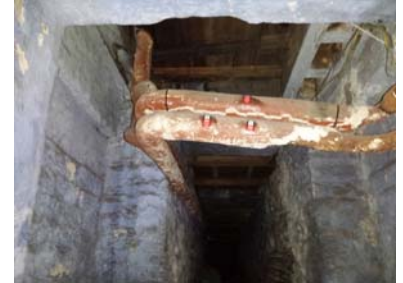
Sample No:	ES/51356/01		
Item:	Pipe insulation		
Location:	B/R004 - Basement - Drop room - To pipework		
Condition:	High Damage		
Extent:	~14 m lin		
Ease of access:	Easy	Surface treatment:	Unsealed
Lab reference:	T901/EUR1/496/001		
Results:	Chrysotile		
Algorithm:	Material	10	+ Priority 6 = 16
Recommendation:	Remove		
Urgency:	Medium (mid-term)		
Further Comments:	This area is contaminated and therefore access should be restricted until remedial works have been undertaken.

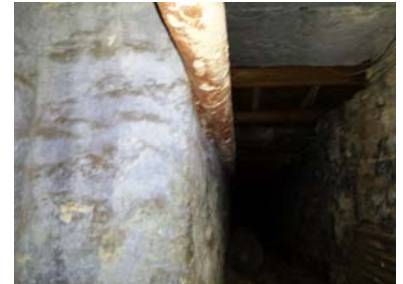
Sample No:	ES/51356/02		
Item:	Insulation residue		
Location:	B/R004 - Basement - Drop room - To walls and ceiling adjacent to pipework		
Condition:	Medium Damage		
Extent:	~8 m lin		
Ease of access:	Easy	Surface treatment:	Unsealed
Lab reference:	T901/EUR1/496/002		
Results:	Chrysotile		
Algorithm:	Material	10	+ Priority 6 = 16
Recommendation:	Remove		
Urgency:	Medium (mid-term)		
Further Comments:	The residue is present to the length of the pipework, 0.5m ² above and 0.5m ² below the pipework. This area is contaminated and therefore access should be restricted until remedial works have been undertaken.

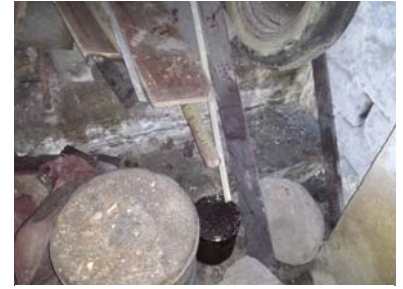
Sample No: ES/51356/03
Item: Insulation debris
Location: B/R004 - Basement - Drop room - To floor
Condition: Low Damage
Extent: <1 m²
Ease of access: Easy **Surface treatment:** Unsealed
Lab reference: T901/EUR1/496/003
Results: Chrysotile
Algorithm: **Material** 10 + **Priority** 5 = 15
Recommendation: Environmental clean
Urgency: Medium (mid-term)
Further Comments: The total floor space is 11m². There are large amounts of rubbish in this area. This area is contaminated and therefore access should be restricted until remedial works have been undertaken.

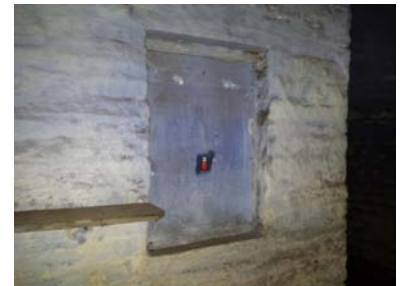
Sample No: ES/51356/04
Item: Insulating board
Location: B/R003 - Basement - Rear store - To wall
Condition: Low Damage
Extent: ~1 m²
Ease of access: Easy **Surface treatment:** Sealed
Lab reference: T901/EUR1/496/004
Results: Chrysotile
Algorithm: **Material** 4 + **Priority** 5 = 9
Recommendation: Manage
Urgency: None (manage)
Further Comments:

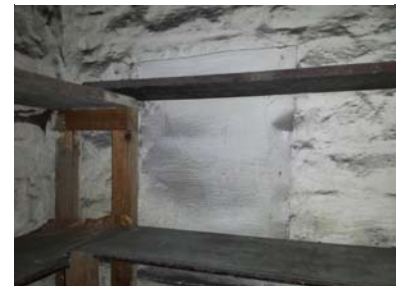
Sample No: ES/51356/05
Item: Insulating board
Location: B/R002 - Basement - Store off stairs - To walls
Condition: Low Damage
Extent: ~1 m²
Ease of access: Easy **Surface treatment:** Sealed
Lab reference: No sample taken
Results: Strongly presumed to be Chrysotile
Algorithm: **Material** 4 + **Priority** 5 = 9
Recommendation: Manage
Urgency: None (manage)
Further Comments: Strongly presumed to be as sample ES/51356/04.

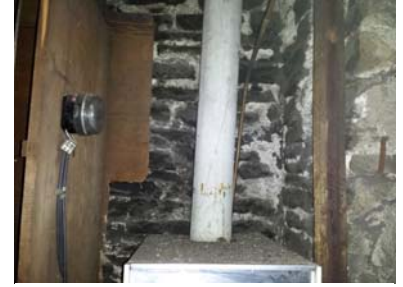
Sample No: ES/51356/08
Item: Cement flue pipe
Location: GF/R005 - Ground Floor - Shop floor - Above boiler
Condition: Low Damage
Extent: ~6 m lin
Ease of access: Easy **Surface treatment:** Unsealed
Lab reference: T901/EUR1/496/008
Results: Chrysotile
Algorithm: Material + Priority =
Recommendation: Manage
Urgency: None (manage)
Further Comments:

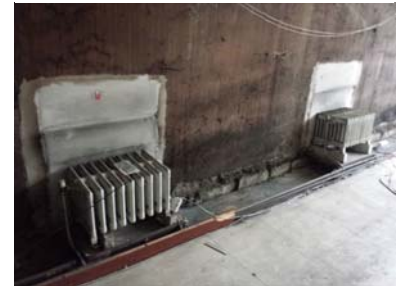
Sample No: ES/51356/09
Item: Insulating board
Location: GF/R005 - Ground Floor - Shop floor - To floor below 2 small radiators
Condition: Low Damage
Extent: <1 m²
Ease of access: Easy **Surface treatment:** Unsealed
Lab reference: T901/EUR1/496/009
Results: Chrysotile
Algorithm: Material + Priority =
Recommendation: Remove
Urgency: Medium (mid-term)
Further Comments: Present to 2 small radiators to the right hand side

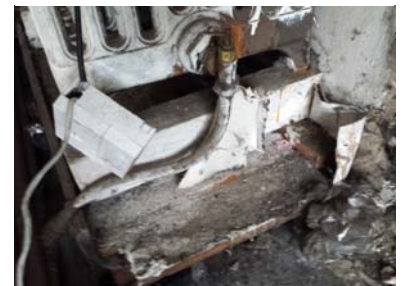
Sample No: ES/51356/10
Item: Insulating board debris
Location: GF/R005 - Ground Floor - Shop floor - To surrounds of 2 small radiators
Condition: High Damage
Extent: ~4 m²
Ease of access: Easy **Surface treatment:** Unsealed
Lab reference: T901/EUR1/496/010
Results: Chrysotile
Algorithm: Material + Priority =
Recommendation: Remove
Urgency: Medium (mid-term)
Further Comments: There are small amount of debris where the boxing has been removed from 2 small radiators.

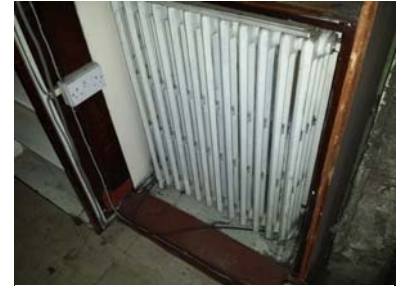
Sample No: ES/51356/11
Item: Insulating board
Location: GF/R005 - Ground Floor - Shop floor - To floor below large radiators on the right hand side
Condition: Low Damage
Extent: <1 m²
Ease of access: Easy **Surface treatment:** Unsealed
Lab reference: No sample taken
Results: Strongly presumed to be Chrysotile
Algorithm: Material 6 + Priority 5 = 11
Recommendation: Remove
Urgency: Medium (mid-term)
Further Comments: Strongly presumed to be as sample ES/51356/09.

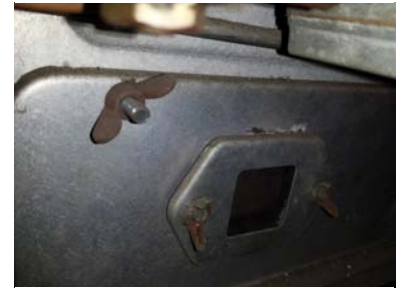
Sample No: ES/51356/14
Item: Gaskets
Location: GF/R005 - Ground Floor - Shop floor - To boiler pilot light glass
Condition: Low Damage
Extent: <1 m²
Ease of access: Medium **Surface treatment:** Sealed
Lab reference: T901/EUR1/496/014
Results: Chrysotile
Algorithm: Material 6 + Priority 5 = 11
Recommendation: Remove
Urgency: Medium (mid-term)
Further Comments:

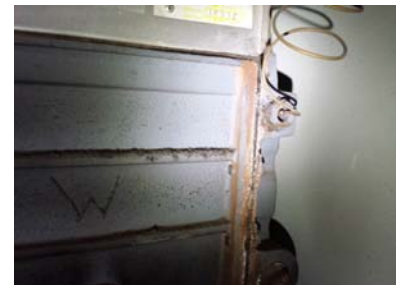
Sample No: ES/51356/15
Item: Gaskets
Location: GF/R005 - Ground Floor - Shop floor - To main body of boiler
Condition: Low Damage
Extent: <1 m²
Ease of access: Easy **Surface treatment:** Sealed
Lab reference: T901/EUR1/496/015
Results: Chrysotile
Algorithm: Material 6 + Priority 5 = 11
Recommendation: Remove
Urgency: Medium (mid-term)
Further Comments:

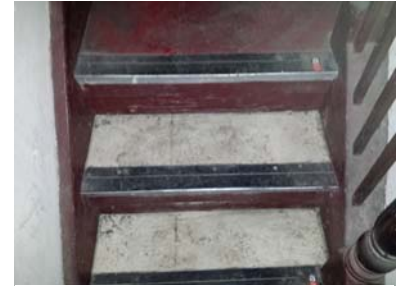
Sample No: ES/51356/18
Item: Black nosing strip
Location: GF/R011 - Ground Floor - Stairs to first floor - To steps
Condition: Low Damage
Extent: ~12 m lin
Ease of access: Easy **Surface treatment:** Composite
Lab reference: T901/EUR1/496/018
Results: Chrysotile
Algorithm: Material + Priority =
Recommendation: Manage
Urgency: None (manage)
Further Comments:

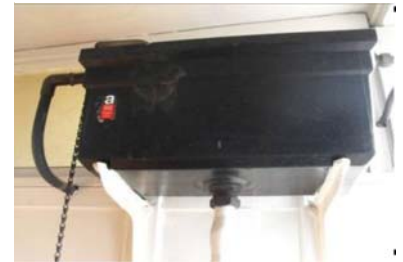
Sample No: ES/51356/21
Item: Toilet cistern
Location: 2F/R020 - 2nd Floor - Toilet - To wall
Condition: Low Damage
Extent: 1 No.
Ease of access: Easy **Surface treatment:** Composite
Lab reference: T901/EUR1/496/021
Results: Chrysotile
Algorithm: Material + Priority =
Recommendation: Manage
Urgency: None (manage)
Further Comments:

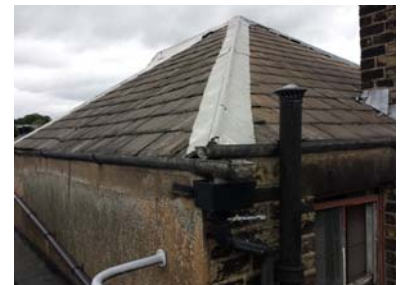
Sample No: ES/51356/23
Item: Cement guttering
Location: E/R099 - External - External areas - To main pitched roof
Condition: Low Damage
Extent: ~36 m lin
Ease of access: Medium **Surface treatment:** Unsealed
Lab reference: T901/EUR1/496/023
Results: Chrysotile
Algorithm: Material + Priority =
Recommendation: Manage
Urgency: None (manage)
Further Comments: The gutters are set in concrete on top of the wall.

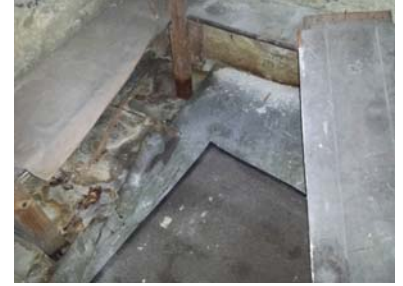
Sample No: ES/51356/06
Item: Green vinyl floor covering
Location: B/R002 - Basement - Store off stairs - To floor
Extent: ~6 m²
Lab reference: T901/EUR1/496/006
Results: No asbestos detected
Recommendation: No action required
Further Comments:

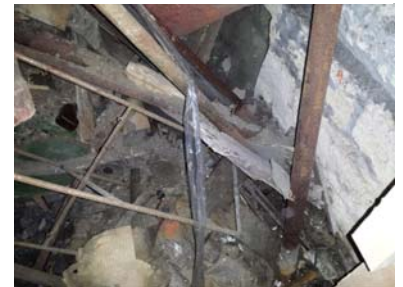
Sample No: ES/51356/07
Item: Green vinyl floor covering
Location: B/R003 - Basement - Rear store - Loose on floor under stairs
Extent: <1 m²
Lab reference: No sample taken
Results: Strongly presumed no asbestos detected
Recommendation: No action required
Further Comments: Strongly presumed to be as sample ES/51356/06.

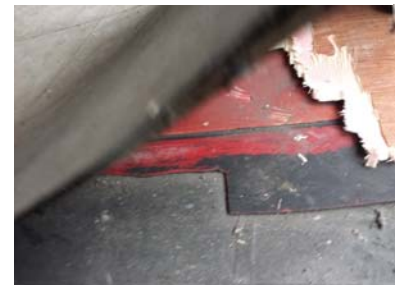
Sample No: ES/51356/12
Item: Red vinyl floor covering
Location: GF/R005 - Ground Floor - Shop floor - To floor below plywood
Extent: ~20 m²
Lab reference: T901/EUR1/496/012
Results: No asbestos detected
Recommendation: No action required
Further Comments:

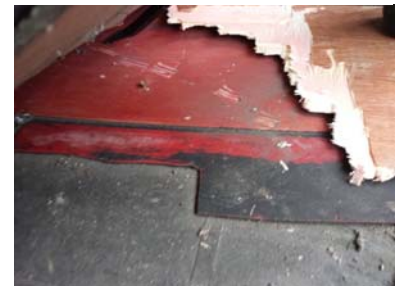
Sample No: ES/51356/13
Item: Red vinyl floor covering
Location: GF/R022 - Ground Floor - Corridor adjacent to basement stairs - To floor below grey vinyl floor tiles and plywood
Extent: ~4 m²
Lab reference: No sample taken
Results: Strongly presumed no asbestos detected
Recommendation: No action required
Further Comments: Strongly presumed to be as sample ES/51356/12.

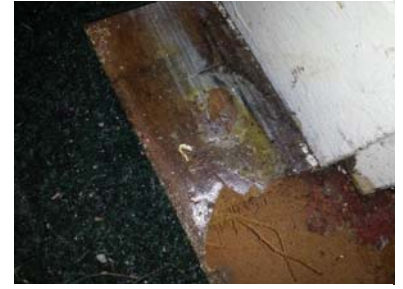
Sample No: ES/51356/16
Item: Orange vinyl floor covering
Location: GF/R006 - Ground Floor - Consultation room - To floor below carpet
Extent: ~12 m²
Lab reference: T901/EUR1/496/016
Results: No asbestos detected
Recommendation: No action required
Further Comments:

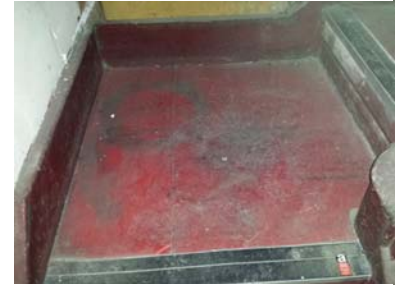
Sample No: ES/51356/17
Item: Red vinyl floor covering
Location: GF/R011 - Ground Floor - Stairs to first floor - To steps
Extent: ~6 m²
Lab reference: No sample taken
Results: Strongly presumed no asbestos detected
Recommendation: No action required
Further Comments: Strongly presumed to be as sample ES/51356/12.

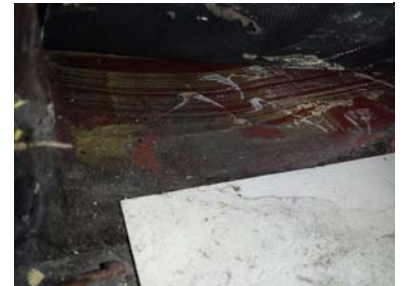
Sample No: ES/51356/19
Item: Red vinyl floor covering
Location: GF/R009 - Ground Floor - Rear store room - To floor below plywood and grey vinyl floor tiles
Extent: ~12 m²
Lab reference: No sample taken
Results: Strongly presumed no asbestos detected
Recommendation: No action required
Further Comments: Strongly presumed to be as sample ES/51356/12. Continues into first floor store below plywood and grey vinyl floor tiles.

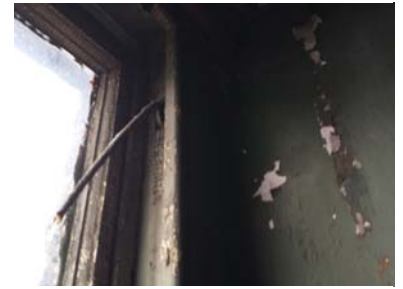
Sample No: ES/51356/22
Item: Sash cord
Location: 2F/R017 - 2nd Floor - Wash up - To windows
Extent: 1 No.
Lab reference: T901/EUR1/496/022
Results: No asbestos detected
Recommendation: No action required
Further Comments: Present to 7 windows in total.
