**Brown Edge Road  
Buxton  
– BS 5837 Tree Survey**

Report Title: **Brown Edge Road, Buxton  
Tree Survey Report**

Revision: **V01**  
Issue Date: **June 2013**  
Report Ref: **4616**

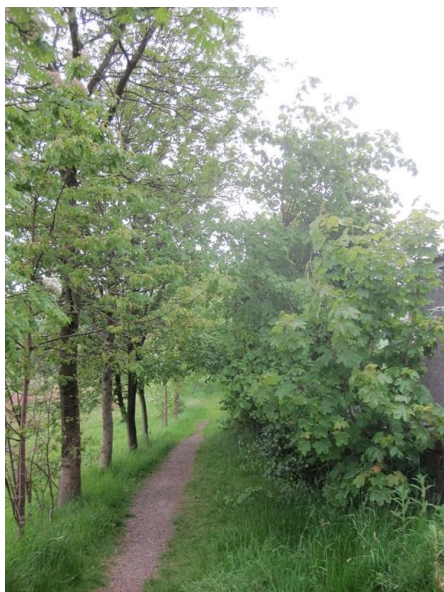
| Tree No | Species | Ht (m) | Stem Diam cm@ 1.5m (mm) | Canopy Spread (m) N- E- S- W | Height of Crown Clearance | Age Class | Est yrs | Overall Condition | Structural condition | Management Recommendations | BS 5837 Category | RPA Radius (m) | RPA (m <sup>2</sup> ) |
|---|---|---|---|---|---|---|---|---|---|---|---|---|---|
| G8 | Mixed group | 7 | 180 | 3-3-3-3 | 1.8 | SM | 40+ | Good | - | - | C2 | 2.16 | 14.66 |

**Tree group G8 (left) and footpath to playing field**

- 4.2.1 As the development proposals assume the removal of G8 and two trees within G6, no protection measures will be required for these trees.
- 4.2.2 It is recommended that replacement tree planting is carried out within the proposed landscape scheme for the site. Proposed tree species should be suitable for small garden spaces, and planted at minimum Heavy Standard size.
- 4.2.3 All trees to be retained require protective fencing in accordance with BS 5837:2012.
- 4.2.4 Additional protective measures will be required where construction access and construction work is justified in the Root Protection Areas of trees to be retained. These measures include no-dig construction for proposed permanent paving and access facilitation pruning where low hanging branches may be liable to damage during construction operations.

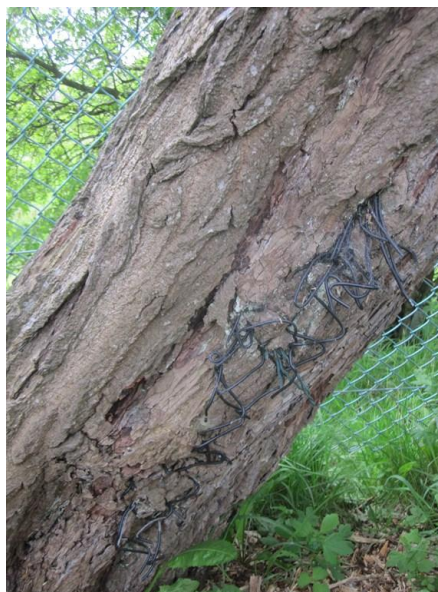
| Tree No | Species | Ht (m) | Stem Diam cm@ 1.5m (mm) | Canopy Spread (m) N- E- S- W | Height of Crown Clearance | Age Class | Est yrs | Overall Condition | Structural condition | Management Recommendations | BS 5837 Category | RPA Radius (m) | RPA (m²) |
|---|---|---|---|---|---|---|---|---|---|---|---|---|---|
| G6 | Mixed group | 15 | 470 | 4-4-4-4 | 2 | OM | 20+ | Fair | Group of overmature Goat Willows with cavities and leaning, one tree with severe chain link fence girdling damage | Monitor, retain if possible for ecological value, remove tree with girdling damage for safety | B2 | 5.64 | 99.93 |

**Girdling damage of goat willow in G6**

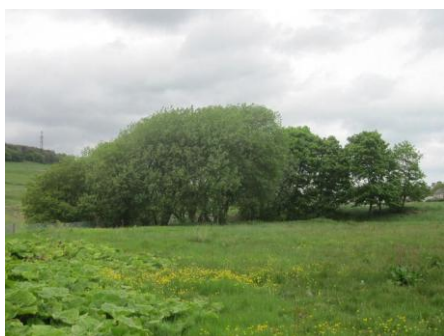
| Tree No | Species | Ht (m) | Stem Diam cm@ 1.5m (mm) | Canopy Spread (m) N- E- S- W | Height of Crown Clearance | Age Class | Est yrs | Overall Condition | Structural condition | Management Recommendations | BS 5837 Category | RPA Radius (m) | RPA (m <sup>2</sup> ) |
|---|---|---|---|---|---|---|---|---|---|---|---|---|---|
| G7A* | Mixed group | 12 | 270 | 4-4-4-4 | 1.5 | M | 40+ | Fair | Group of Goat Willow and Norway Maple. One Willow dying and leaning to north | If possible, retain willow for ecological value | B2 | 3.24 | 32.98 |

**Group G6 and G7**

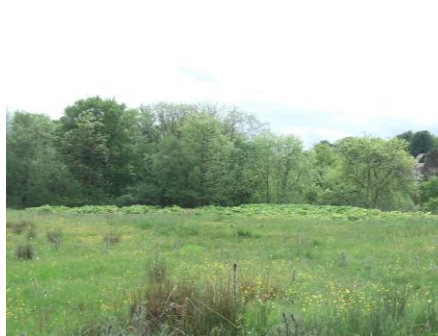
| Tree No | Species | Ht (m) | Stem Diam cm@ 1.5m (mm) | Canopy Spread (m) N- E- S- W | Height of Crown Clearance | Age Class | Est yrs | Overall Condition | Structural condition | Management Recommendations | BS 5837 Category | RPA Radius (m) | RPA (m <sup>2</sup> ) |
|---|---|---|---|---|---|---|---|---|---|---|---|---|---|
| T17* | Betula nigra | 10 | 250 | 2-2-2-2 | 1.5 | M | 40+ | Fair | Strong lean to north | Remove | U | 3.00 | 28.27 |

**Trees T14- T18**
