Ridge Farm Barns and out building

Structural Condition Report

Project No. 2077
August 2009

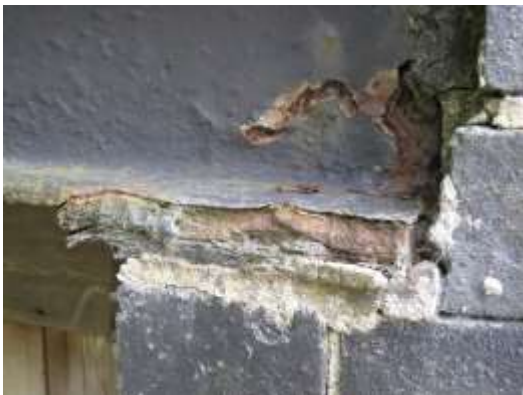
- 1) Steel lintel over barn door badly corroded with high % loss – needs replacing (figs 1,2,3)
- 2) Stone cills cracked – need repair or replace
- 3) Roof sags by some 200mm – see internal note number 3) – (fig 5)
- 4) Base of wall needs rebuilding – bricks missing
- 5) Some minor cracks / signs of building settlement – general repair / making good required
- 6) External timbers show some signs of deterioration – timber survey required
- 7) Generally all external elevations need repointing
- 8) Drainage survey required

Fig 1) corrosion of lintel bearing

- Steel lintel over barn door needs replacing
- Steel beams in general needs rubbing back and protecting
- Some settlement in one area identified on plan. This specific area should be investigated with possible minor underpin works required
- Where roof sag is occurring, the purlins have been checked for structural adequacy and deemed to be well undersized (overstressed) and predicted deflections through calculation accord with the magnitude of deflection evident on site. These timbers need replacing.
- Structural steel beam identified on plan is undersized and showing signs of excessive deflection. Needs replacing or strengthening.
- Some cracking (loss of bond) has occurred at a number of corners – these areas will need steel straps to tie areas together
- Damp penetration into lower ground is extensive in areas and will need addressing as part of the conversion works

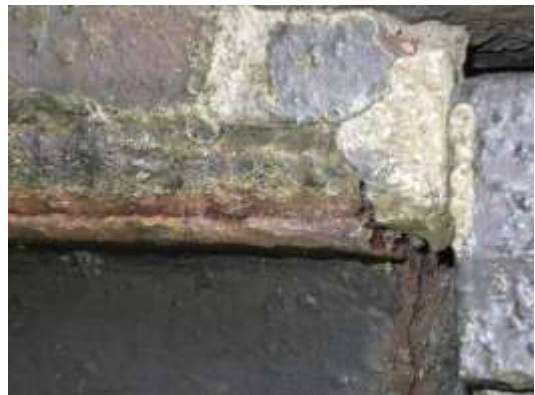
fig 2) lintel bearing area

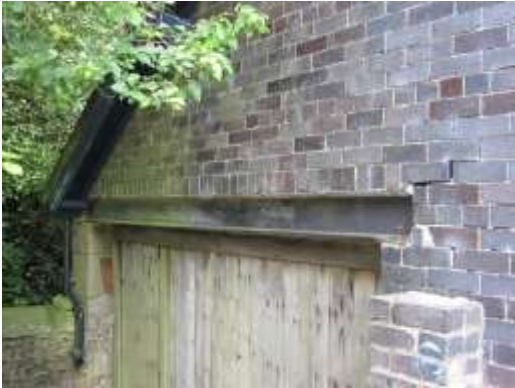
Fig 3) lintel needs replacing

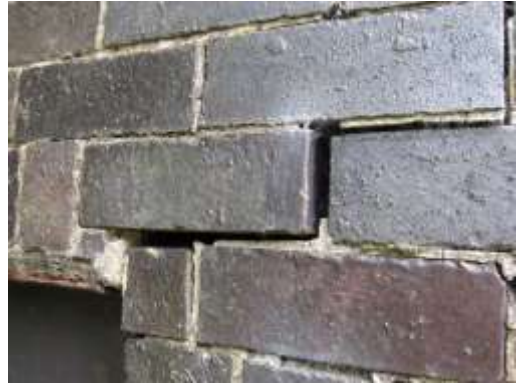
fig 4) damage due to lintel

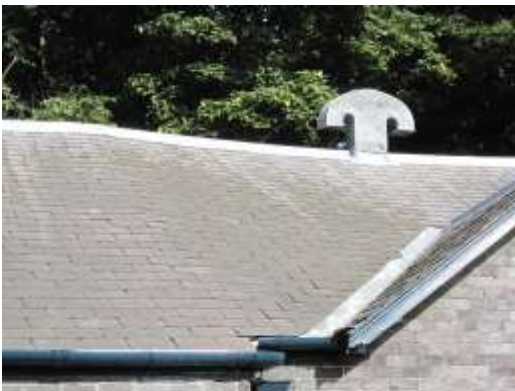
Fig 5) roof sag

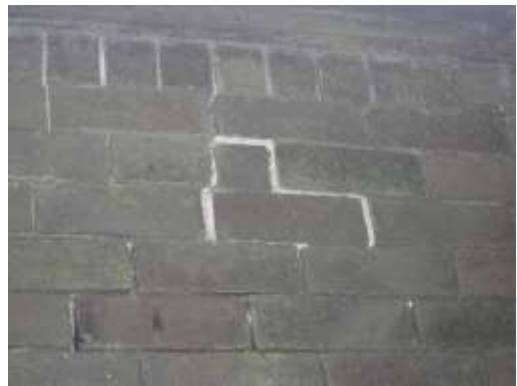
fig 6) general repointing

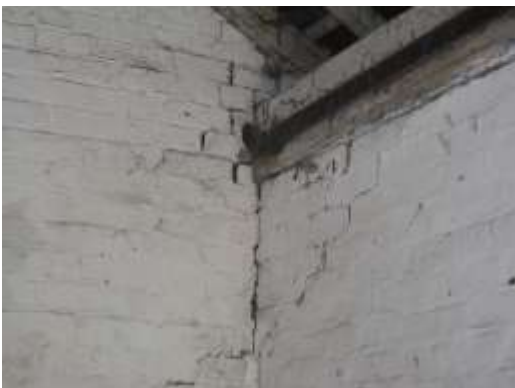
- 1) Ends of 75 by 75 filler joists exposed – these voids should be filled to protect joists (fig 8)
- 2) Movement cracks at wall corner with some separation – steel ties required to stitch corner together (fig 7)

Fig 7) separation at corner

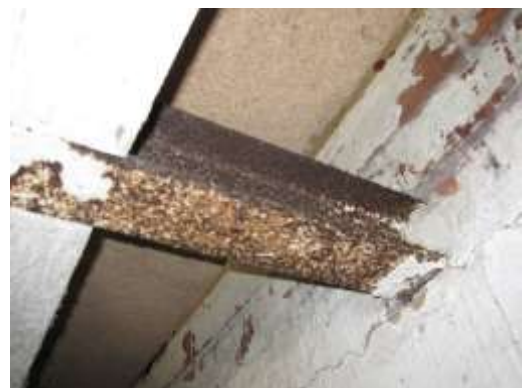
fig 8) filler joist floors

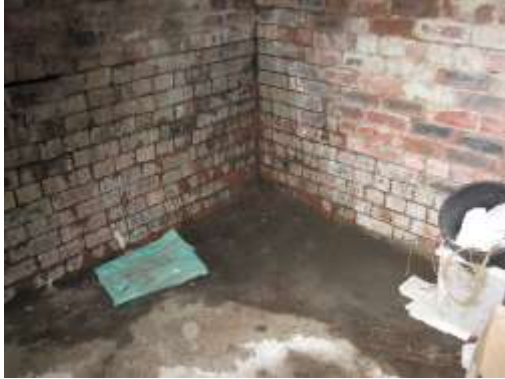
- 5) Large area of damp penetration (fig 9)
- 6) Large crack in walls running vertically – appears to be some settlement in corner of wall (fig 16)
- 7) Crack over doorway – wall movement. Will require steel straps to stitch together (fig 15)

Fig 9) damp penetration

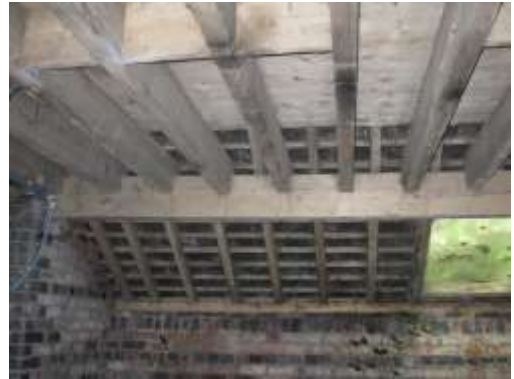
- 8) 140 by 120 steel supporting 600 high wall plus floor. Beam shows visible deflection. Design check shows this steel to be undersized (fig 12,23)
- 9) Damp penetration to corner – standing water on floor (fig 10)

fig 10) roof construction

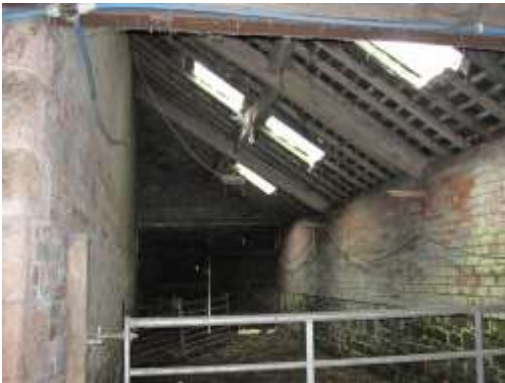
Fig 11) roof over lower barn

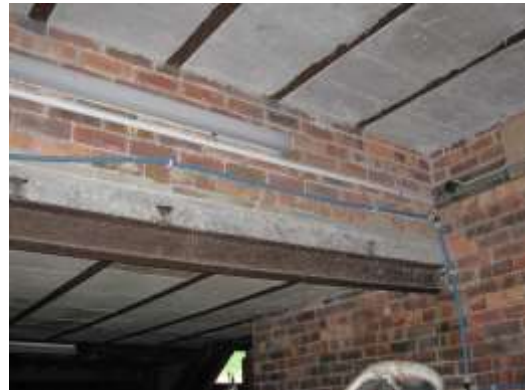
fig 12) undersized steel- sag

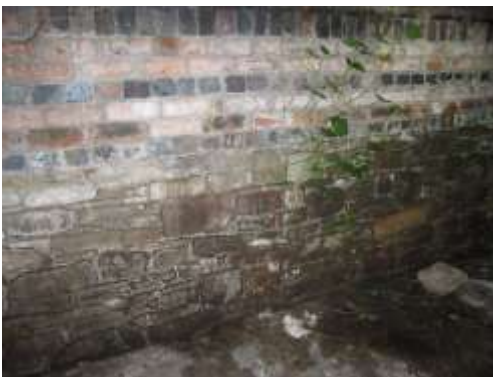
Fig 13) settlement

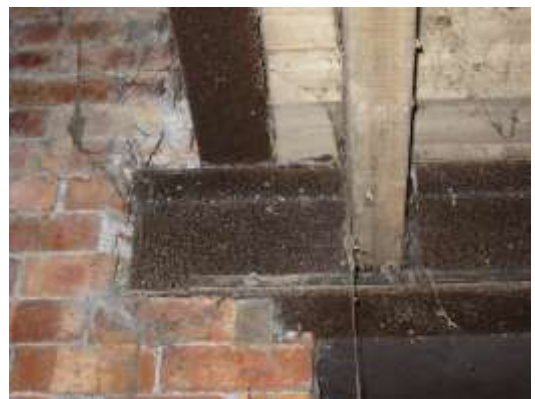
- 10) 280 by 110 timber – visible signs of deflection. Design check shows this timber to be undersized
- 11) Some steel corrosion on beam over – needs brushing back and protecting (fig 14)

fig 14) surface rusting

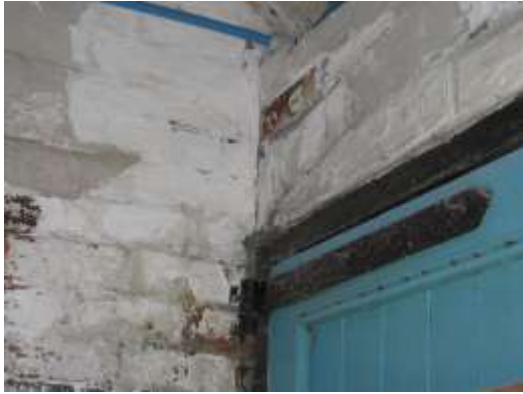
Fig 15) crack over door

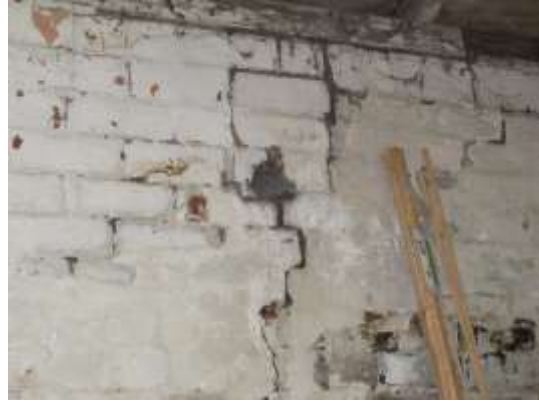
Fig 16) settlement cracks

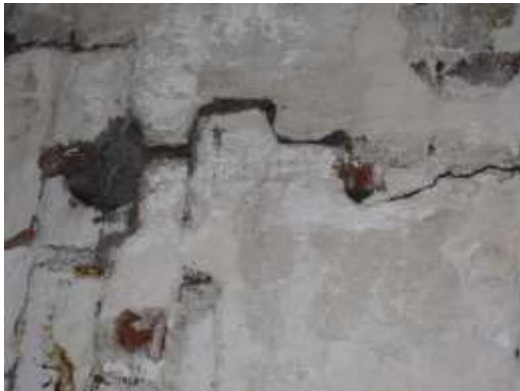
Fig 17) settlement cracks

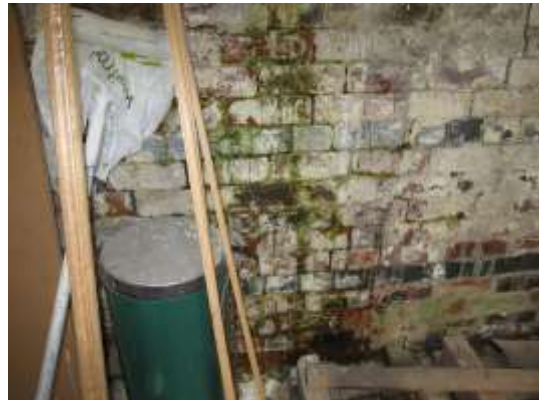
fig 18) damp penetration

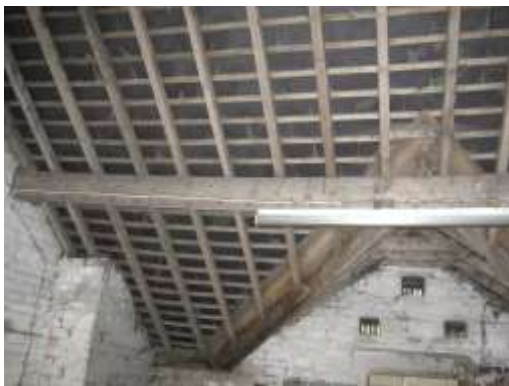
- 3) 220 by 110 timber purlin sagging by up to 200mm. Design check indicates this purlin to be well undersized and over stressed (fig 19,20)
- 4) Subsidence cracks visible near corner of wall – area appears to have subsided by circa 2 to 3 inches – probably historic

Fig 19) undersized purlin

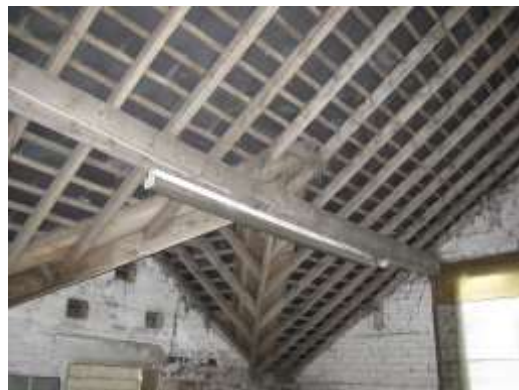
fig 20) undersized purlin

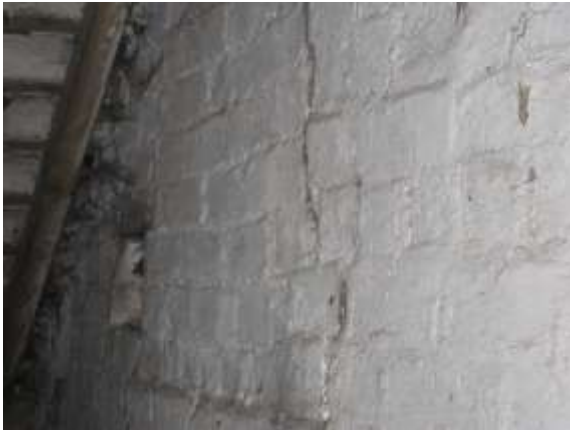
Fig 21) settlement crack

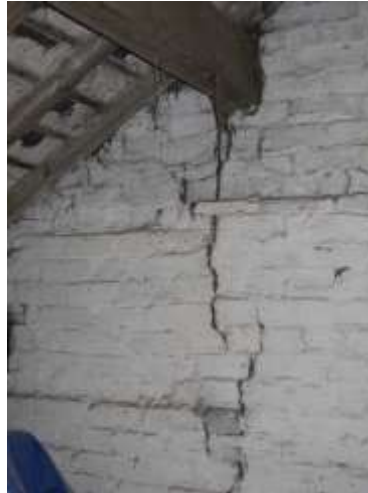
Fig 22) settlement crack

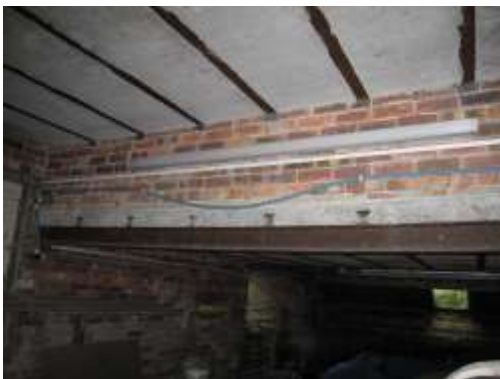
Fig 23) undersized beam

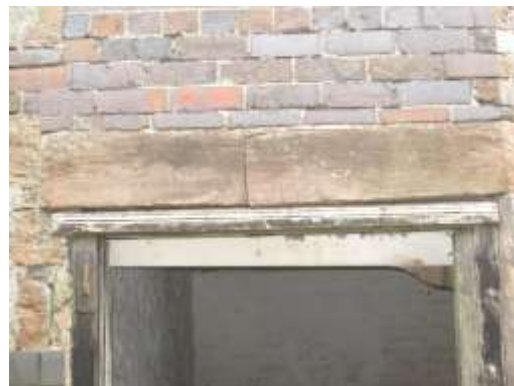
- Cracking to lintel to front of building (fig 24)
- Settlement crack on front elevation – probably historic (fig 25)
- Generally needs repointing
- Not all elevations accessible due to overgrowth, but building seems to be in sound condition with not major signs of distress

fig 24) cracked lintel

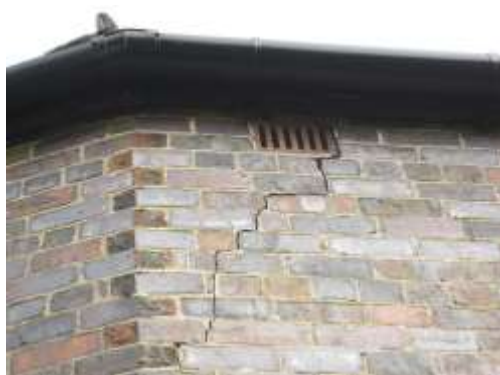
Fig 25) movement at corner

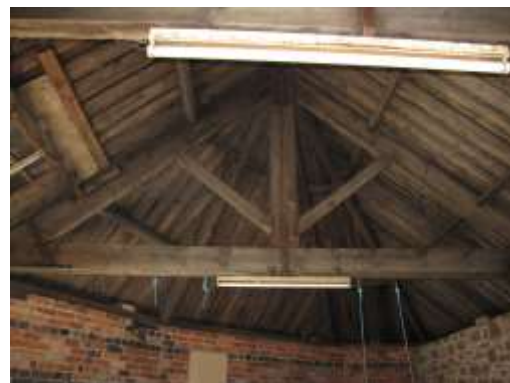
- King post truss supports to roof look in reasonable condition but timber survey is recommended (fig 26)
- Crack across filler joist floor to first floor – runs parallel with filler joists. Not reflected on soffit. Suggest repaired at first floor level (fig 27)
- Settlement crack over lintel to lower level. Needs tie to stitch together (fig 28)
- External crack to front elevation is reflected internally
- Central steel supporting first floor (4800 span) has been checked for structural adequacy and found to be undersized (deflection evident on site)

fig 26) king post truss

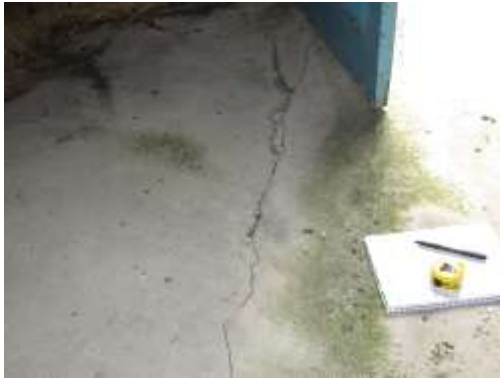
Fig 27) first floor crack in slab

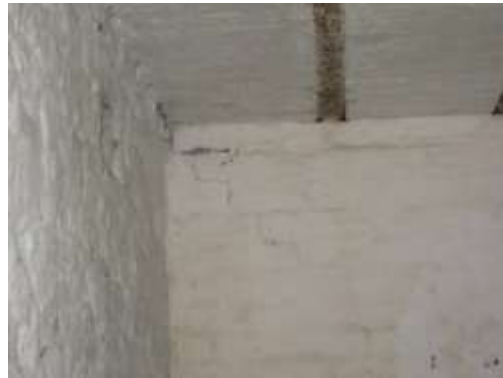
fig 28) corner crack

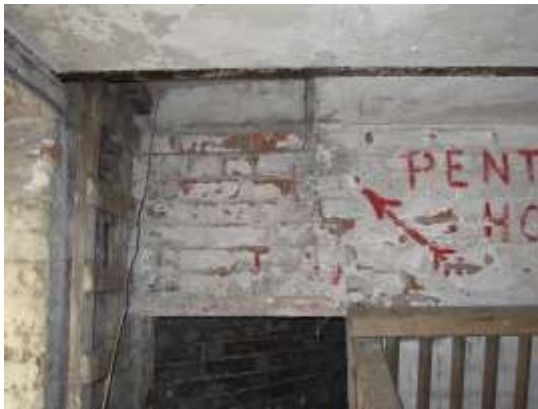
Fig 29) settlement around door
