WHITE PEAK TREE CONSULTANCY LTD

Land adjacent to 'Gadley House' Manchester Road Buxton

Arboricultural Implication Study

March 2015
wptc.gen-15.001

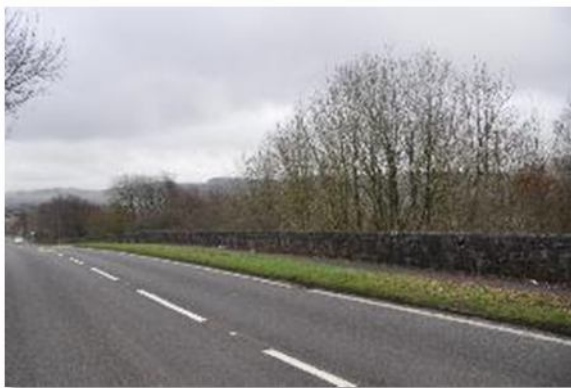
Photograph 1

- 2.2 **Brief site description:** Buxton is a spa town located in Derbyshire, England. It lies at around 307metres above sea level and vies with Alston, Cumbria as the highest market town in England. Cavendish Golf Club and its associated course lies to the west of Buxton on the rising ground between Manchester Road (Long Hill) to the north east and Bishops Lane to the south west. The development land is located to the north of the course on the bank immediately east of 'Gadley House' and just below Manchester Road. The generally character of the locality is rural fringe (photograph 1).

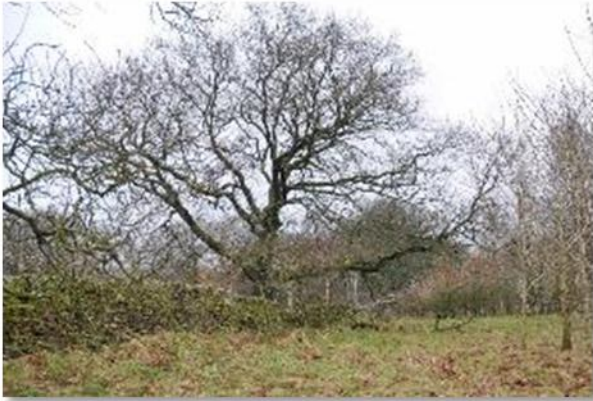
Photograph 2

3.6 **Tree 1 and Tree 2 – English oak:** These two trees stand within the expansive rear garden of 'Gadley House' to the west of the proposed development area. They are typical specimens of English oak with compact crown structures and low lateral branches that extend over the boundary wall and encroach into the development land (photograph 2).

- 3.7 It is apparent that they will not be directly affected by the current proposal because the nearest dwelling plots are likely to be positioned well away on the higher ground to the east of their location. Nonetheless, an appropriate tree protection barrier should be erected to ensure that no construction activities, material storage or vehicular movement occurs in the proximity of these trees as described below in sections 3.20-3.27.

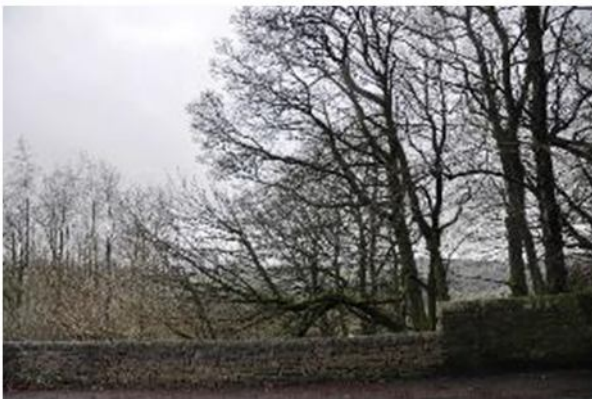
Photograph 3

- 3.8 **Group 3 – beech, sycamore and horse chestnut:** This mixed group of broad-leaved trees stand north and west of the proposed development area, also within the grounds of 'Gadley House'. Generally they are tall and slender specimens that have grown up together as a group and consequently have developed co-dominant crowns that emerge to one overall crown mass. Despite their generally tall habit, several of these trees have low branches that extend over the boundary to a considerable extent with one horse chestnut presenting a very low arching branch that touches the ground with the proposed development area (photograph 3).

- 3.9 The current outline proposal takes account of these low overhanging branches and the encroaching root zones of these trees by retaining a 'buffer zone' of at least 8 metres along the boundary with 'Gadley '. This strip would remain undeveloped and allow the adjacent trees to remain unaffected by the proposal. Further information in on protection measures are included in sections 3.20-3.27.
- 3.10 **Tree 4, Tree 5 and Tree 6 – willow:** These three specimens of goat willow are typical over-mature examples with leaning and subsiding stems that reach down to the ground in places. Deadwood and broken branches are scattered throughout their crowns and they are generally decrepit in form and low in vigour (photograph 4).

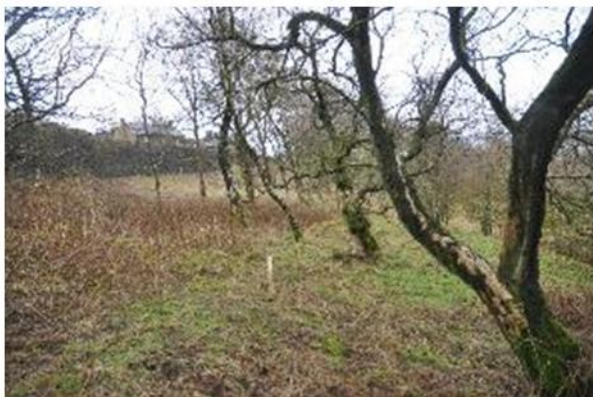
Photograph 6

- 3.14 **Area 8 – birch:** With the exception of few outlying trees, this sparse area of downy birch extends to the south and east away from the proposed development area (photograph 6). Because of this it will be possible to retain the greater part of Area 8 without any risk the integrity of the trees, either during or after the development process. This will however be dependant of the proper implementation of adequate tree protection measures as outlined below in sections 3.20-3.27.

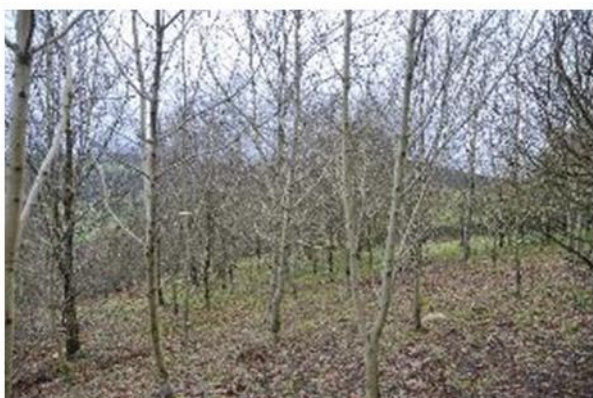
Photograph 7

- 3.15 **Area 9 – ash, birch, rowan, oak, cherry, hazel, hawthorn maple:** This area covers the greater part of the site and comprise substantial blocks of common ash, downy and silver birch, rowan, English oak, bird cherry, common hazel, common hawthorn, field maple and Norway maple. All these trees appear to have been planted as part of greater plantation scheme some years ago, as most are spaced at equidistant centres and of comparable age across each species block. Redundant stakes and partially degraded tubular tree shelters are also evident across the whole area (photograph 7).

- 3.16 Perennial weeds and tall grasses are beginning to establish in the more open parts of the area particularly, mainly on the upper part of the slope, along the boundary wall below Manchester Road. Unfortunately, the undifferentiating removal of the majority (if not all) of the trees within Area 9 that lie the development window will be necessary if the current outline proposal is to be realised. It may be possible to retain an area of trees towards the west near to the boundary with 'Gadley House', but ideally this option should be assessed at the reserved matters stage.

- 3.17 Fortunately, it will be possible to integrate some new individual trees into the development in mitigation for those that are being lost. However, this will not wholly compensate for the quantity being lost and some supplementary off site planting may be appropriate. Opportunely, the relatively young age of the trees and the nature of the site should enable their replacement elsewhere in the golf course.
