B. J. UNWIN FORESTRY CONSULTANCY

Site: **part of Branksome
Care Home,**
56 St.John's Road, Buxton,
SK17 6TR.

Subject: **BS5837 Tree Survey**
Of site for proposed extension including:-
➤ **Tree Constraints** on site.
➤ **Arboricultural Implications** of proposed re-
development.
➤ **Tree Retention & Tree Protection Method
statement.**

Surveyor: Jim Unwin
Date: April 2014 stage 2 June 2014

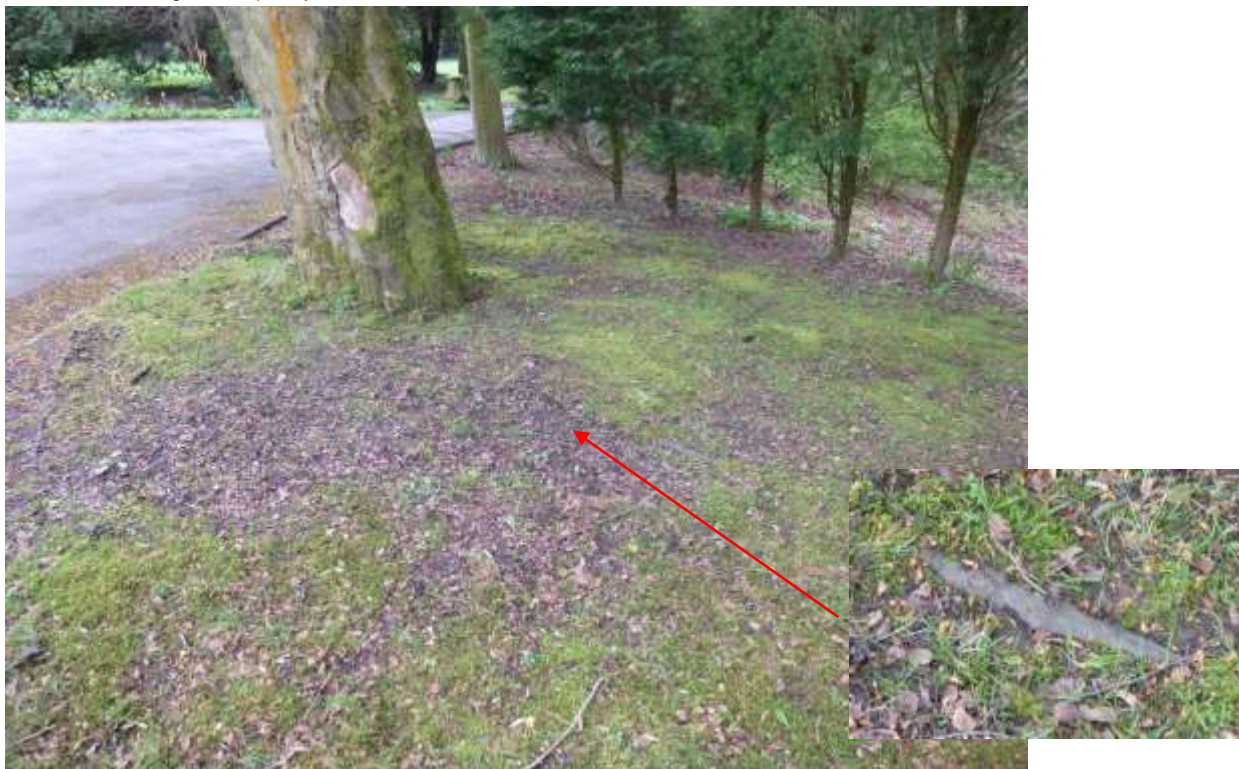
T4	Beech	93	19 4 19	8 11 5 7	M	F	10-20	Lean east north east. Some exposed roots on south west side suggest some rootplate movement. Dominates nearby building.	B2 size C1 quality.	11.2	Remove completely. Or attempt to re-balance by 4m off all parts of main stems to north and east. 3m off north and east sides.
T5	Lawson cypress	38	13 4 14	1.5 2 2 1	Em / M	F	20-40	Part of drive side avenue.	C1	4.6	
T6	Spruce	23	15 12 0	1.2m all round	Em	P	10	Part of drive side. Poor: spindly.	U		Fell.
T7	Lawson cypress	32	13 3.5 14	1.25 2.5 1.5 1.5	Em / M	F	20-40	Part of drive side.	C1	3.9	
T8	Holly	17, 20	9 2.5 9.5	2 3 1.5 1.5	Em / M	F	20-40	Part of drive side.	C1	3.2	
T9	Camperdown elm	36	4.5 1 4.5	3 2 2 3	M	F	10-20	Weeping elm. Grafted at 1.8m height.	C1	4.4	
G10	Lawson cypress x many	45	13 0 14	1.5 2 1.5 2	M	F	10-20	Northern tree of long mostly Lawson cypress avenue down drive.	B2	5.4	
H11	Leyland cypress	13-25	12-15 1.5 6	1.25m external	Em	F	10-20	Good hedge, tall and narrow.	C2	3.0	Top at 8m approx. half height, and shape in upper sides.

P3: View east to base of beech T4. One of several exposed roots marked.

- Spaces 12-14 are within RPA of H11 and beech T4. Remove both.

- Beech T4 already shades the existing property, and together with H11 will shade the new extension. Remove both.
- Sycamore, ash & cherry T1-T3 will cast afternoon shade onto the new extension. Crown lifting and trimming back is required.

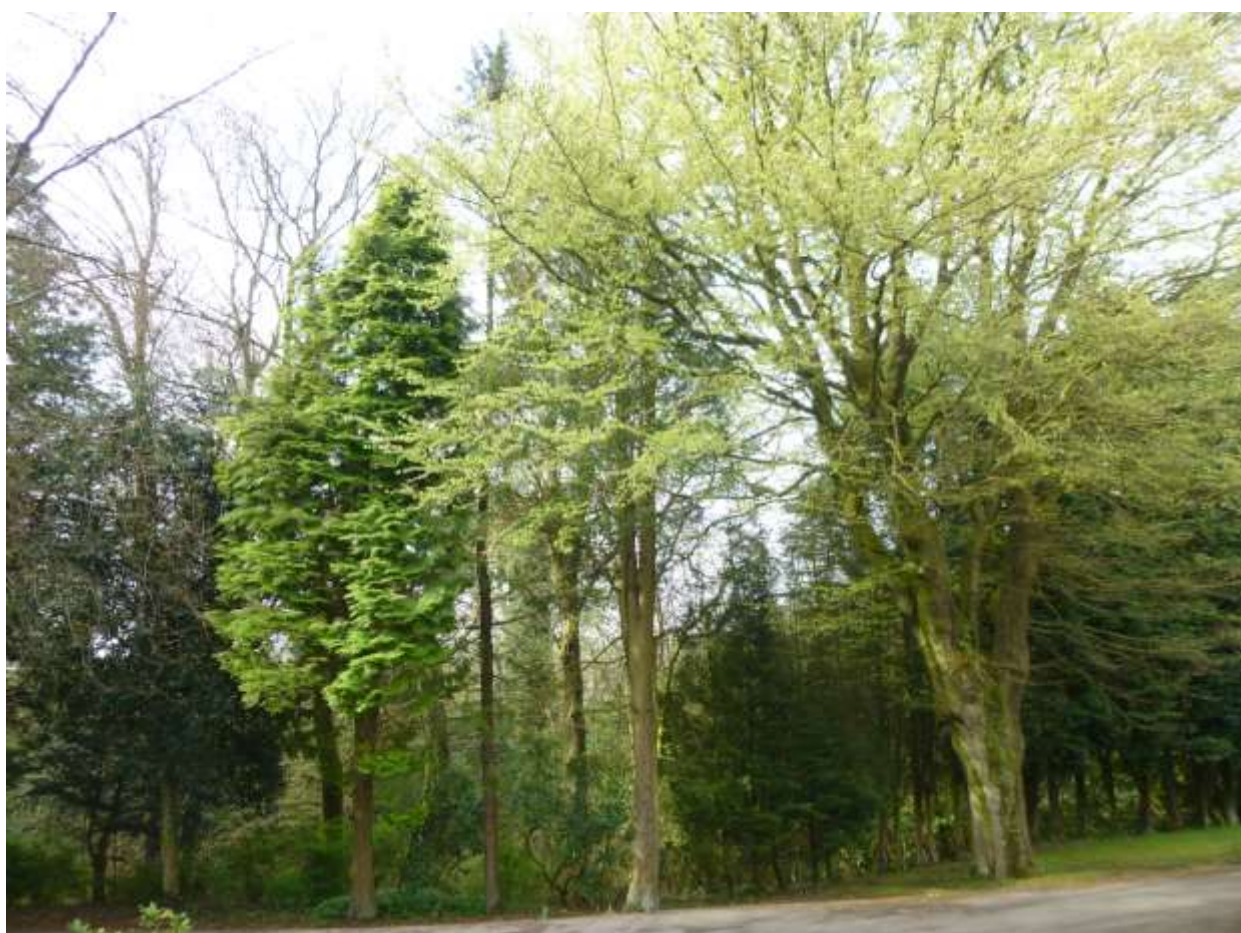
- Beech T4 is a problematic tree. It is very large but leans significantly north east over the access drive and close to the building. It severely dominates the centre of the already-overgrown site. Additionally there are exposed roots on the tension side of the rootplate (see photos). Either it needs heavy crown reduction to restore balance, or better, complete removal to create some glade areas in a congested site.

P4: View south west to beech T4 right and other avenue trees T5-8 on its left.

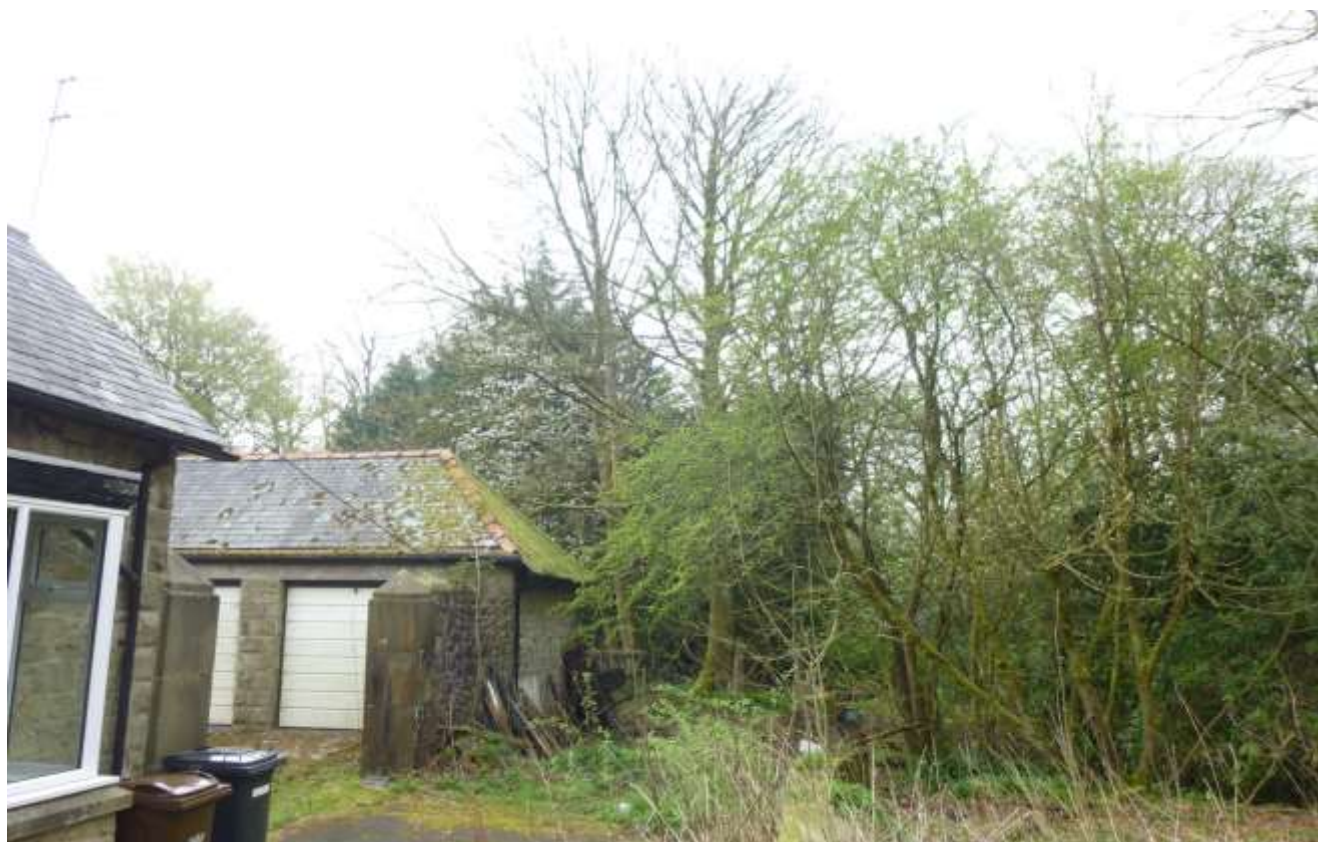
T12	Hawthorn	12, 17, 18	7 2 7.5	4 4.5 1.5 1.5	M	F	10-20	Three stem, self-sown, 1.6m west of garden wall.	C2	3.4	Crown lift east side.

P5: View south east to sycamore T1 & ash T2 centre. Hawthorn T12 on right.

- T1-T4 and H11 will all shed material and over-bear the new extension. T4 has other problems so remove it with H11. Prune back T1-T3.
