Our Ref: TEW/J1015221
Your Ref:

19th May 2015

STRUCTURAL REPORT
Redundant Building, Hill Top Farm, Higher Chisworth, SK13 5SA

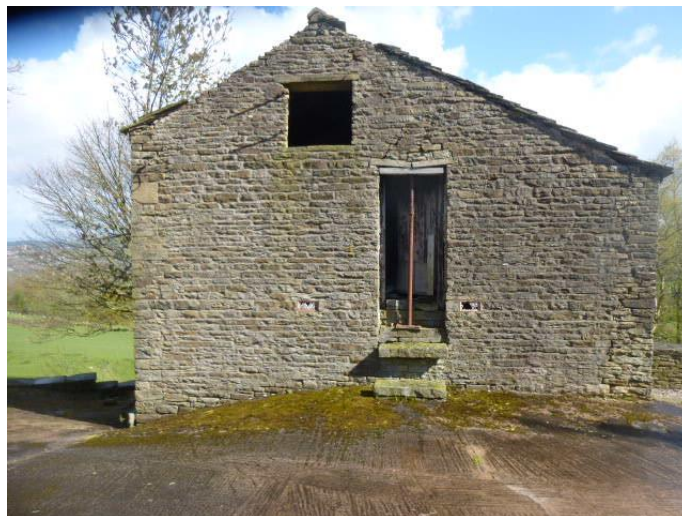
Southern Elevation (facing driveway) – Figure 1

5.1 The elevation incorporates a hay loft type aperture within the pike gable section with retrospectively introduced pedestrian door placed below raised slightly above the entrance driveway. The elevation is of coursed stone faced solid construction having an overall thickness of around 500mm.

Figure 1 - southern elevation

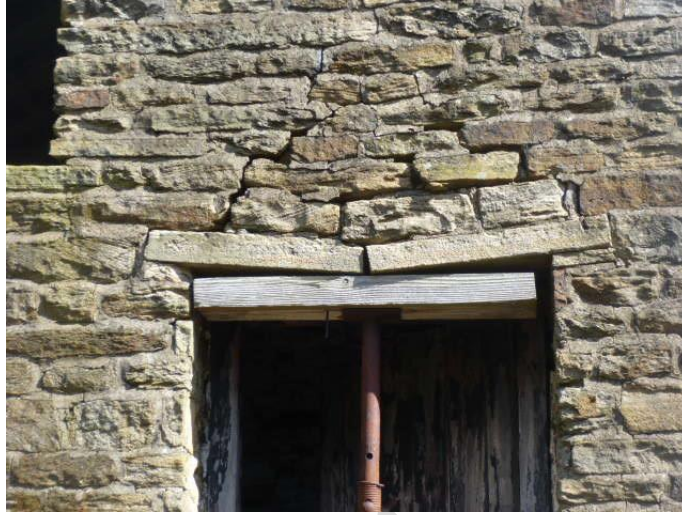
- 5.2 The dressed stone lintel over the entrance door has failed at mid span. An Acro type prop is currently in place to support masonry over. Figure 2.

Figure 2 - failed lintel

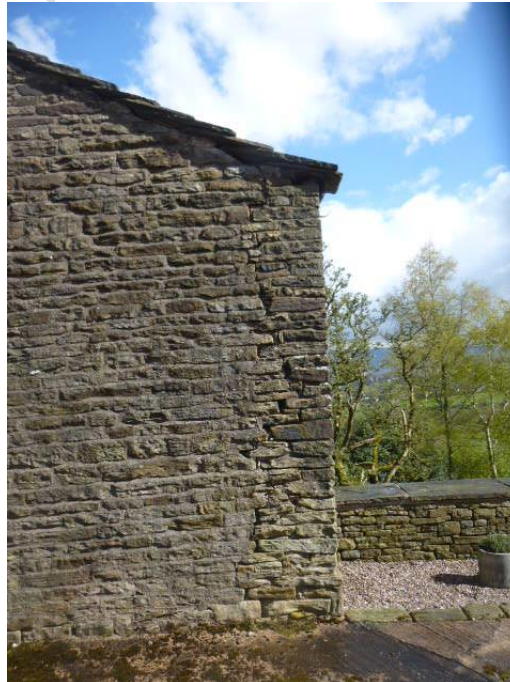
- 5.3 The pike section of the elevation leans backwards towards the north by approximately 100-150mm. A substantial vertical crack was recorded to the right hand side corner arris following deflection/movement of the right hand side eastern elevation. The crack has a maximum opening of approximately 15-20mm. Figure 3.
- 5.4 The stonework jointing is eroded with flag verge detail over the pike section failed and in part missing.

Figure 3 - cracking to arris

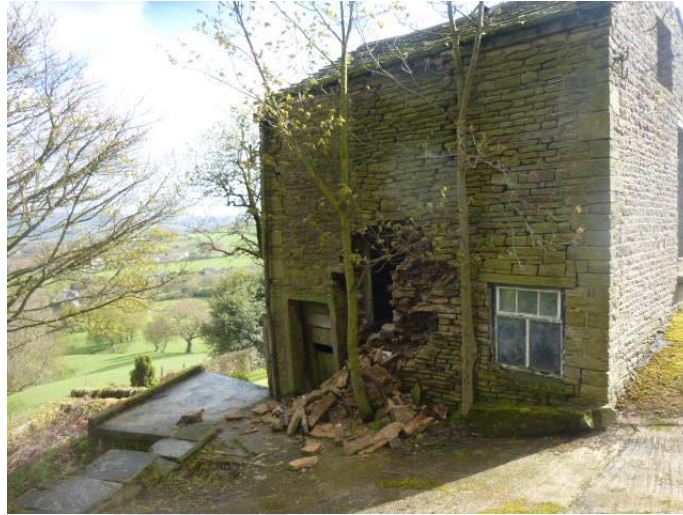
Western Elevation (facing Sandy Lane) - Figure 4

- 5.5 The elevation is in the main of two storey in height with eaves height of approximately 5.1 metres to the northern corner. Ground levels to this elevation increase towards the entrance driveway above the ground floor line.
- 5.6 The elevation is of coursed stone faced solid construction having an overall thickness of around 500mm. Original window and door apertures are supported with natural dressed stone sill and head members.

Figure 4 - western elevation

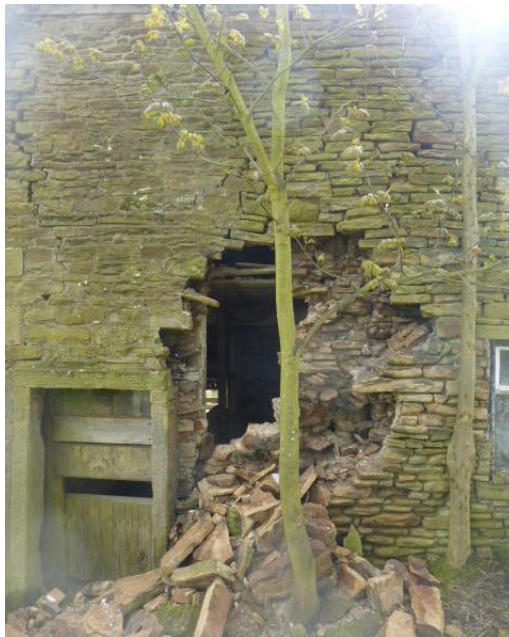
- 5.7 The central ground floor area has collapsed with remaining masonry over the central area currently precariously self supporting on to the adjacent ground floor window and door reveals. Figure 5.

Figure 5 - central collapsed area

- 5.12 Two semi mature trees are growing to the base of the wall. Figure 5.

- 7.3 There is evidence of significant structural movement and collapse. It is believed that the collapsed elevation to the western façade occurred in around Christmas 2014. The remaining wall is considered to be unstable and is likely that the remaining parts will in the short term collapse. This will then further compromise structural support to the roof over, the suspended timber floor and walls and it is likely that these will collapse sympathetically.

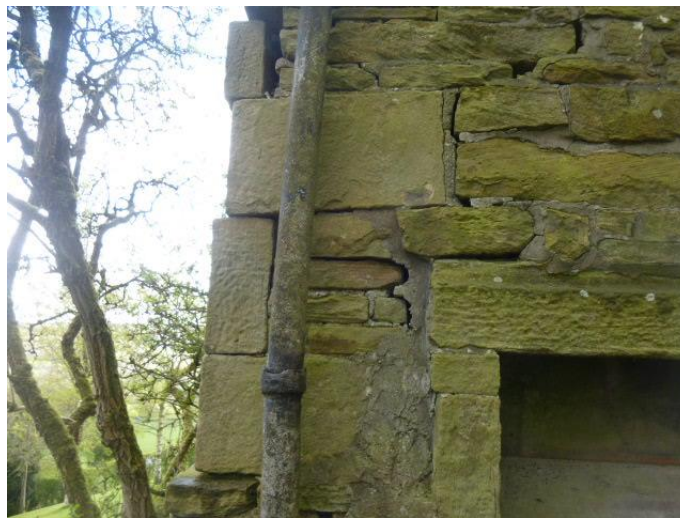
- 5.8 Significant curling/spreading was recorded to the eaves detail more significantly to the central panel.
- 5.9 The main central panel remaining between the window and door apertures has deflected vertically following compression of the remaining stonework to self support.
- 5.10 To this remaining central masonry panel significant damage/bulge was recorded having a vertical displacement of approximately 100-150mm.
- 5.11 Significant cracking was recorded to the left hand side of the entrance door reveal continuing to the buildings full height. The corner has pulled away from the main façade by approximately 50mm. Figure 6

Figure 6 - cracking to left hand side of door reveal

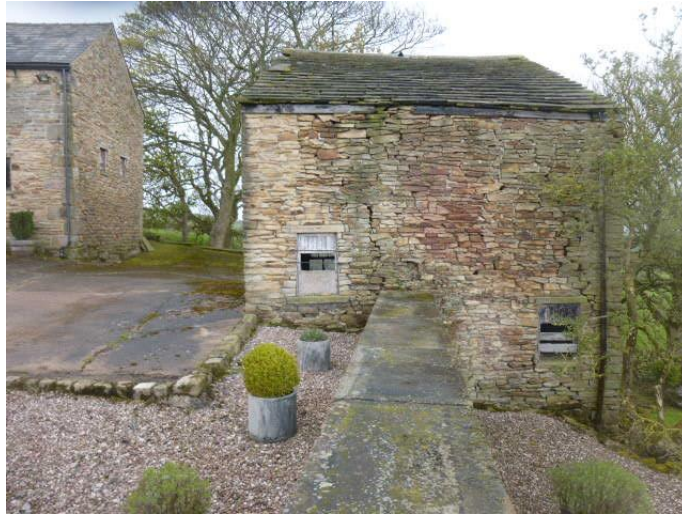
Eastern Elevation – Figure 7

- 5.13 The elevation is of randomly laid stone faced solid construction having an overall thickness of around 500mm. Window and door apertures are supported with natural dressed stone sill and head members.
- 5.14 Ground levels increase in level significantly towards the southern boundary, a masonry constructed retaining wall has been placed to partially terrace the plot.
- 5.15 The northern corner arris is two storey in height with ground levels increasing towards the driveway above the lower ground floor parts.

Figure 7 - eastern elevation

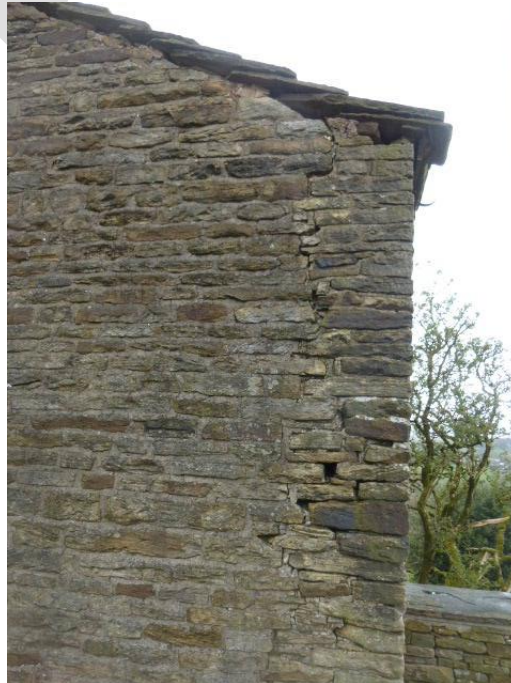
- 5.16 Significant vertical cracking was recorded to the right hand side of the lower right hand side window aperture to the property's full height with cracks having a maximum width of approximately 50mm with cracking then continuing to the left hand side of the sill member. (Figure 8)
- 5.17 To the upper left hand side parts further similar cracking can be seen to the right hand side of the upper window reveal. Again continuing to its full height. Cracks are approximately 50-75mm in width.

Figure 8 - cracking to rear corner arris

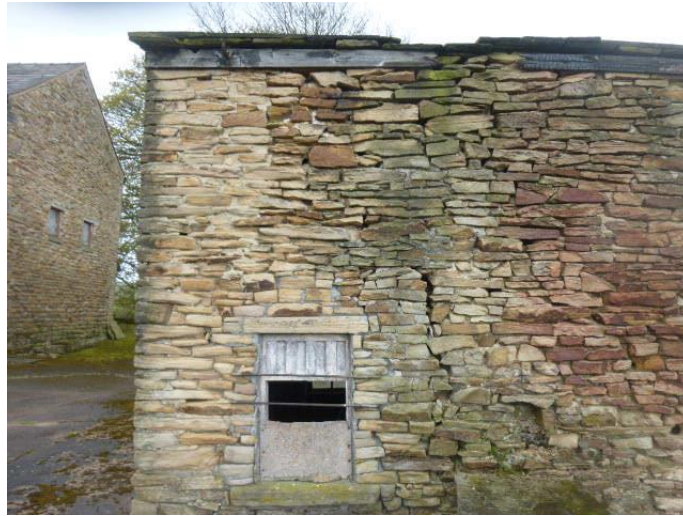
Figure 9 - cracking towards front elevation

- 5.18 Significant spreading/curling was recorded to the central masonry area at eaves level with vertical displacement of approximately 100-150mm.
- 5.19 The stone face has eroded significantly aggravated by heat from fire damage.
- 5.20 Levels generally reduce to the coursing towards the northern garden elevation.

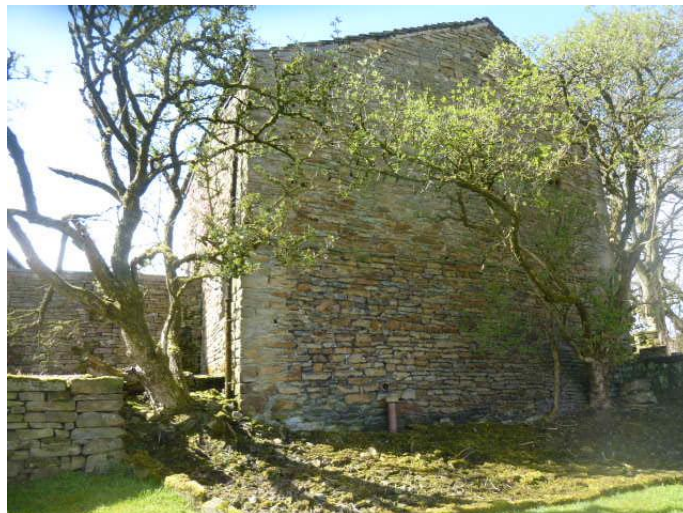
Northern Elevation

Figure 10 - northern elevation

- 5.23 A significant bulge/ripple was recorded from the plinth line upwards having vertical displacement of approximately 150-200mm.
- 5.24 Vertical cracking was recorded along the wall face in the main above the plinth line with further significant crack to the right hand side arris continuing below the plinth vertically to the verge. Cracks range from 25 to 100mm.
- 5.25 The stonework jointing is generally perished.

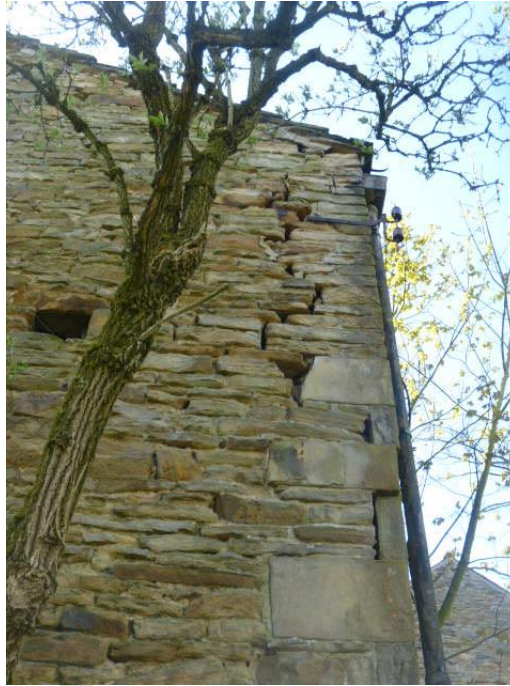
Figure 11 - cracking towards western elevation

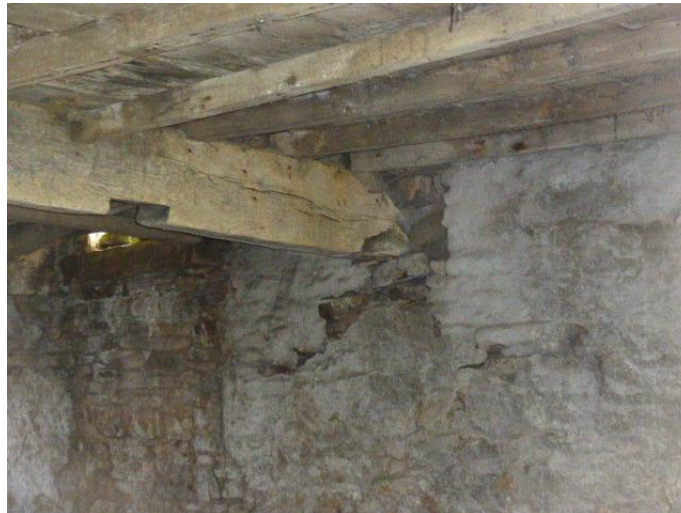
- 6.3 The bearing to the timber beam has failed where it runs into the drive/southern elevation. The beam has dropped causing the floor structure over to deflect accordingly. Figure 12.
- 6.4 General cracking and misalignment of the inner face of the external walls was recorded corresponding to movement evident to the external parts.
- 6.5 There is evidence of significant timber infestation and rot attack to the remaining timbers.

Figure 12 - deflected/failed beam

- 7.4 It is likely that partial collapse present has been aggravated by failure of the main hay loft timber supporting beam which runs north to south. The southern bearing has failed allowing the beam to drop pushing the adjacent flank elevations further out of alignment, to the western elevation obviously beyond structural stability.
