Initial Bat and Nesting Bird Survey of Riverside Mill, Glossop

30th April 2015

The site was at Riverside Mill, George Street, Glossop. SK13 8AY.

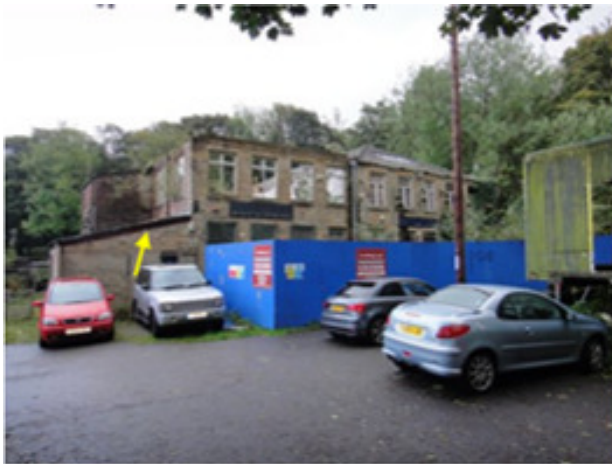
Many gaps suitable for roosting bats such as under barge boards (photos 1 and 3).

P1 NW aspect, gaps under barge boards

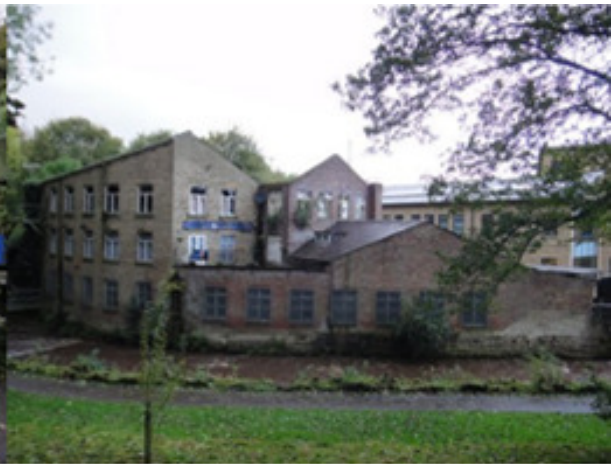
There were gaps under roofing slates suitable for roosting bats. (photo 2)

P2 SE aspect, many broken windows

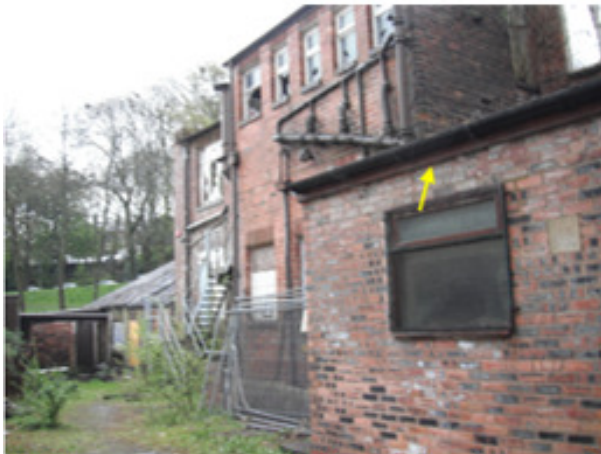
P3 N. aspect, gaps under barge boards

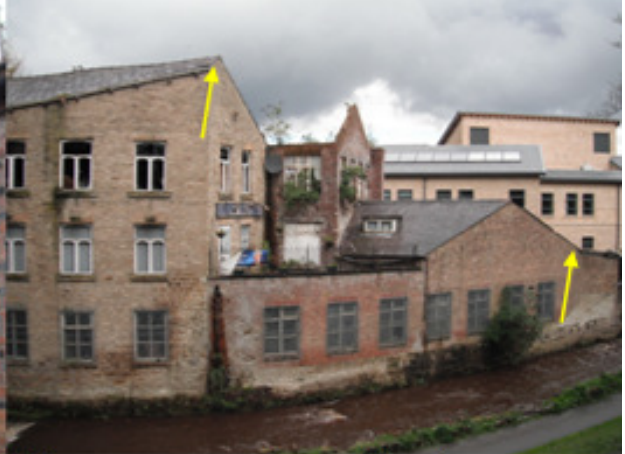
P4 S. aspect, gaps under roofing slates

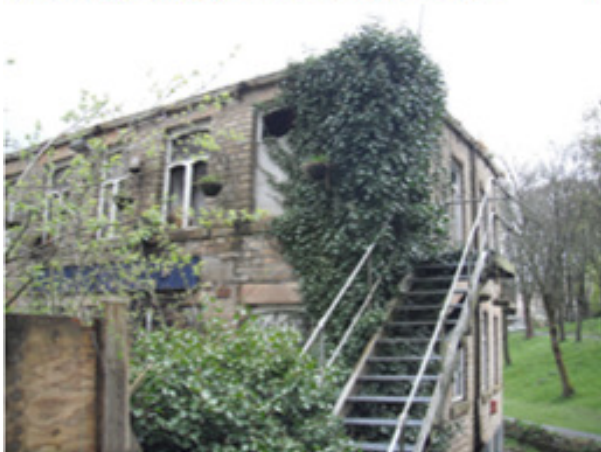
There was a thick covering of Ivy at the SW corner (photo 5), of high potential for nesting birds, but of low suitability for roosting bats. The Ivy could hide suitable crevices in the masonry.

4.3 Most of these building were likely to be used by nesting birds. The Ivy on building 2 was considered particularly likely to be used.

P5 Ivy at SW corner, building 2

5.2 Care must be taken to avoid disturbing nesting birds. Carrying out structural work/demolition avoiding the nesting season, March to August inclusive, will minimise any problems with nesting birds.

If active nests are found, they must be left undisturbed (5 metre exclusion zone recommended) until the young have fledged. If there is any doubt refer to a suitably qualified ecologist.

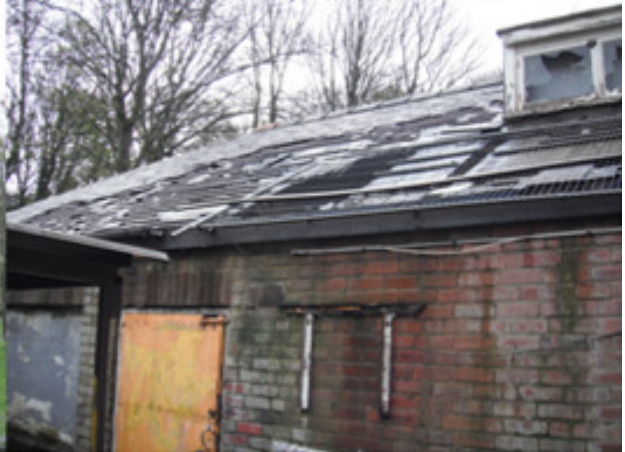
Building 7 Single storey lean-to, incomplete slate roof (photo 6)

Many gaps under partial slate roof and easy bat access into the interior.

P6 Missing slates, building 7

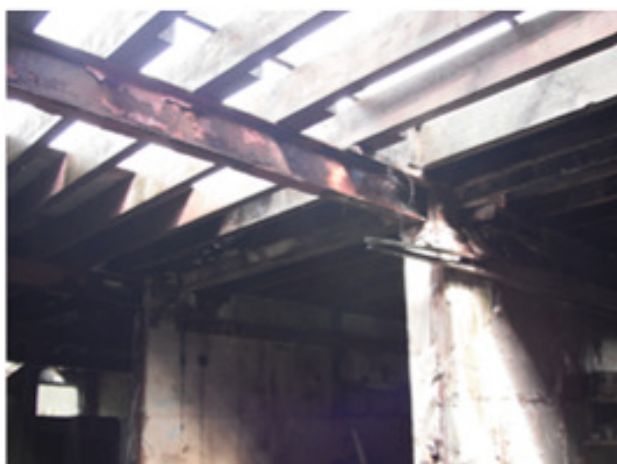
Easy bat access through missing roof area. (photo 7)
There were holes in the masonry suitable for roosting bats.

P7 Building 1, missing roof

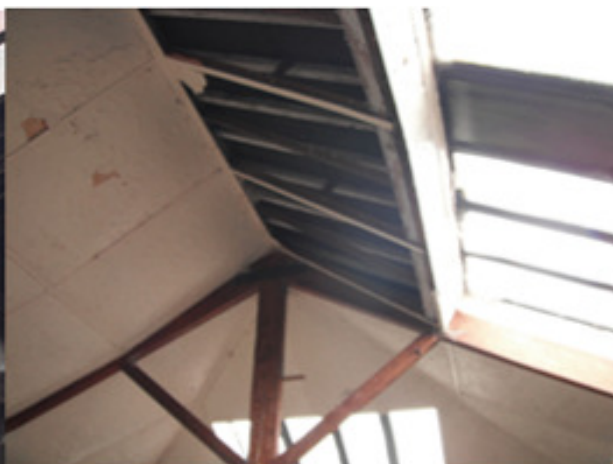
The first floor was open to the roof and infested with pigeons. The roof was of slate partially lined with boarding (photo 8). There were several skylights and many broken windows.

P8 Building 2, board-lined slate and skylights

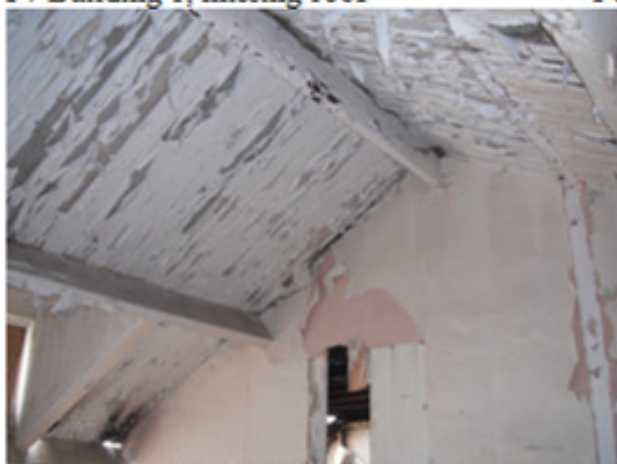
Roof board-lined (photo 9) and relatively complete, with gaps suitable for bat access at missing slates.

P9 Building 4, board-lined slates, some slates missing.

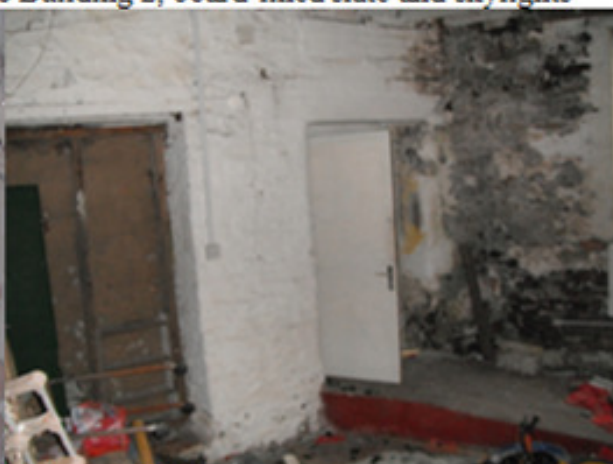
There was a basement running under buildings 1, 2, 3 and 4 (photo 10). Although there were crevices in the masonry it was considered too dry to be of more than very low suitability for hibernating bats.

P10 Basement
