Demolition Survey

Former Buxton Rail Shed
Station Road
Buxton
Derbyshire
SK17 6AQ

3.1 DB Schenker commissioned Environmental Essentials Ltd to undertake a Demolition Survey of:

Former Buxton Rail Shed, Station Road, Buxton, Derbyshire, SK17 6AQ

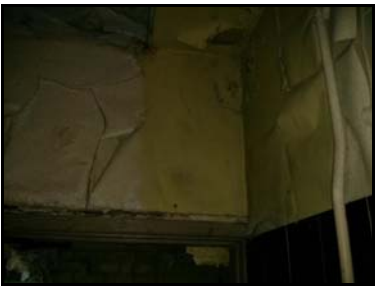
Sample No	Building	Floor	Analysis
	P-109746/001	Former Buxton Rail Shed	Ground Floor	No asbestos detected
	Area/Location/Position	Material description	Quantity	Confirmation of product type
	001 - Male WC - Paint to walls	Textured coatings	N/A	Non-asbestos material
	Product type	Condition	Surface Treatment	Asbestos type
	-	-	-	-
	Material Risk Score	Priority Risk Score	Total Risk Score	Accessibility
	0	-	0	-
Recommended action	-			
Recommendation comments	-			
Surveyor comments	Inspection revealed ceramic cisterns and plastic soil pipes.

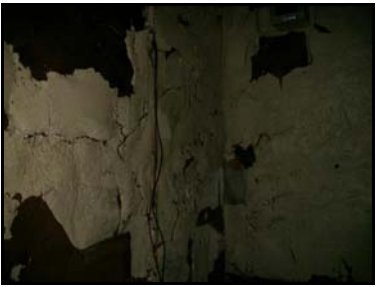
Sample No	Building	Floor	Analysis
	P-109746/002	Former Buxton Rail Shed	Ground Floor	No asbestos detected
	Area/Location/Position	Material description	Quantity	Confirmation of product type
	002 - Female WC - Paint to walls	Textured coatings	N/A	Non-asbestos material
	Product type	Condition	Surface Treatment	Asbestos type
	-	-	-	-
	Material Risk Score	Priority Risk Score	Total Risk Score	Accessibility
	0	-	0	-
Recommended action	-			
Recommendation comments	-			
Surveyor comments	Inspection revealed ceramic cisterns and plastic soil pipes.

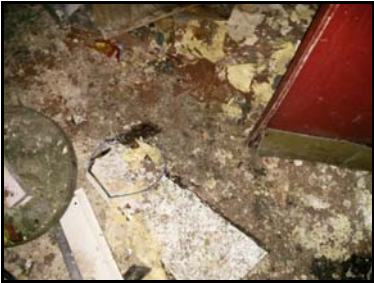
Sample No	Building	Floor	Analysis
	P-109746/003	Former Buxton Rail Shed	Ground Floor	No asbestos detected
	Area/Location/Position	Material description	Quantity	Confirmation of product type
	003 - Changing room - Floor tiles	Thermoplastic floor tiles	N/A	Non-asbestos material
	Product type	Condition	Surface Treatment	Asbestos type
	-	-	-	-
	Material Risk Score	Priority Risk Score	Total Risk Score	Accessibility
	0	-	0	-
Recommended action	-			
Recommendation comments	-			
Surveyor comments	-

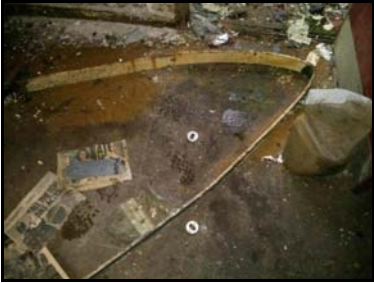
Sample No	Building	Floor	Analysis
	P-109746/004	Former Buxton Rail Shed	Ground Floor	No asbestos detected
	Area/Location/Position	Material description	Quantity	Confirmation of product type
	004 - Changing room - Floor tiles	Thermoplastic floor tiles	N/A	Non-asbestos material
	Product type	Condition	Surface Treatment	Asbestos type
	-	-	-	-
	Material Risk Score	Priority Risk Score	Total Risk Score	Accessibility
	0	-	0	-
Recommended action	-			
Recommendation comments	-			
Surveyor comments	-

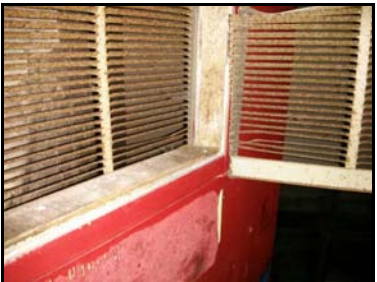
Sample No	Building	Floor	Analysis
	P-109746/005	Former Buxton Rail Shed	Ground Floor	No asbestos detected
	Area/Location/Position	Material description	Quantity	Confirmation of product type
	006 - Battery store - Board panel within fire doors	Insulating board	N/A	Non-asbestos material
	Product type	Condition	Surface Treatment	Asbestos type
	-	-	-	-
	Material Risk Score	Priority Risk Score	Total Risk Score	Accessibility
	0	-	0	-
Recommended action	-			
Recommendation comments	-			
Surveyor comments	The sampled material is present to both doors within this area.

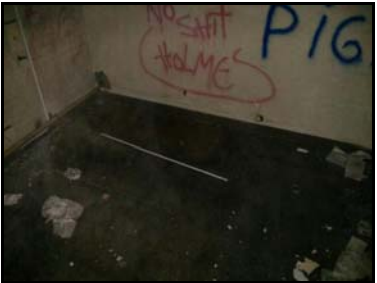
Sample No	Building	Floor	Analysis
	P-109746/006	Former Buxton Rail Shed	Ground Floor	No asbestos detected
	Area/Location/Position	Material description	Quantity	Confirmation of product type
	009 - Store - Floor tiles	Thermoplastic floor tiles	N/A	Non-asbestos material
	Product type	Condition	Surface Treatment	Asbestos type
	-	-	-	-
	Material Risk Score	Priority Risk Score	Total Risk Score	Accessibility
	0	-	0	-
Recommended action	-			
Recommendation comments	-			
Surveyor comments	-

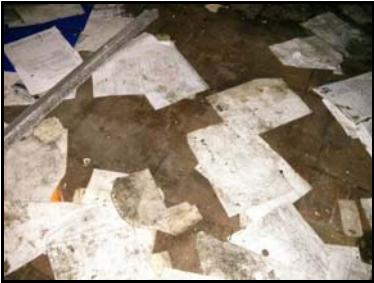
Sample No	Building	Floor	Analysis
	P-109746/007	Former Buxton Rail Shed	Ground Floor	No asbestos detected
	Area/Location/Position	Material description	Quantity	Confirmation of product type
	010 - Office - Floor tiles	Thermoplastic floor tiles	N/A	Non-asbestos material
	Product type	Condition	Surface Treatment	Asbestos type
	-	-	-	-
	Material Risk Score	Priority Risk Score	Total Risk Score	Accessibility
	0	-	0	-
Recommended action	-			
Recommendation comments	-			
Surveyor comments	-

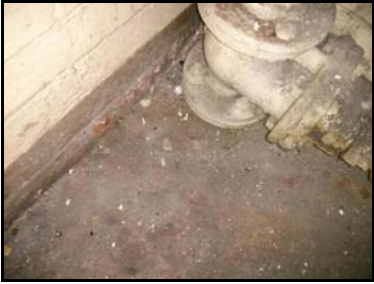
Sample No	Building	Floor	Analysis
	P-109746/008	Former Buxton Rail Shed	Ground Floor	No asbestos detected
	Area/Location/Position	Material description	Quantity	Confirmation of product type
	011 - Store - Gasket	Gasket	N/A	Non-asbestos material
	Product type	Condition	Surface Treatment	Asbestos type
	-	-	-	-
	Material Risk Score	Priority Risk Score	Total Risk Score	Accessibility
	0	-	0	-
Recommended action	-			
Recommendation comments	-			
Surveyor comments	-

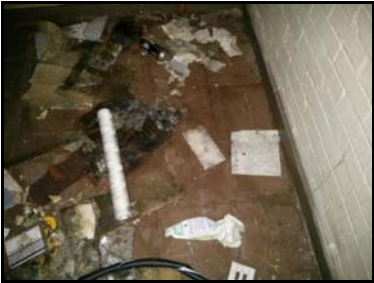
Sample No	Building	Floor	Analysis
	P-109746/009	Former Buxton Rail Shed	Ground Floor	No asbestos detected
	Area/Location/Position	Material description	Quantity	Confirmation of product type
	012 - Store - Floor tiles	Thermoplastic floor tiles	N/A	Non-asbestos material
	Product type	Condition	Surface Treatment	Asbestos type
	-	-	-	-
	Material Risk Score	Priority Risk Score	Total Risk Score	Accessibility
	0	-	0	-
Recommended action	-			
Recommendation comments	-			
Surveyor comments	-

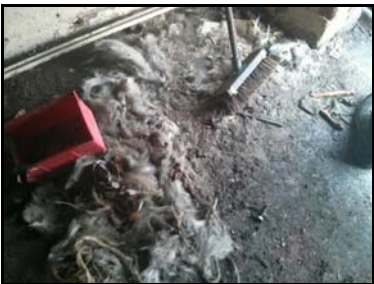
Sample No	Building	Floor	Analysis
	P-109746/010	Former Buxton Rail Shed	Ground Floor	Chrysotile
	Area/Location/Position	Material description	Quantity	Confirmation of product type
	018 - Boiler room - Paper debris to floor	Paper	1 m ²	Asbestos paper
	Product type	Condition	Surface Treatment	Asbestos type
	2	2	1	1
	Material Risk Score	Priority Risk Score	Total Risk Score	Accessibility
	6	-	6	2 - Easily disturbed
Recommended action	Remove – LARC			
Recommendation comments	-			
Surveyor comments	The sampled material is present throughout the area where long strand MMMF insulation is present to the floor.

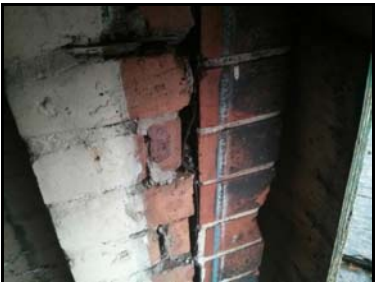
Sample No	Building	Floor	Analysis
	P-109746/011	Former Buxton Rail Shed	Ground Floor	No asbestos detected
	Area/Location/Position	Material description	Quantity	Confirmation of product type
	018 - Boiler room - Bitumen within wall cavity	Bituminous products	N/A	Non-asbestos material
	Product type	Condition	Surface Treatment	Asbestos type
	-	-	-	-
	Material Risk Score	Priority Risk Score	Total Risk Score	Accessibility
	0	-	0	-
Recommended action	-			
Recommendation comments	-			
Surveyor comments	A limited inspection was conducted to the walls within this area due to their poor condition. No inspection was possible to the ceiling or water tanks due to height and access restrictions.

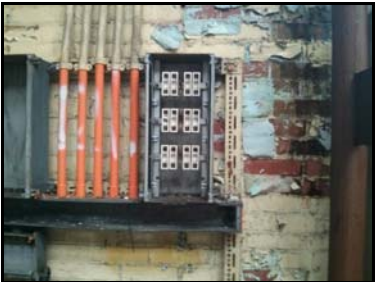
Sample No	Building	Floor	Analysis
	P-109746/012	Former Buxton Rail Shed	Ground Floor	Chrysotile
	Area/Location/Position	Material description	Quantity	Confirmation of product type
	019 - Engine shed - Woven flash guards	Woven product	11 Number	Asbestos woven material
	Product type	Condition	Surface Treatment	Asbestos type
	2	1	1	1
	Material Risk Score	Priority Risk Score	Total Risk Score	Accessibility
	5	-	5	1 - Occasional disturbance
Recommended action	Remove – NLW			
Recommendation comments	-			
Surveyor comments	-

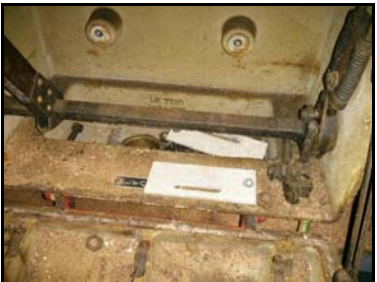
Sample No	Building	Floor	Analysis
	P-109746/013	Former Buxton Rail Shed	Ground Floor	Chrysotile
	Area/Location/Position	Material description	Quantity	Confirmation of product type
	019 - Engine shed - Panel within electrics	Cement product	1 Number	Asbestos cement
	Product type	Condition	Surface Treatment	Asbestos type
	1	1	1	1
	Material Risk Score	Priority Risk Score	Total Risk Score	Accessibility
	4	-	4	0 - Usually inaccessible
Recommended action	Remove – NLW			
Recommendation comments	-			
Surveyor comments	-

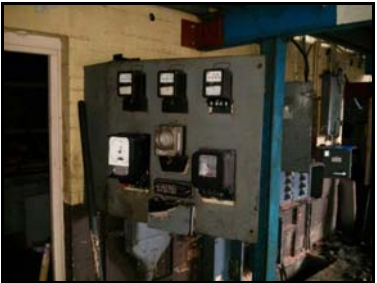
Sample No	Building	Floor	Analysis
	P-109746/014	Former Buxton Rail Shed	Ground Floor	Chrysotile
	Area/Location/Position	Material description	Quantity	Confirmation of product type
	019 - Engine shed - Door to electrical unit	Reinforced plastic material	1 m ²	Asbestos reinforced plastic
	Product type	Condition	Surface Treatment	Asbestos type
	1	1	1	1
	Material Risk Score	Priority Risk Score	Total Risk Score	Accessibility
	4	-	4	1 - Occasional disturbance
Recommended action	Remove – NLW			
Recommendation comments	-			
Surveyor comments	-

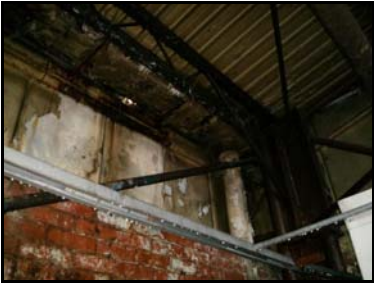
Sample No	Building	Floor	Analysis
	P-109746/015	Former Buxton Rail Shed	Ground Floor	Crocidolite, Chrysotile
	Area/Location/Position	Material description	Quantity	Confirmation of product type
	019 - Engine shed - Guttering	Cement product	200 m linear	Asbestos cement
	Product type	Condition	Surface Treatment	Asbestos type
	1	1	1	3
	Material Risk Score	Priority Risk Score	Total Risk Score	Accessibility
	6	-	6	0 - Usually inaccessible
Recommended action	Remove – NLW			
Recommendation comments	-			
Surveyor comments	The guttering could only be sampled from the mezzanine level due to height restrictions but is identical throughout the entire area. The downpipes from the guttering could only be sampled externally put are of an identical material internally. The high level wall panels were also sampled externally due to height and access restrictions internally.

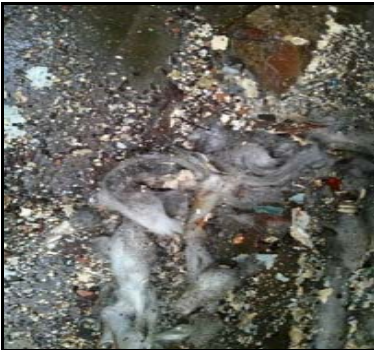
Sample No	Building	Floor	Analysis
	P-109746/016	Former Buxton Rail Shed	Ground Floor	No asbestos detected
	Area/Location/Position	Material description	Quantity	Confirmation of product type
	019 - Engine shed - Paper debris to floor	Paper	N/A	Non-asbestos material
	Product type	Condition	Surface Treatment	Asbestos type
	-	-	-	-
	Material Risk Score	Priority Risk Score	Total Risk Score	Accessibility
	0	-	0	-
Recommended action	-			
Recommendation comments	-			
Surveyor comments	The sampled material is present throughout the area where long strand MMMF insulation is present to the floor. No inspection was conducted within the pits due to them being flooded.

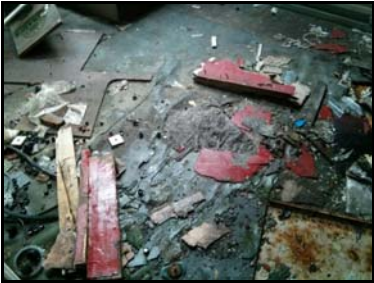
Sample No	Building	Floor	Analysis
	P-109746/017	Former Buxton Rail Shed	First Floor	No asbestos detected
	Area/Location/Position	Material description	Quantity	Confirmation of product type
	020 - Mezzanine level - Vinyl flooring	Vinyl product	N/A	Non-asbestos material
	Product type	Condition	Surface Treatment	Asbestos type
	-	-	-	-
	Material Risk Score	Priority Risk Score	Total Risk Score	Accessibility
	0	-	0	-
Recommended action	-			
Recommendation comments	-			
Surveyor comments	A limited inspection was conducted due to the timber floor being water damaged and holes being visible.

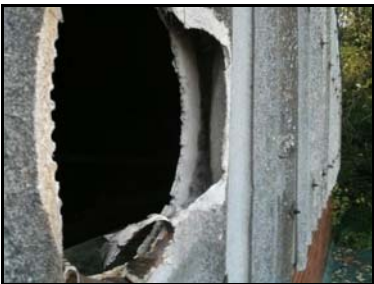
Sample No	Building	Floor	Analysis
	P-109746/018	Former Buxton Rail Shed	External	No asbestos detected
	Area/Location/Position	Material description	Quantity	Confirmation of product type
	021 - External - Insulation within cavity of high level wall cladding	Insulation	N/A	Non-asbestos material
	Product type	Condition	Surface Treatment	Asbestos type
	-	-	-	-
	Material Risk Score	Priority Risk Score	Total Risk Score	Accessibility
	0	-	0	-
Recommended action	-			
Recommendation comments	-			
Surveyor comments	The sampled material was identified where damage has occurred to the wall cladding to the gable end.

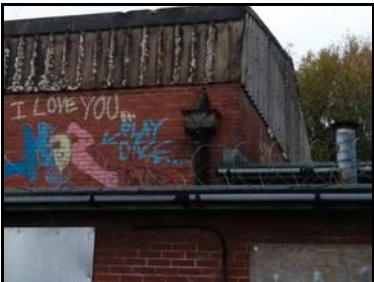
Sample No	Building	Floor	Analysis
	P-109746/019	Former Buxton Rail Shed	External	Chrysotile
	Area/Location/Position	Material description	Quantity	Confirmation of product type
	021 - External - Hoppers and downpipes	Cement product	25 m linear	Asbestos cement
	Product type	Condition	Surface Treatment	Asbestos type
	1	1	1	1
	Material Risk Score	Priority Risk Score	Total Risk Score	Accessibility
	4	-	4	0 - Usually inaccessible
Recommended action	Remove – NLW			
Recommendation comments	-			
Surveyor comments	All hoppers and downpipes are of an identical material. Downpipes are also visible from within the building at high level.

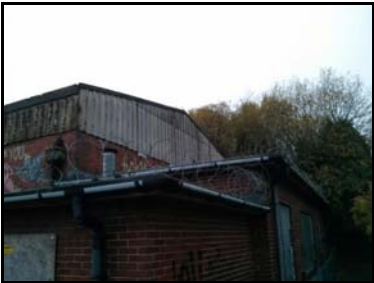
Sample No	Building	Floor	Analysis
	P-109746/020	Former Buxton Rail Shed	External	Chrysotile
	Area/Location/Position	Material description	Quantity	Confirmation of product type
	021 - External - High level wall cladding	Cement product	100 m ²	Asbestos cement
	Product type	Condition	Surface Treatment	Asbestos type
	1	1	1	1
	Material Risk Score	Priority Risk Score	Total Risk Score	Accessibility
	4	-	4	0 - Usually inaccessible
Recommended action	Remove – NLW			
Recommendation comments	-			
Surveyor comments	-

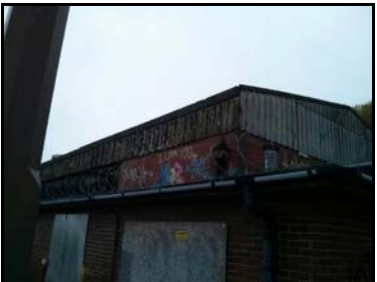
Sample No	Building	Floor	Analysis
	P-109746/021	Former Buxton Rail Shed	External	Chrysotile
	Area/Location/Position	Material description	Quantity	Confirmation of product type
	021 - External - High level wall cladding	Cement product	100 m²	Asbestos cement
	Product type	Condition	Surface Treatment	Asbestos type
	1	1	1	1
	Material Risk Score	Priority Risk Score	Total Risk Score	Accessibility
	4	-	4	0 - Usually inaccessible
Recommended action	Remove – NLW			
Recommendation comments	-			
Surveyor comments	-

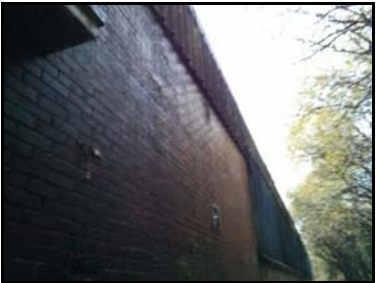
Sample No	Building	Floor	Analysis
	P-109746/022	Former Buxton Rail Shed	External	Chrysotile
	Area/Location/Position	Material description	Quantity	Confirmation of product type
	021 - External - High level wall cladding	Cement product	100 m²	Asbestos cement
	Product type	Condition	Surface Treatment	Asbestos type
	1	1	1	1
	Material Risk Score	Priority Risk Score	Total Risk Score	Accessibility
	4	-	4	0 - Usually inaccessible
Recommended action	Remove – NLW			
Recommendation comments	-			
Surveyor comments	-

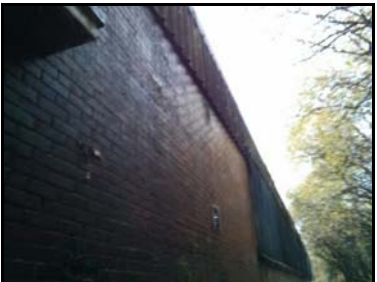
Sample No	Building	Floor	Analysis
	P-109746/023	Former Buxton Rail Shed	External	Chrysotile
	Area/Location/Position	Material description	Quantity	Confirmation of product type
	021 - External - High level wall cladding	Cement product	100 m ²	Asbestos cement
	Product type	Condition	Surface Treatment	Asbestos type
	1	0	1	1
	Material Risk Score	Priority Risk Score	Total Risk Score	Accessibility
	3	-	3	0 - Usually inaccessible
Recommended action	Remove – NLW			
Recommendation comments	-			
Surveyor comments	-

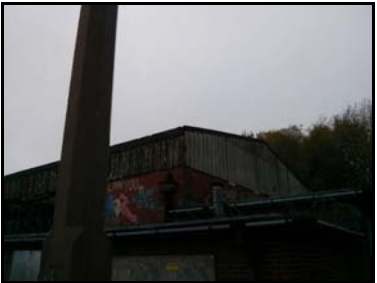
Sample No	Building	Floor	Analysis
	P-109746/024	Former Buxton Rail Shed	External	No asbestos detected
	Area/Location/Position	Material description	Quantity	Confirmation of product type
	021 - External - Felt to main roof	Bituminous products	N/A	Non-asbestos material
	Product type	Condition	Surface Treatment	Asbestos type
	-	-	-	-
	Material Risk Score	Priority Risk Score	Total Risk Score	Accessibility
	0	-	0	-
Recommended action	-			
Recommendation comments	-			
Surveyor comments	-

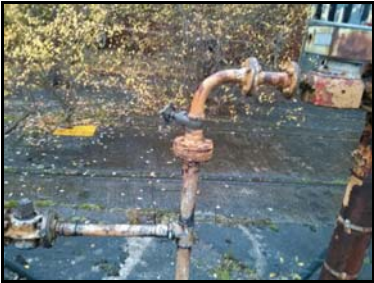
Sample No	Building	Floor	Analysis
	P-109746/025	Former Buxton Rail Shed	External	Chrysotile
	Area/Location/Position	Material description	Quantity	Confirmation of product type
	021 - External - Gaskets to fuel pumps	Gasket	1 m ²	Asbestos gasket
	Product type	Condition	Surface Treatment	Asbestos type
	2	0	1	1
	Material Risk Score	Priority Risk Score	Total Risk Score	Accessibility
	4	-	4	0 - Usually inaccessible
Recommended action	Remove – NLW			
Recommendation comments	-			
Surveyor comments	A composite sample was taken of all gaskets to fuel pumps.

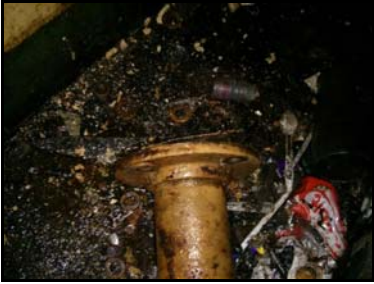
Sample No	Building	Floor	Analysis
	P-109746/026	Former Buxton Rail Shed	Ground Floor	Chrysotile
	Area/Location/Position	Material description	Quantity	Confirmation of product type
	022 - Fuel store - Gaskets	Gasket	1 m ²	Asbestos gasket
	Product type	Condition	Surface Treatment	Asbestos type
	2	1	1	1
	Material Risk Score	Priority Risk Score	Total Risk Score	Accessibility
	5	-	5	1 - Occasional disturbance
Recommended action	Remove – NLW			
Recommendation comments	-			
Surveyor comments	An extremely limited inspection was conducted due to the large amount of stored items within this area.

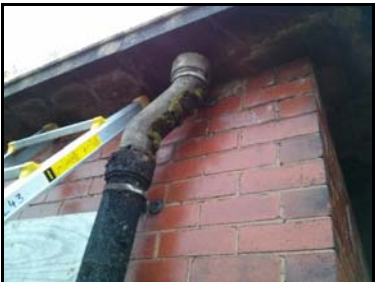
Sample No	Building	Floor	Analysis
	P-109746/027	Former Buxton Rail Shed	External	Chrysotile
	Area/Location/Position	Material description	Quantity	Confirmation of product type
	024 - External to fuel store - Downpipes	Cement product	4 m linear	Asbestos cement
	Product type	Condition	Surface Treatment	Asbestos type
	1	1	1	1
	Material Risk Score	Priority Risk Score	Total Risk Score	Accessibility
	4	-	4	1 - Occasional disturbance
Recommended action	Remove – NLW			
Recommendation comments	-			
Surveyor comments	All downpipes are of an identical material.

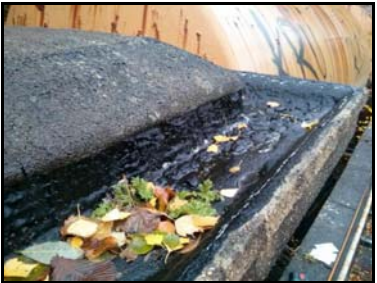
Sample No	Building	Floor	Analysis
	P-109746/028	Former Buxton Rail Shed	External	No asbestos detected
	Area/Location/Position	Material description	Quantity	Confirmation of product type
	024 - External to fuel store - Bitumen covering to guttering	Bituminous products	N/A	Non-asbestos material
	Product type	Condition	Surface Treatment	Asbestos type
	-	-	-	-
	Material Risk Score	Priority Risk Score	Total Risk Score	Accessibility
	0	-	0	-
Recommended action	-			
Recommendation comments	-			
Surveyor comments	-

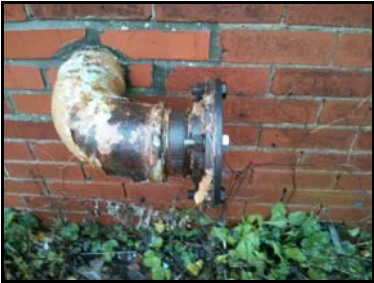
Sample No	Building	Floor	Analysis
	P-109746/029	Former Buxton Rail Shed	External	Chrysotile
	Area/Location/Position	Material description	Quantity	Confirmation of product type
	024 - External to fuel store - Gaskets	Gasket	1 m ²	Asbestos gasket
	Product type	Condition	Surface Treatment	Asbestos type
	2	0	1	1
	Material Risk Score	Priority Risk Score	Total Risk Score	Accessibility
	4	-	4	0 - Usually inaccessible
Recommended action	Remove – NLW			
Recommendation comments	-			
Surveyor comments	A composite sample was taken of the external gaskets.

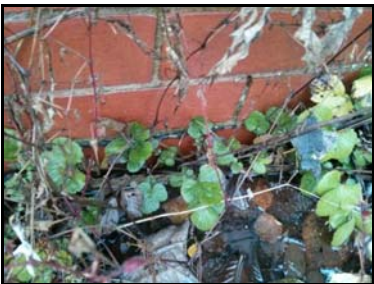
Sample No	Building	Floor	Analysis
	P-109746/030	Former Buxton Rail Shed	External	No asbestos detected
	Area/Location/Position	Material description	Quantity	Confirmation of product type
	024 - External to fuel store - Damp proof course	Bituminous products	N/A	Non-asbestos material
	Product type	Condition	Surface Treatment	Asbestos type
	-	-	-	-
	Material Risk Score	Priority Risk Score	Total Risk Score	Accessibility
	0	-	0	-
Recommended action	-			
Recommendation comments	-			
Surveyor comments	The external inspection of the fuel stores revealed modern roofing felt. No inspection was conducted to the top of the fuel tanks due to safety reasons.

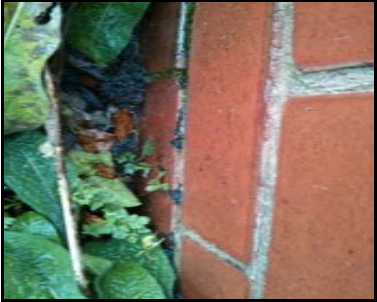
Sample No	Building	Floor	Analysis
	P-109746/031	Former Buxton Rail Shed	External	No asbestos detected
	Area/Location/Position	Material description	Quantity	Confirmation of product type
	021 - External - Damp proof course	Bituminous products	N/A	Non-asbestos material
	Product type	Condition	Surface Treatment	Asbestos type

-	-	-	-
	Material Risk Score	Priority Risk Score	Total Risk Score	Accessibility
	0	-	0	-
Recommended action	-			
Recommendation comments	-			
Surveyor comments	The external inspection was conducted from ladders only. Plastic downpipes and concrete soffits were identified. Inspection beneath the felt above the concrete soffits revealed timber of which inspection beneath revealed the concrete guttering/soffit. The pitched roof was only visually inspected due to height and safety restrictions. Beneath the felt a metal roof was revealed which was visible internally. No inspection was possible to the flat roof of the boiler room due to height restrictions.

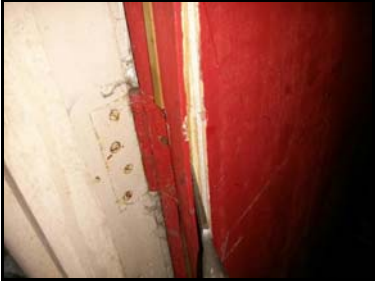
Sample No	Building	Floor	Analysis
	P-109746/As 005	Former Buxton Rail Shed	Ground Floor	Strongly presumed; No asbestos detected
	Area/Location/Position	Material description	Quantity	Confirmation of product type
	007 - Chemical store - Board panel within fire doors	Insulating board	N/A	Strongly presumed; Non-asbestos material
	Product type	Condition	Surface Treatment	Asbestos type
	-	-	-	-
	Material Risk Score	Priority Risk Score	Total Risk Score	Accessibility
	0	-	0	-
Recommended action	-			
Recommendation comments	-			
Surveyor comments	The sampled material is present to both doors within this area.

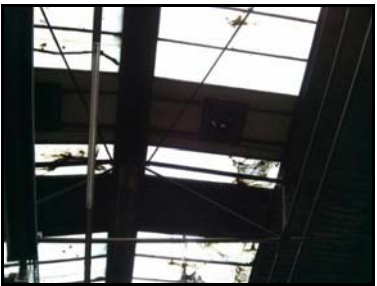
Sample No	Building	Floor	Analysis
	P-109746/P001	Former Buxton Rail Shed	Ground Floor	Presumed to contain asbestos
	Area/Location/Position	Material description	Quantity	Confirmation of product type
	019 - Engine shed - Roof panels	Insulating board	8 m ²	N/A
	Product type	Condition	Surface Treatment	Asbestos type
	2	1	2	3
	Material Risk Score	Priority Risk Score	Total Risk Score	Accessibility
	8	-	8	0 - Usually inaccessible
Recommended action	Remove – LARC			
Recommendation comments	-			
Surveyor comments	The identified material has been presumed due to height and access restrictions.

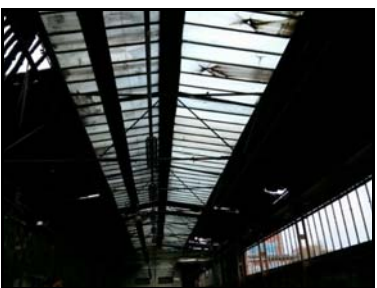
Sample No	Building	Floor	Analysis
	P-109746/P002	Former Buxton Rail Shed	Ground Floor	Presumed to contain asbestos
	Area/Location/Position	Material description	Quantity	Confirmation of product type
	019 - Engine shed - Woven seals to roof glazing	Woven product	100 m linear	N/A
	Product type	Condition	Surface Treatment	Asbestos type
	2	1	1	3
	Material Risk Score	Priority Risk Score	Total Risk Score	Accessibility
	7	-	7	0 - Usually inaccessible
Recommended action	Remove – LARC			
Recommendation comments	-			
Surveyor comments	The identified material has been presumed due to height and access restrictions.
