Lead Surveyor: M. Crompton
Assistant D. Burgess
Surveyor(s):
Date(s) of Survey: 23/11/2015
Report Reference: CH/15/11/708/AA
Date Report Issued:
Purpose of Survey:

Report on Survey of Asbestos Materials at

Riverside Mill
George Street
Glossop
SK13 8AY

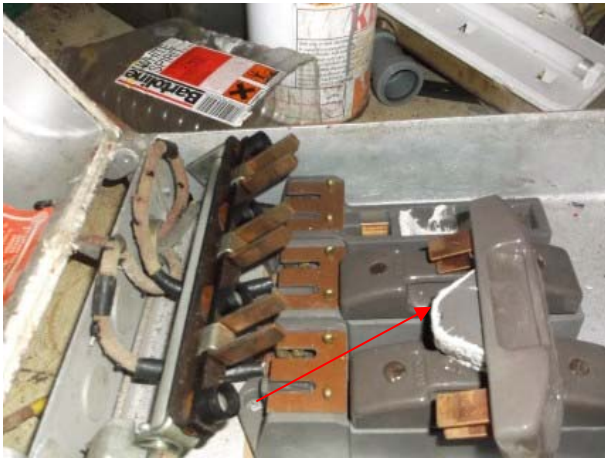
Items & Content: Woven flash guards containing chrysotile.
Sample No: 15/11/B/23/MAC2.

Sample No: 15/11/B/23/MAC2.
Room: B.05 Workshop – Disused Fuse Box.
Woven flash guards.

Location: Room: B.05 Workshop – Disused Fuse Box.

Recommendation: These materials should be removed and disposed of prior to refurbishment, by suitably trained and equipped personnel only, working under the guidance of a safe working procedure and in accordance with the requirements of The Control of Asbestos Regulations 2012 and The Hazardous Waste (England and Wales) Regulations 2005 (as amended in 2009).

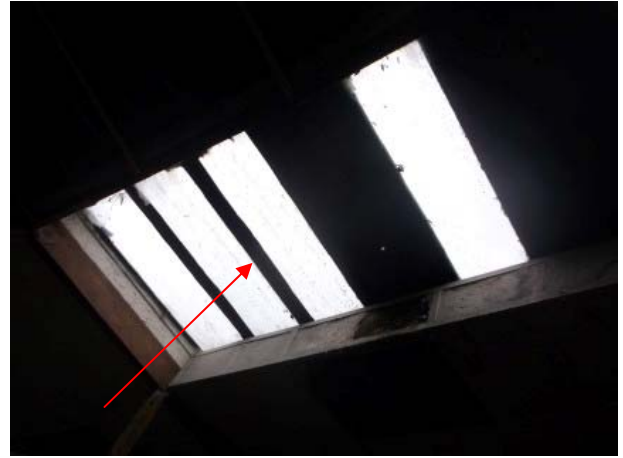
1.03 Dining Room	RS	Ceiling – Textured coating	15/11/B/23/MAC10	No Asbestos Detected	C	-	-	-	-	-	-	-	-	-
		Skylights – Rope seals	15/11/B/23/MAC11	Chrysotile	C	36m ²	Low	Fair	2	1	2	1	6	REMOVE
		Sink – Bitumen pad	15/11/B/23/MAC12	No Asbestos Detected	C	-	-	-	-	-	-	-	-	-
		Other information – No other suspect ACMs identified during survey of this area.												
L.01 Loft	RS	Ceiling – Sarking	15/11/B/23/MAC13	No Asbestos Detected	C	-	-	-	-	-	-	-	-	-
		Other information – Plaster board. Sarking to ceiling. No other suspect ACMs identified during survey of this area.

Items & Content: Rope Seals containing chrysotile.
Sample No: 15/11/B/23/MAC11.

Sample No: 15/11/B/23/MAC11.
1.03 Dining Room – Skylights.
Rope Seals.

Location: 1.03 Dining Room – Skylights

Recommendation: These materials should be removed and disposed of prior to refurbishment, by either suitably trained and equipped personnel or a licensed asbestos removal contractor only, working under the guidance of a safe working procedure and in accordance with the requirements of The Control of Asbestos Regulations 2012 and The Hazardous Waste (England and Wales) Regulations 2005 (as amended in 2009).
Notification (via an ASB NNLW1 Notification Form) may be required to The Health and Safety Executive prior to any works being carried out to these materials.
