TREE REPORT (BS 5837:2012)

PROPOSED DEVELOPMENT

140/141 RIVERSVALE
GADLEY LANE
BUXTON
DERBYSHIRE

Author: P Murray
Date: 6th March 2016
Ref: PM/06/03/16

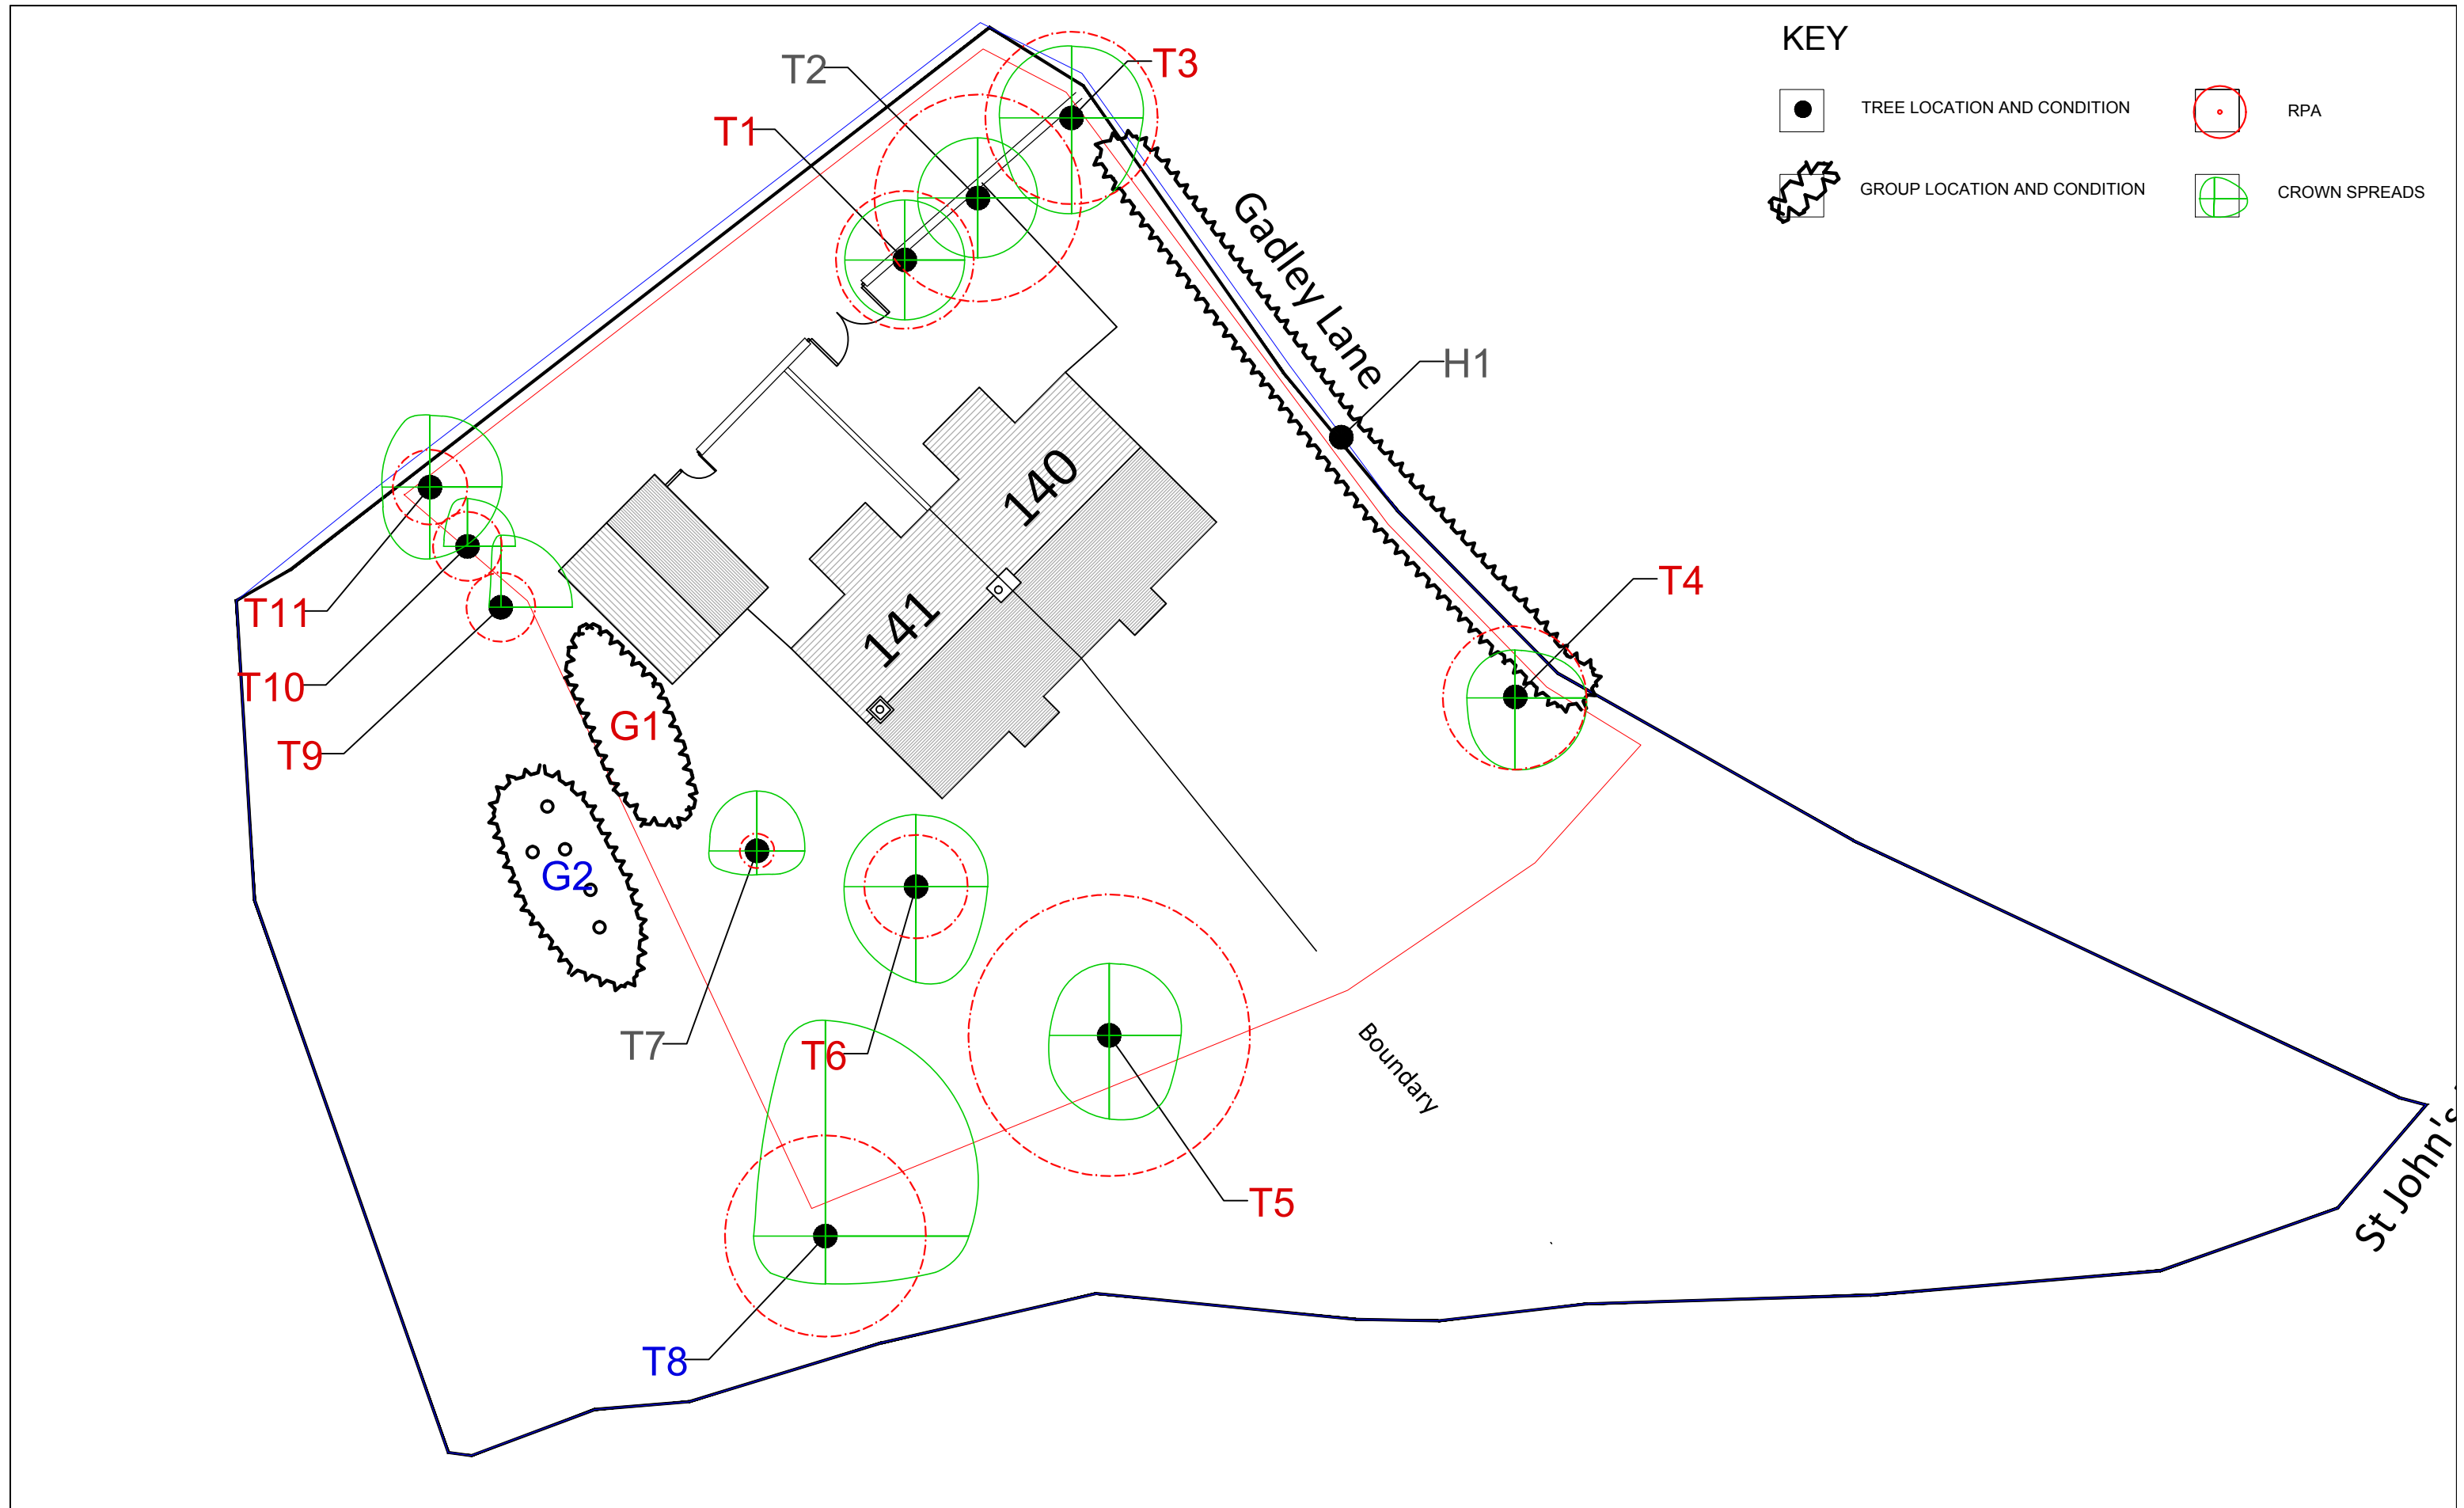
DRAWING: MY525/RB/TREE/01

5.1 The Site Layout Plan within Appendix Four identifies the trees in relation to the proposed development.
