THE OCTAGON
PAVILION GARDENS
HIP RAFTER END,
COLUMN AND SPANDREL
REPAIRS

Drawn	n/w	Eng	SW
Scales As noted at A1			
Drawing No		Ver	
23765/30		4

SPANDREL, HIP RAFTER END AND CORNER COLUMN REPAIRS

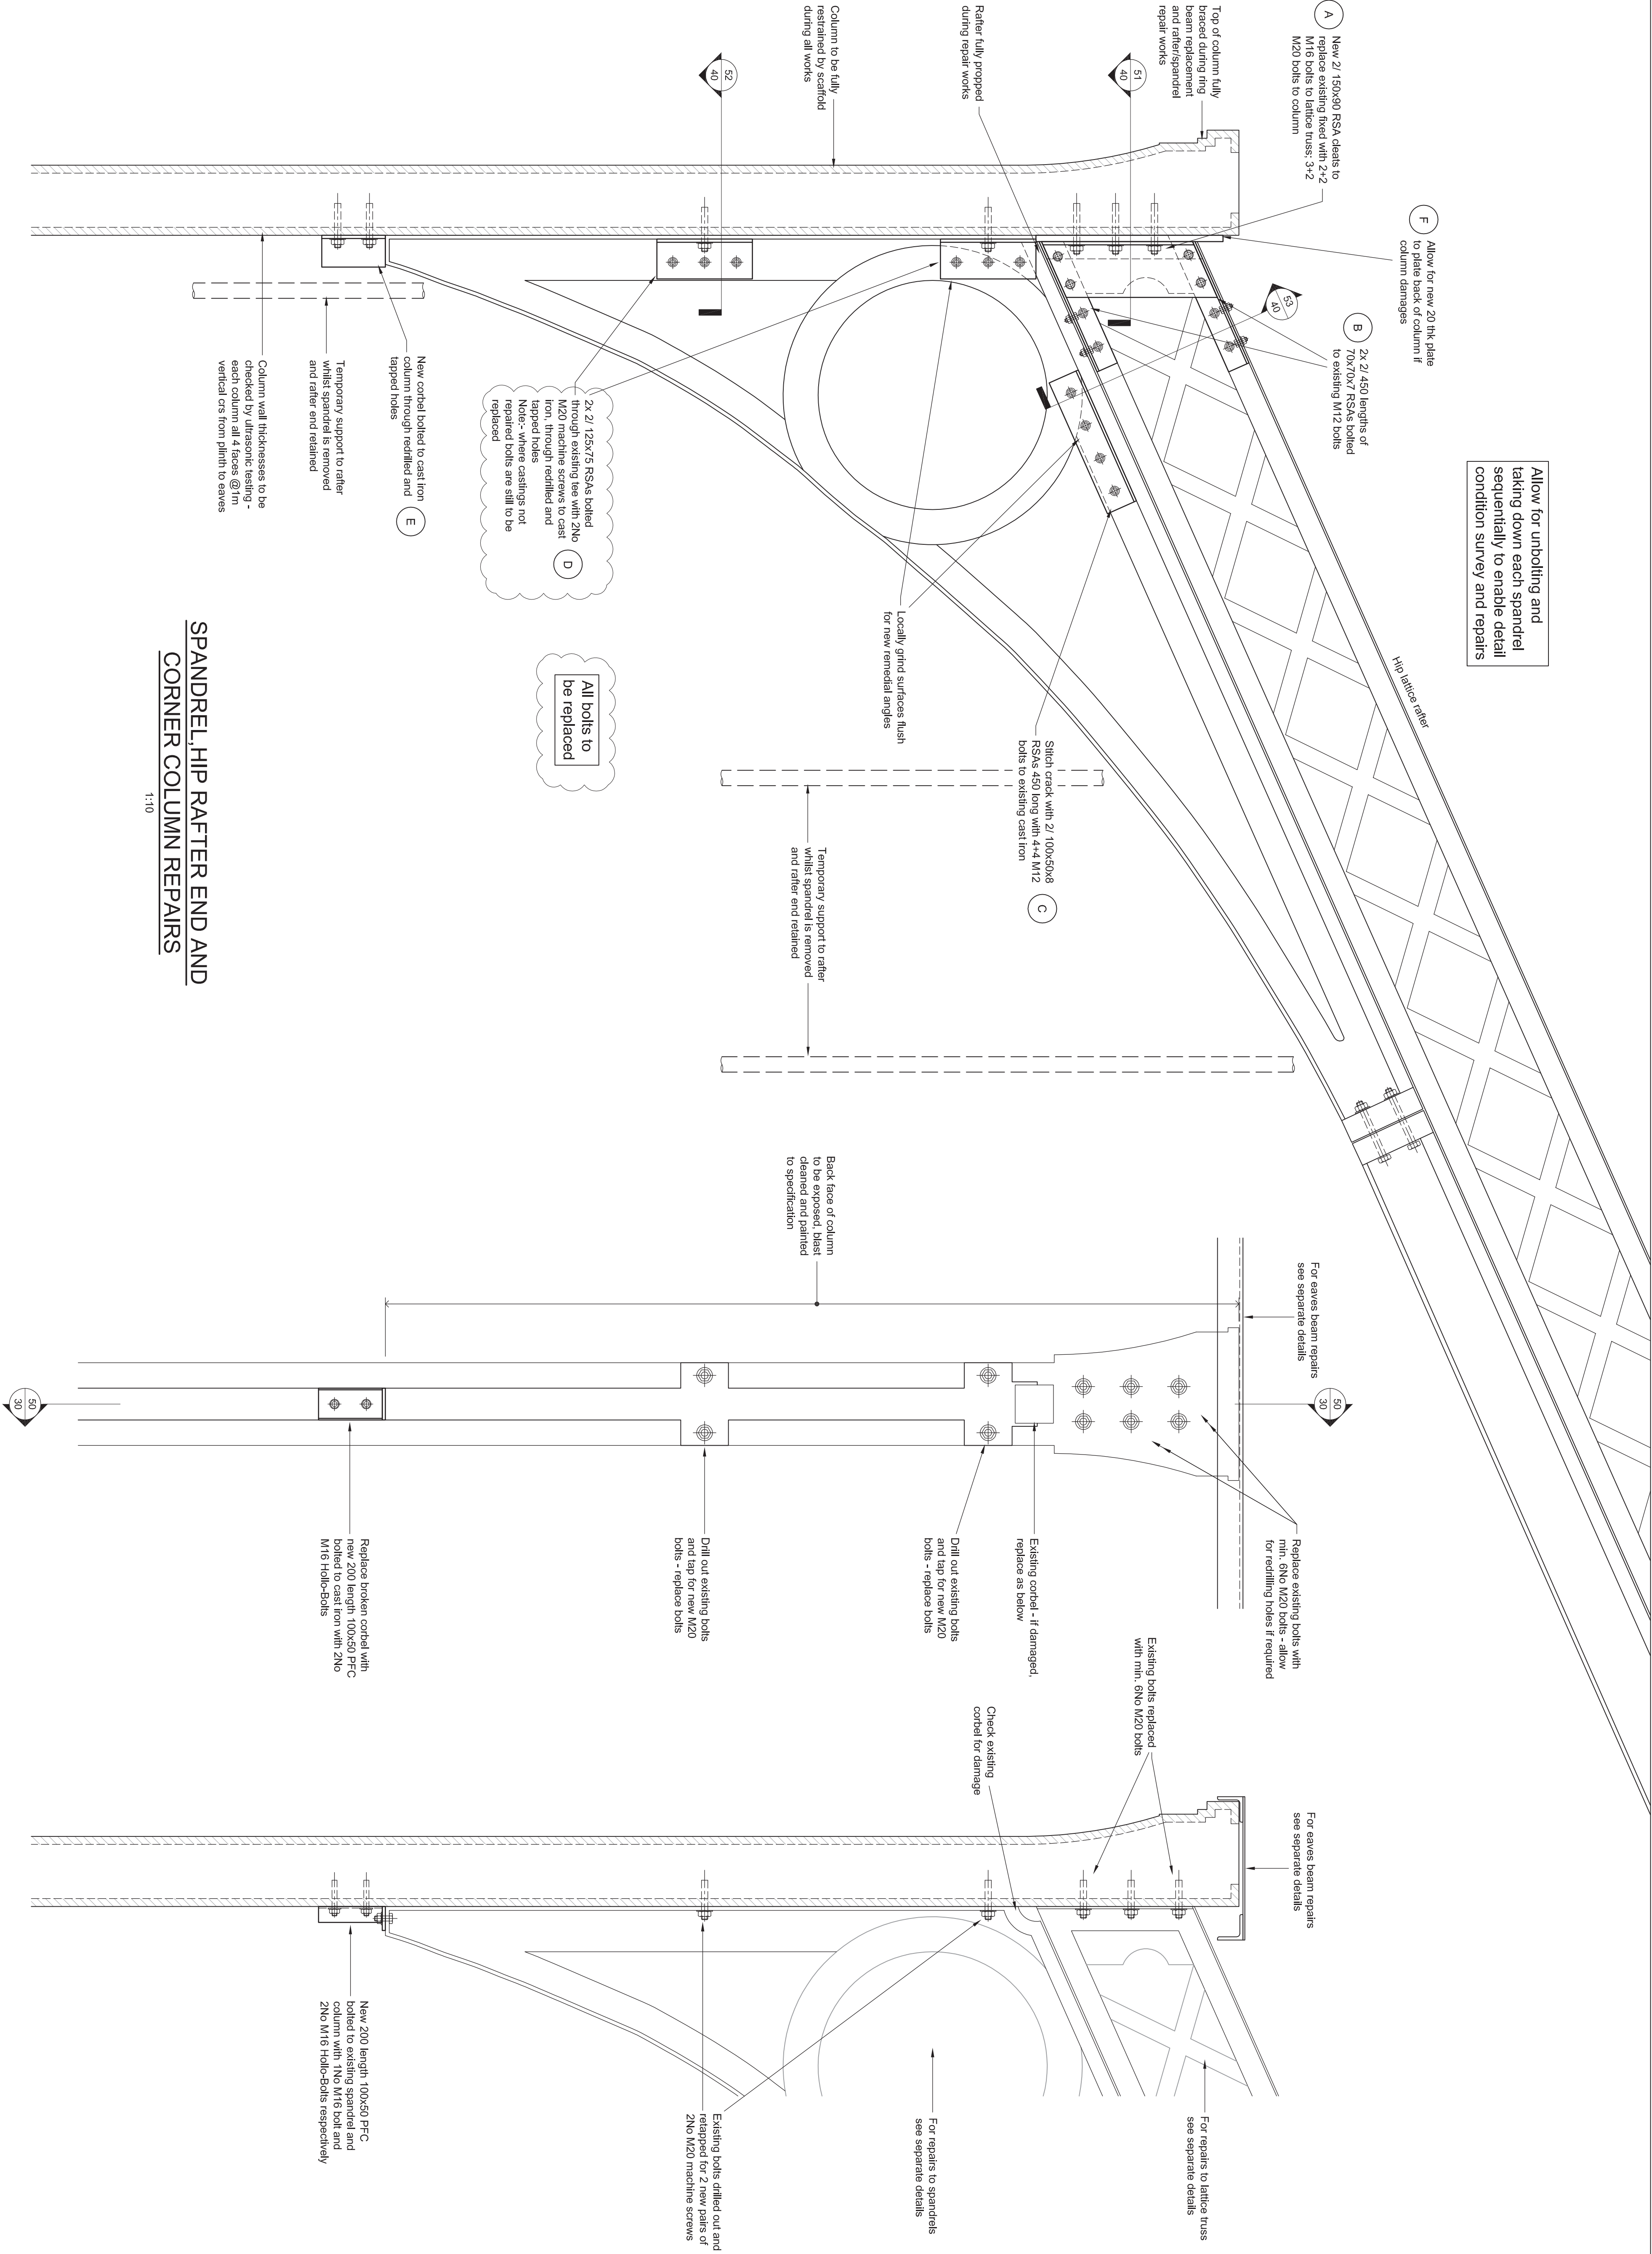
Existing corbel - if damaged,
replace as below

Check existing —
corbel for damage

Allow for unbolting and taking down each spandrel sequentially to enable detail condition survey and repairs

F Allow for new 20 thk plate to plate back of column if column damages

A
New 2" 130x30 KSA cleats to
replace existing fixed with 2+2
M16 bolts to lattice truss; 3+2
M20 bolts to column

B 2x 2/ 450 lengths of
70x70x7 RSAs bolted
to existing M12 bolts

C
RSAs 450 long with 4+4 M12
bolts to existing cast iron

Locally grind surfaces flush
for new remedial angles

Temporary support to raft
whilst spandrel is removed
and rafter end retained

Back face of coating to be exposed, cleaned and painted to specification

Replace existing bolts with min. 6No M20 bolts - allow for redrilling holes if required

Drill out existing bolts and tap for new M20 bolts - replace bolts

Replace broken corbel with new 200 length 100x50 PFC bolted to cast iron with 2No M16 Hollo-Bolts

Existing bolts replaced with min. 6No M20 bolts

All bolts to
be replaced

2X 2/125x75 RSAs bolted through existing tee with 2M20 machine screws to cast iron, through redrilled and tapped holes

Temporary support to rafter whilst spandrel is removed and rafter end retained

- Column wall thicknesses to be checked by ultrasonic testing - each column all 4 faces @1m vertical crs from plinth to eaves
