C1/CAS01/Chapel/RA/RA/DR1

8th October 2016

**Land off Combs Road, Chapel-en-le-Frith.
Drainage report**

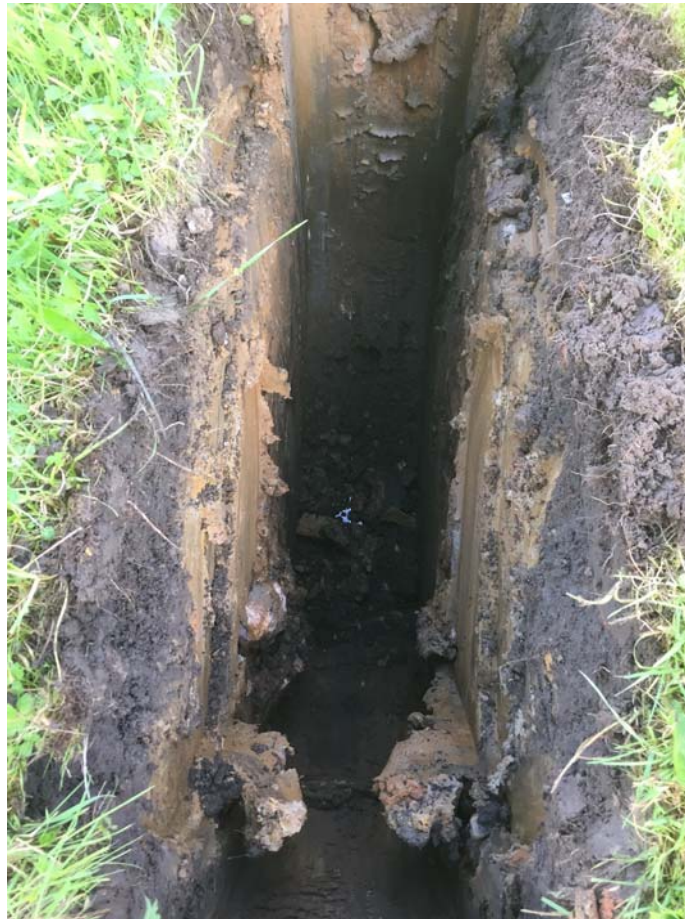
SA1 was excavated to a depth of 1.5m where water ingress was noted in the pit base. This pit was not tested as BRE365 and Building Regulations Part H requires the test to be done above ground water levels. It was noted that the strata was of a clayey nature and infiltration was unlikely, this pit was left open in order to let the water equalise and this confirm water table levels at this location. Over the duration of the day water of depth 100mm was recorded in the pit base. (1.4m BGL)

Photo 1 – SA1 with water ingress at base.

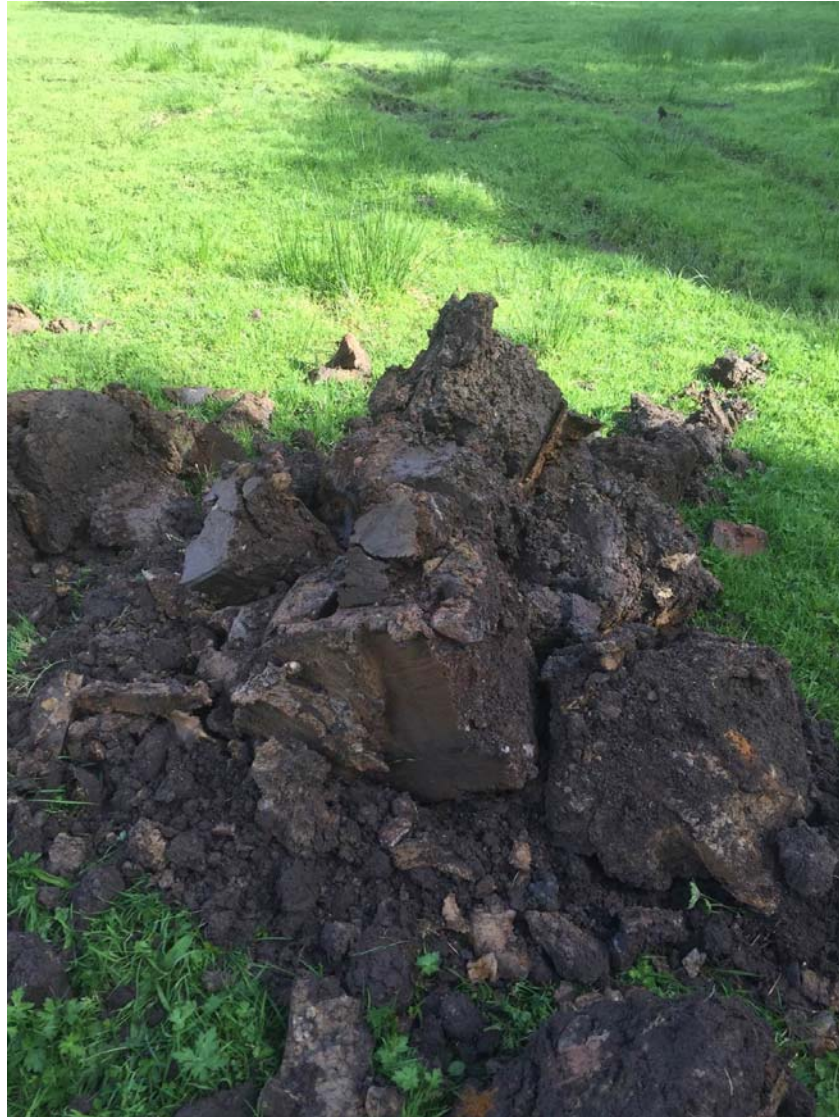
Photo 2 – SA1 excavated material

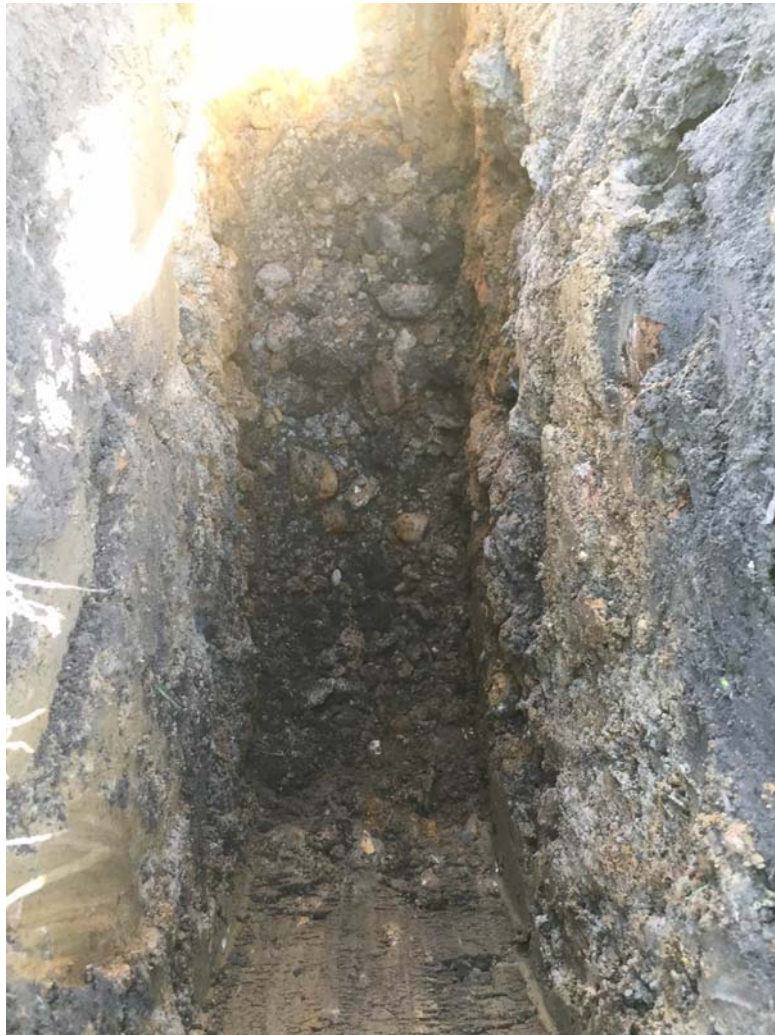
SA2 was excavated to a depth of 1.2m. The excavated material was still clayey in nature but more gravelly than SA1. Groundwater was not recorded so a test was commenced. Unfortunately over the duration of the day zero infiltration was recorded at this location.

Photo 3 – SA2 pit base.

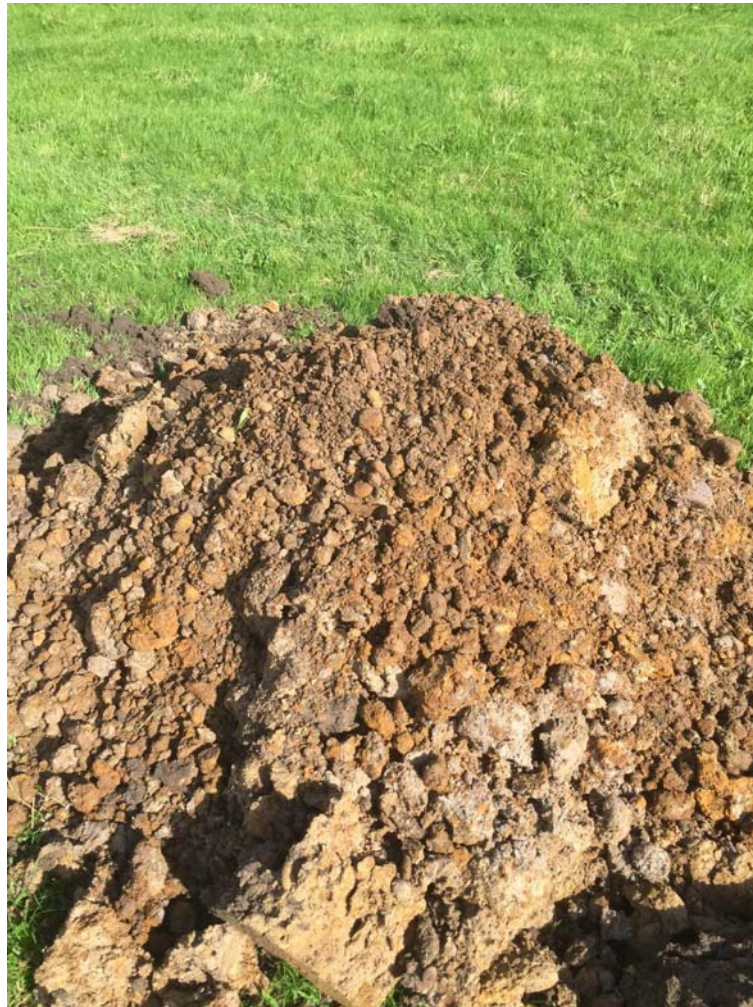
Photo 4 – SA2 excavated material.

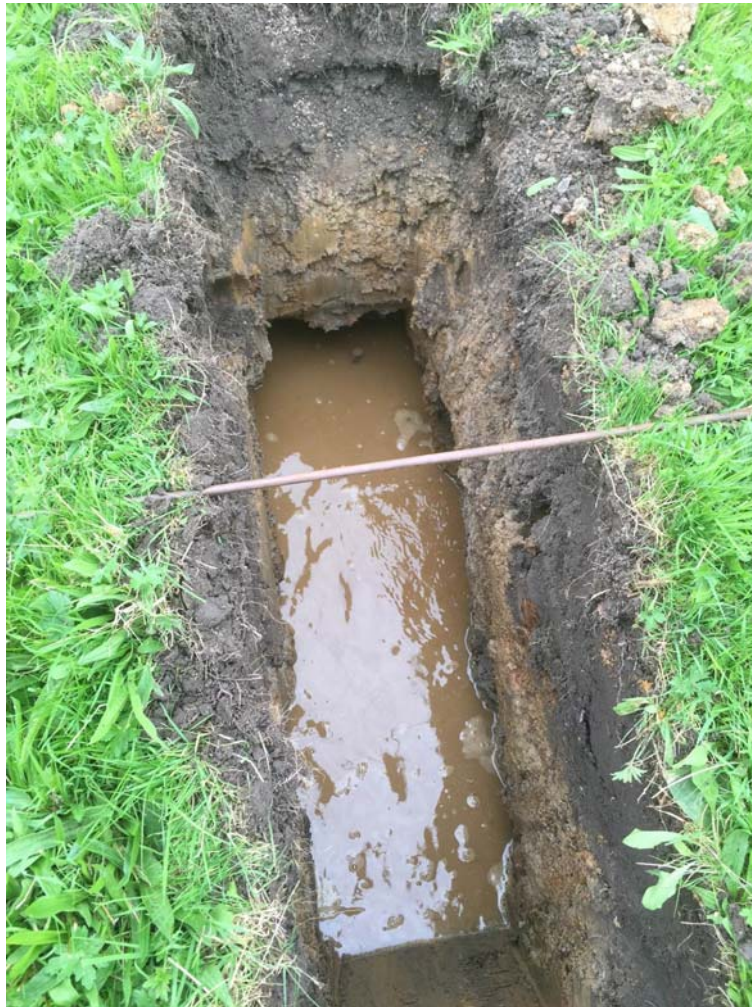
Photo 5 – SA2 infiltration test.

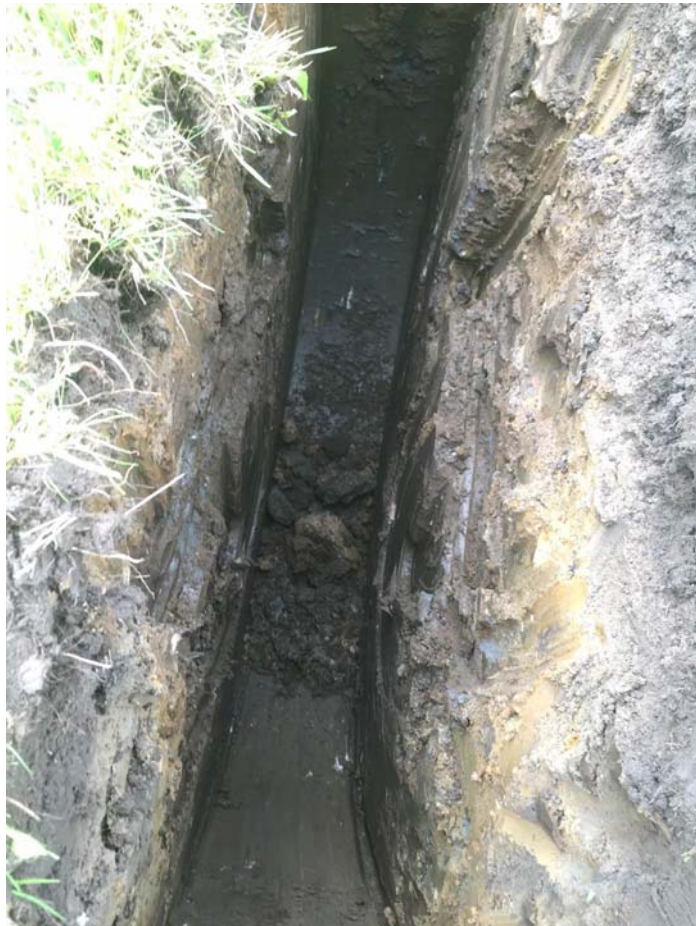
SA3 was excavated to a depth of 1.3m. The stratum was initially gravelly clay and becoming more cohesive in nature at depth. The overlaying gravelly clay was moist. A test was also undertaken on the pit and again zero infiltration recorded.

Photo 6 – SA3 pit base

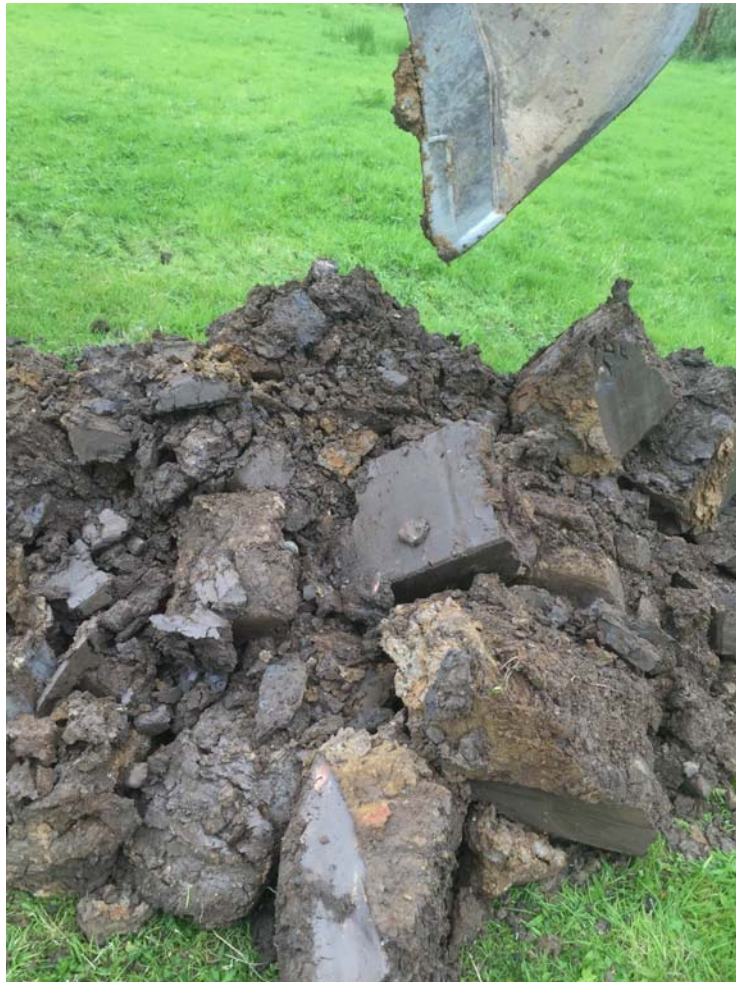
Photo 7 – SA3 excavated material

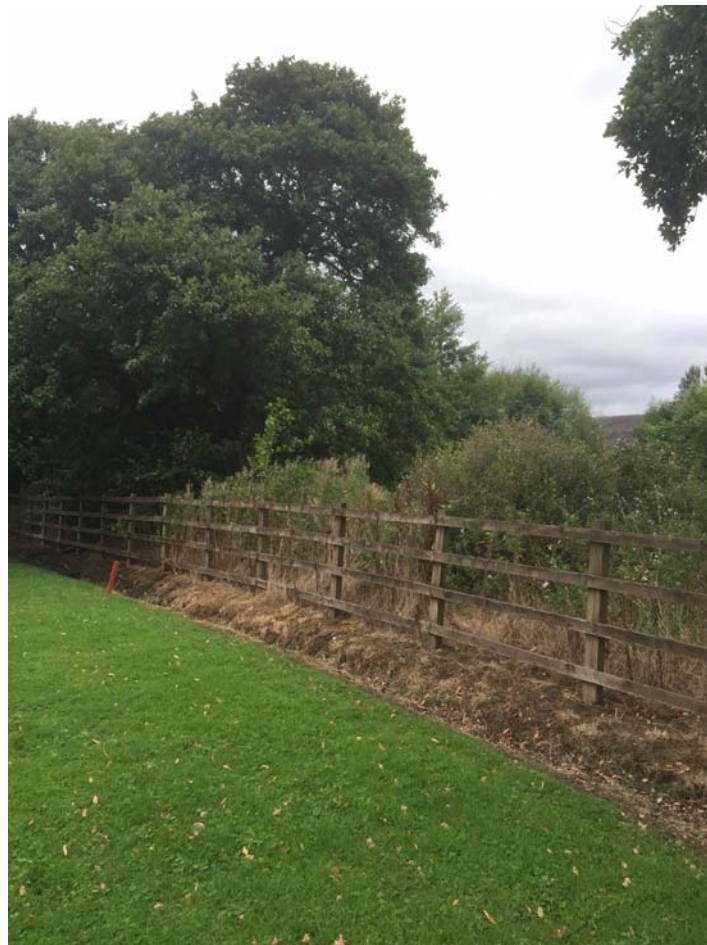
There is a ditch excavated along this boundary on the golf course side which has been provided to prevent overland run off from the development field

Photo 8 – Ditch along north eastern boundary at golf course

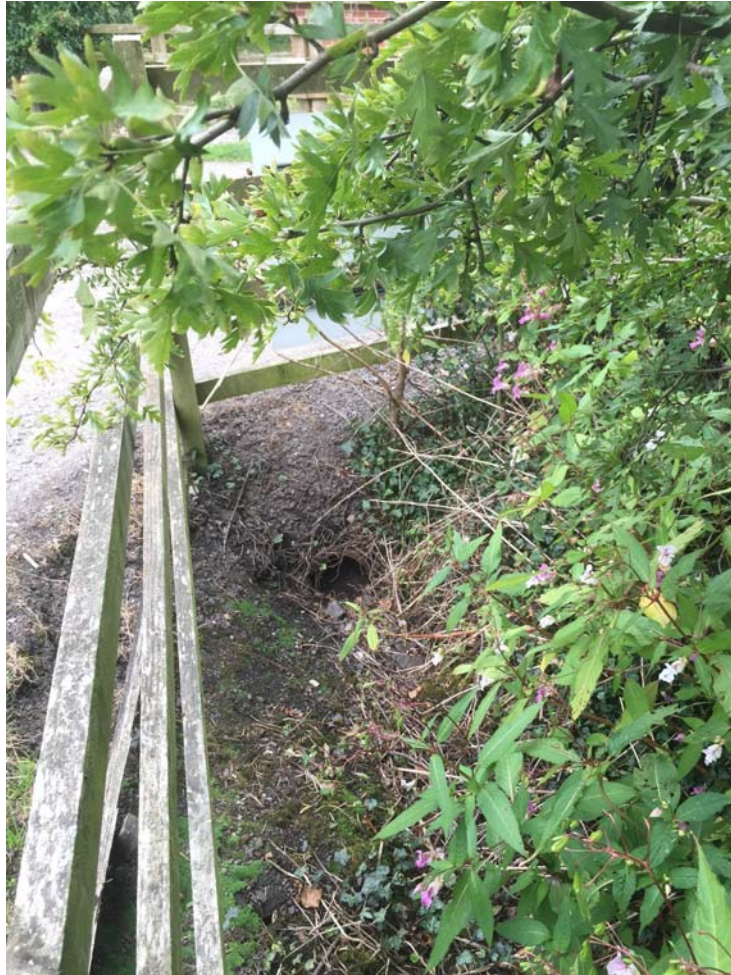
This ditch heads east along the boundary and then north into a 225 pipe which crosses the golf course access road.

Photo 9 – 225mm pipe from ditch under access road.

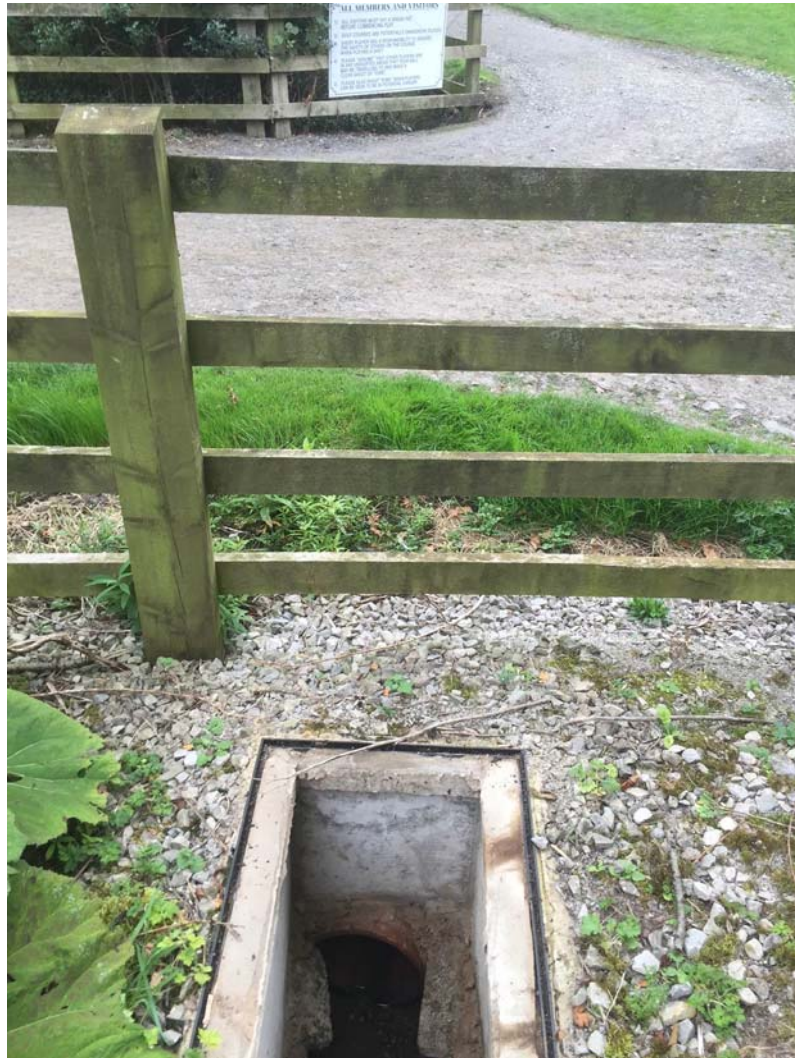
Photo 10 – 225mm pipe from ditch under access road and into manhole.

From the above photo it is clear that the ditch connects into the manhole, the ditch is located beyond, underneath the white sign fixed to the fence. This manhole had another pipe from the east and seems to cater land drainage for this area of the golf course.

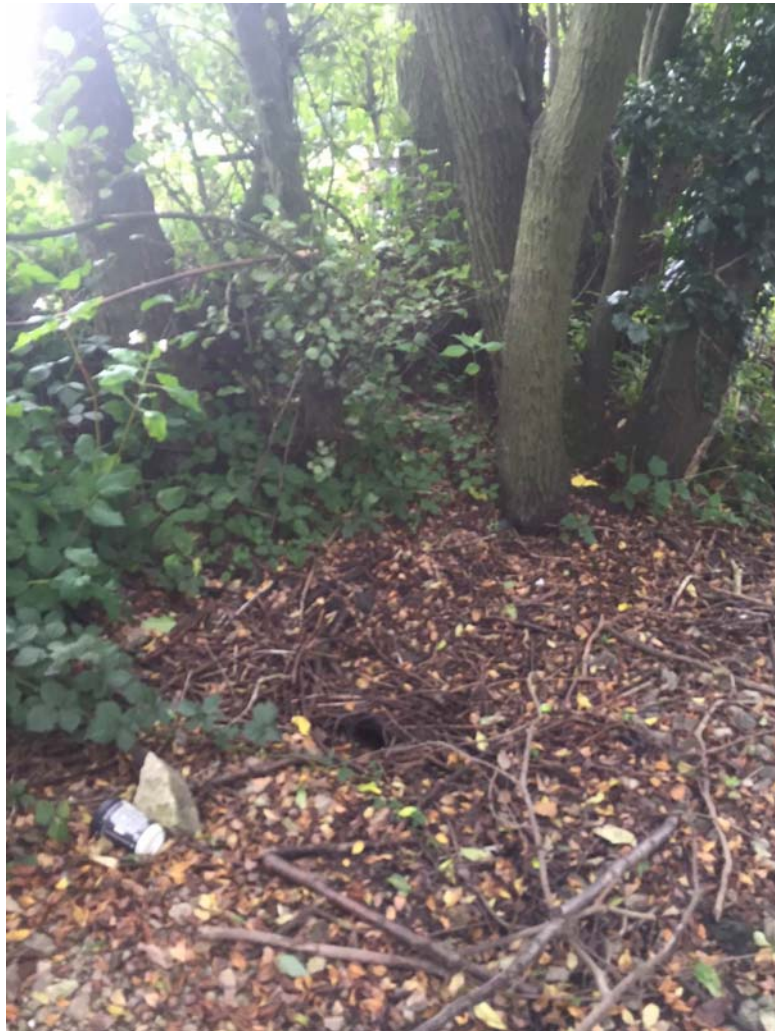
This manhole has an outfall pipe which then discharges into Combs Reservoir.

Photo 11 – 225mm pipe from manhole into Combs Reservoir bank.

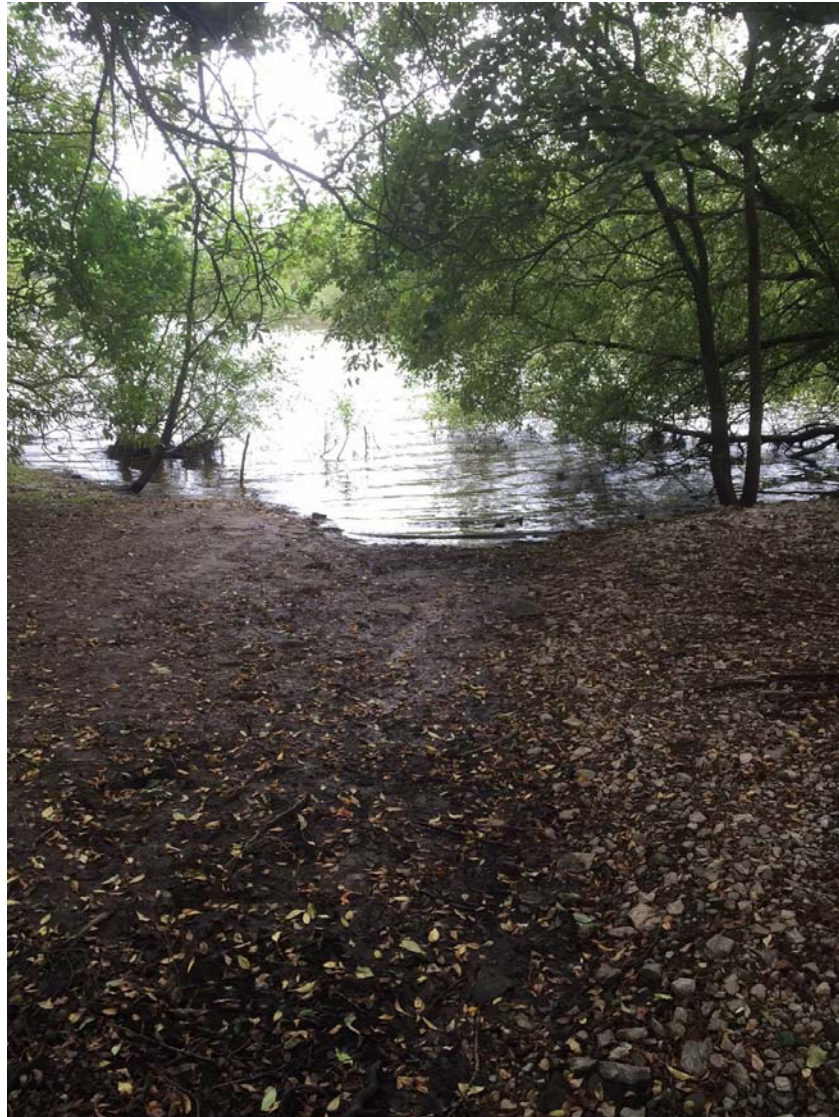
When standing at the outfall pipe and facing the reservoir it is clear to see a wet area leading down to the reservoir which proves that this system is functioning.

Photo 12 – Looking from 225mm pipe towards Combs Reservoir.

It is therefore proposed to utilise this system as the proposed outfall for the development.

A balancing pond can be provided on site with a flow control device such as hydro brake or orifice plate prior to the ditch outfall. This device would limit flows to a Greenfield rate equivalent to that currently conveying overland to this ditch.
