BS5837 2012 Tree Information Buxton Caravan Club Site

The Caravan Club
East Grinstead, RH19 1UA

Buxton CC site
Grin Low Road
Buxton
SK17 6UJ

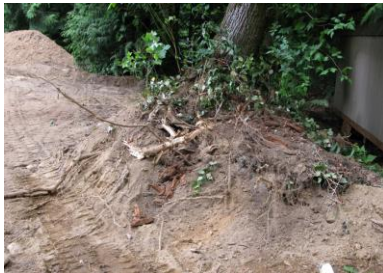
This photo shows a combination of damage. The roots have been severed or damaged in such a way that stability has been lost and this tree was felled. If the same damage had not led to an immediate tree failure the tree would have been sent into an irreversible spiral of decline.

The loss of roots will have caused a lack of structural support, loss of moisture take up, loss of oxygen take up and a means of the tree storing energy as starch within root structures. This type of root damage causes a slow decline in tree foliage known as crown die back.

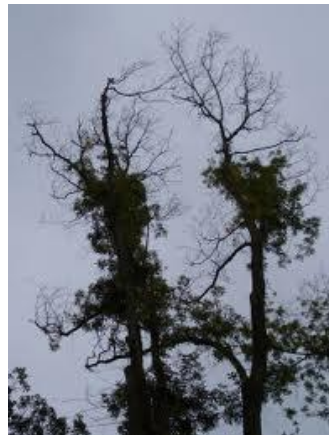
The picture to the right shows the years after the completion of a development site. Operators will often mention how they have driven over them. This is what happens once they leave.

die back of foliage several years after the completion of a development site. Machine operators have dug roots or driven over them.
