## **Consultant's Advice Note – 21 Hall St, New Mills**

Date: 5<sup>th</sup> April 2017

Doc No: CAN/01

### **Structural Vulnerability – HPBC Planning Application HPK/2017-116**

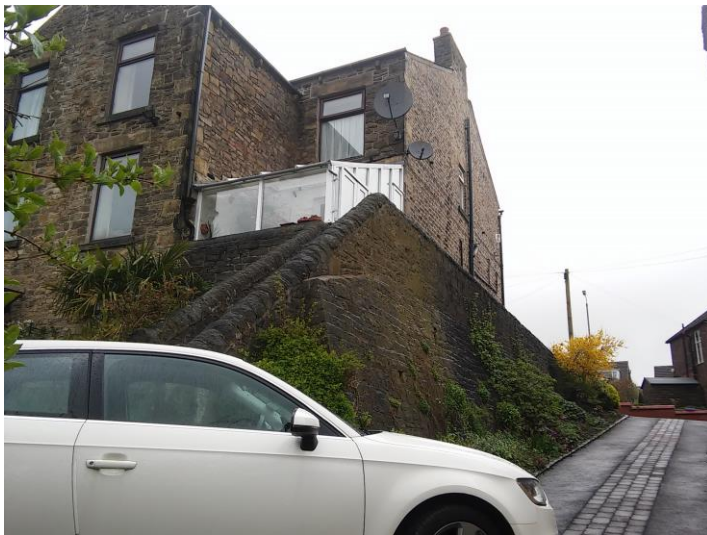
View from SE – 4.5m high retaining walls, steeply sloping ground, “perched” main structure. Side access road in good repair, neatly landscaped and well maintained. No 19 (out of shot) is to the right of the driveway.

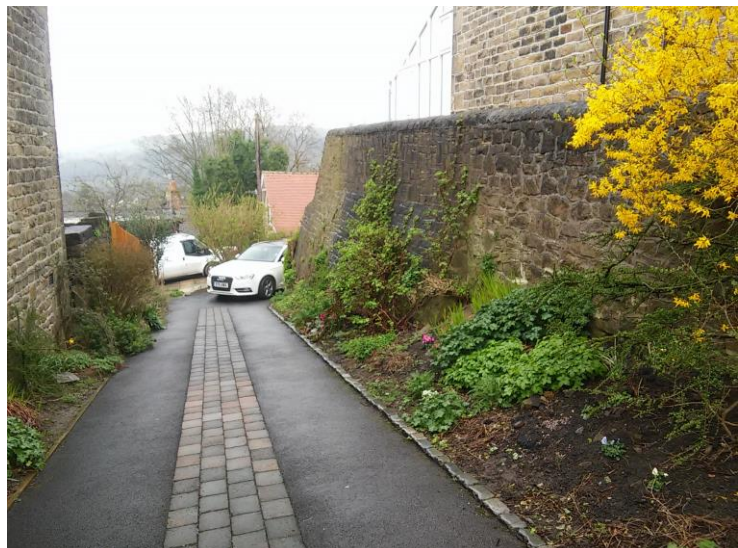
View from NW looking down the driveway (public access by foot only)  
Unlike the view above this photograph does not give a true indication of the gradient of the slope.

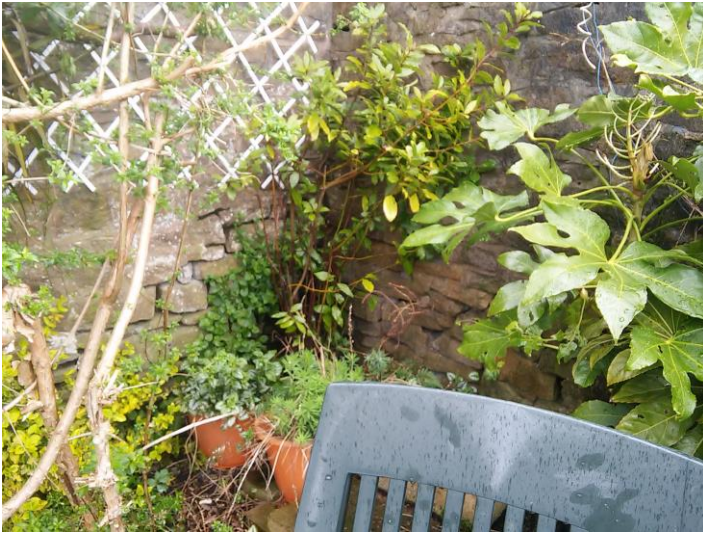
Open jointed nature of the stone masonry to the secluded rear garden. This is potentially very vulnerable to excessive vibration.

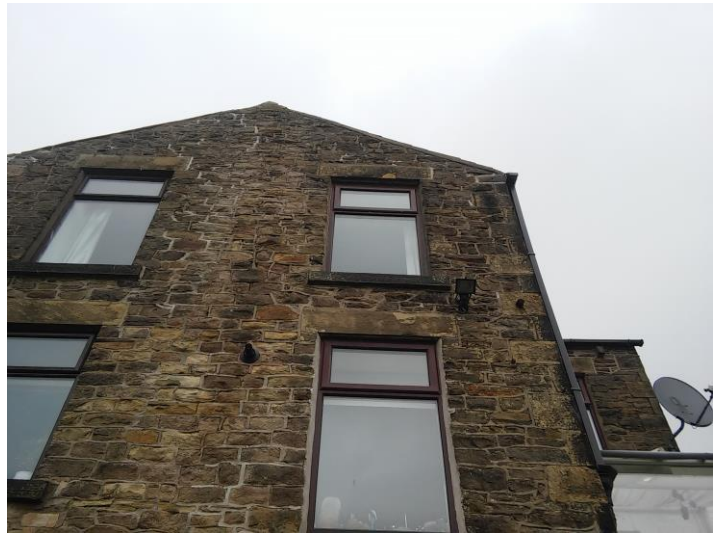
Random jointed stone masonry to the high rear gable wall. Note repointed historic crack repairs.

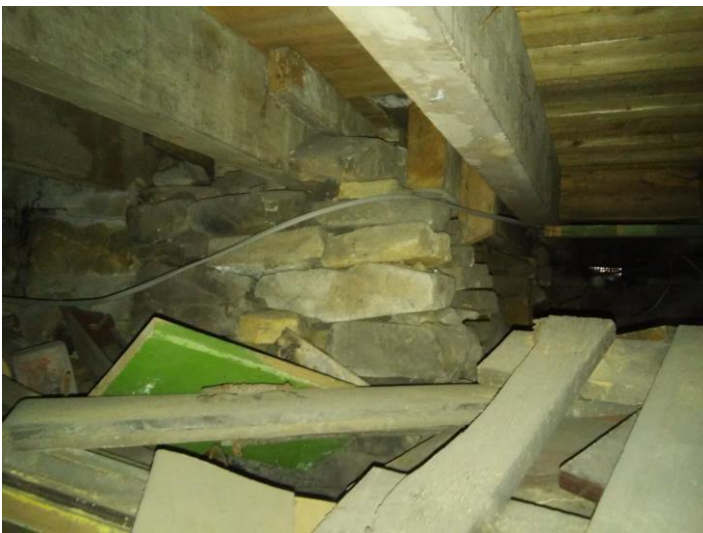
Inspection of the subfloor void below the upper ground floor suggests weak / friable lime mortar jointing has been used for the masonry, with some sections of open jointed (effectively "dry stone" joints) walling to the main gable.

Internal view of the open jointed masonry beneath the ground floor / gable wall. This is potentially very vulnerable to excessive vibration.
