Management Asbestos Survey Report

Client	Thomas Greateorex & Sons Limited Retirement Benefit Scheme 29 Knowleston Place Matlock Derbyshire DE4 3BU	Site Address	Heath Street Garage Heath Street Buxton SK17 6LT
Reference	J001014	Survey Date	20 Feb 2017
Report Date	22 Feb 2017	Surveyor	Glynn Gibson

Site Address: Heath Street Garage, Heath Street, Buxton, SK17 6LT

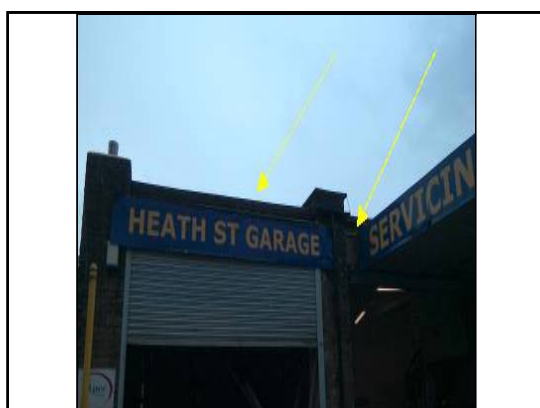
Heath Street Garage Heath Street Buxton SK17 6LT	Date: 20 Feb 2017	Record Sheet No:2
	Ref: J001014	Surveyor: Glynn Gibson

Sample No.:	Inspection No.:	Location:	Item/Material/Product:	Quantity /Extent:	Asbestos Type
Presumed	8	Car garage, External, External, E01, Roof	Bitumen felt	150m ²	Chrysotile

Accessibility:	Condition:
Usually inaccessible or unlikely to be disturbed	Good Condition

Material Assessment Algorithm		Score	Material Assessment Total (a)	Priority Assessment Total (b)	Total Score (a+b)
Product Type (1-3)		1			
Damage/Deterioration (0-3)		0	2	0	2
Surface Treatment (0-3)		0			
Asbestos Type (1-3)		1

Actions	Timescale	Action	Timescale
Monitor condition/Re-inspect	12 Months	Air Test	
Encapsulate or Enclose		Removal by Appropriate Contractor	
Operate Safe System of Work		Restrict Access	
Permit to Work Required		Repair Under Controlled Conditions

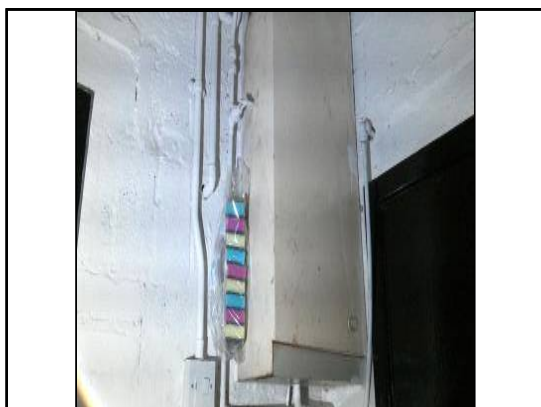
Heath Street Garage Heath Street Buxton SK17 6LT	Date: 20 Feb 2017	Record Sheet No:1
	Ref: J001014	Surveyor: Glynn Gibson

Sample No.:	Inspection No.:	Location:	Item/Material/Product:	Quantity /Extent:	Asbestos Type
Presumed	3	Car garage, Ground Floor, GF3, G03, Water boiler	Seals	1no.	Chrysotile

Accessibility:	Condition:
Usually inaccessible or unlikely to be disturbed	Good Condition

Material Assessment Algorithm		Score	Material Assessment Total (a)	Priority Assessment Total (b)	Total Score (a+b)
Product Type (1-3)		2			
Damage/Deterioration (0-3)		0	4	0	4
Surface Treatment (0-3)		1			
Asbestos Type (1-3)		1

Actions	Timescale	Action	Timescale
Monitor condition/Re-inspect	12 Months	Air Test	
Encapsulate or Enclose		Removal by Appropriate Contractor	
Operate Safe System of Work		Restrict Access	
Permit to Work Required		Repair Under Controlled Conditions

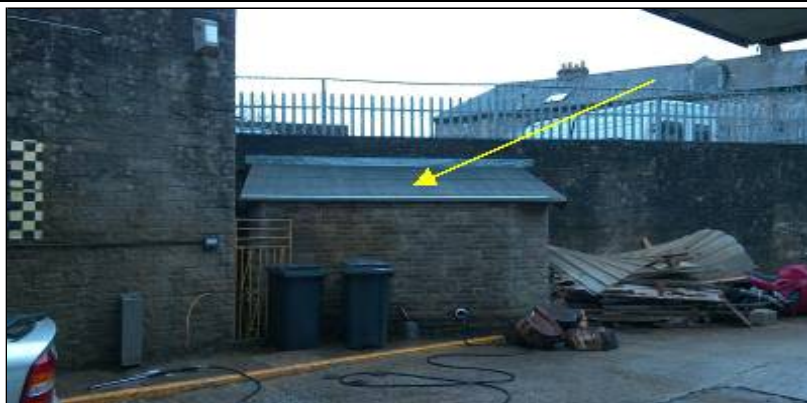
Sample No: AC000477		Inspection No.		9	
Location: Car garage, External, External, E01, Lower roof/Pressure washer store					
Item/Material: Bitumen felt					
Other Rooms/Areas Where Similar Material Presumed:					
Location		Inspection No.			
		Analysis Result		No Asbestos Detected in Sample

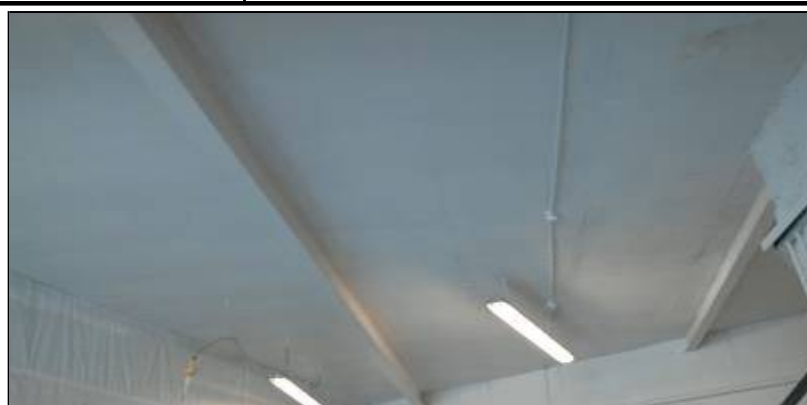
Sample No: AC000476		Inspection No.		2	
Location: Car garage, Ground Floor, GF2, G02, Ceiling					
Item/Material: Plasterboard					
Other Rooms/Areas Where Similar Material Presumed:					
Location		Inspection No.			
		Analysis Result		No Asbestos Detected in Sample

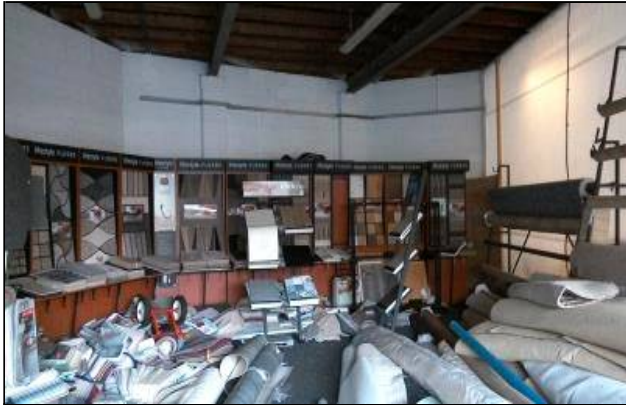
Location / Description:
Car garage, Ground Floor, GF1, G01
No suspect material found
Concrete floor, with carpet, block walls,
timber roof structure(no boards
underneath) plastic boarding to to of
shutter door, steel beams(no boarding) old
flue entrance next to shutter door with
metal flue end still in situ.

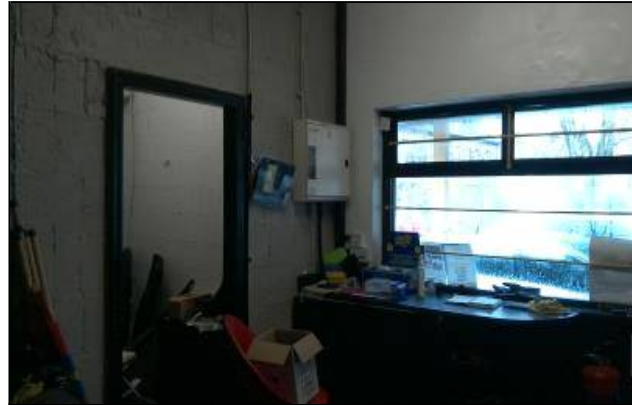
Location / Description:
Car garage, Ground Floor, GF4, G04
No suspect material found
Concrete floor with carpet, block walls,
plasterboard ceiling, plastered wall around
window, modern electrics and heater.

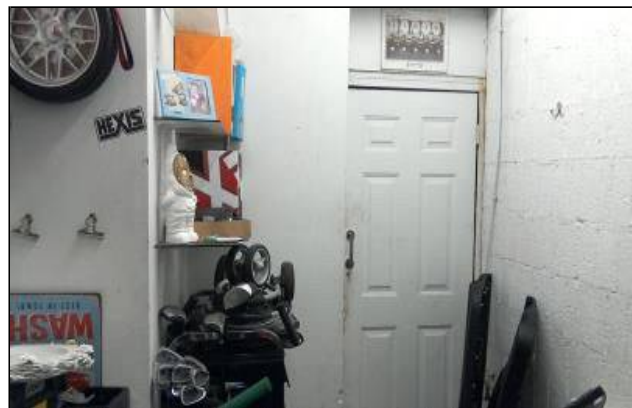
Location / Description:
Car garage, Ground Floor, GF5, G05
No suspect material found
Concrete floor with carpet, block walls,
plasterboard ceiling, plasterboard wall to
left side and door, timber above door.

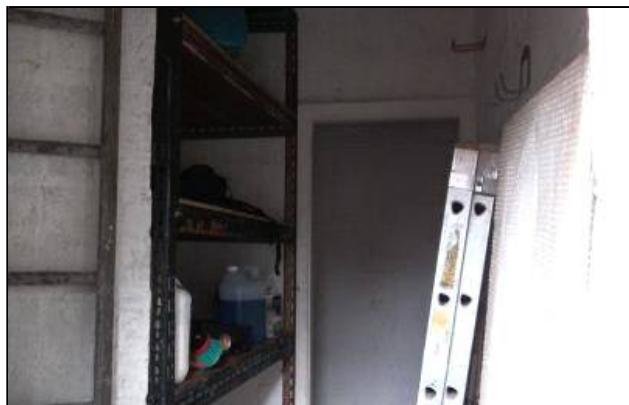
Car garage, Ground Floor, GF6, G06

No suspect material found

Concrete floor with ceramic tiles, block walls, plasterboard ceiling, modern cistern.

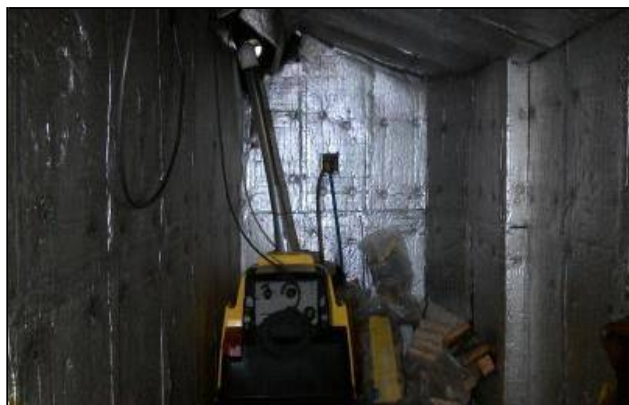
Car garage, Ground Floor, GF7, G07

No suspect material found
