Asbestos Risk Management

Refurbishment and Demolition Survey

**Laundry Buildings
Ellison Street
Glossop
SK13 8BY**

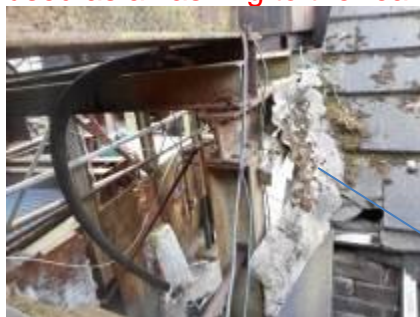
There is a small fragment of corrugated asbestos cement which has been used as a flashing to the rear l/h corner adjacent to a tank stillage.

Fragment of corrugated AC

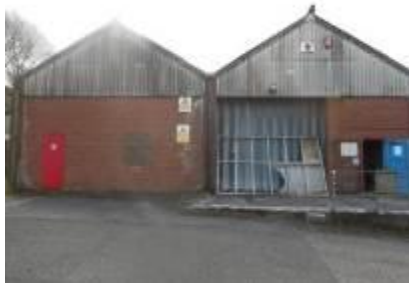
AC gables and verge cappings

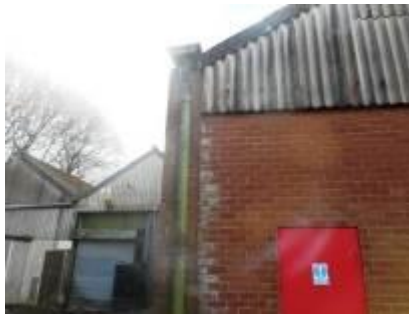
AC gable and downpipe

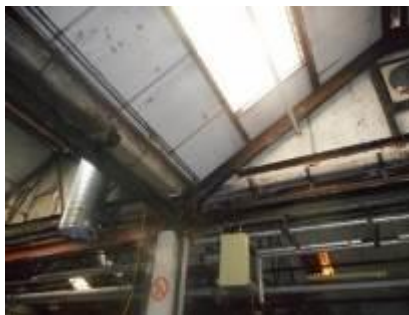
Non-asbestos insulation panels to roof and gables. AC gutter to base of rear gables. Presume ACMs to 2 Thermolier Space heaters

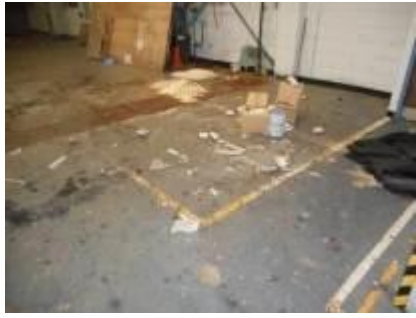
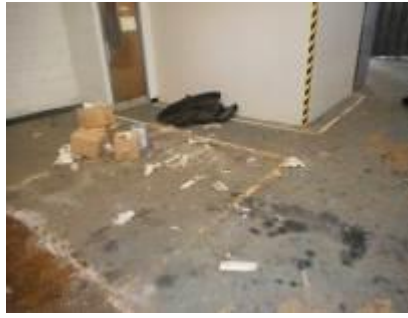
Sample GF1 02

Floor debris from a cement ridge section recorded NADIS. This appears to be a section of replacement ridge (white in colour) but it is recommended that it is disposed of as asbestos waste

Cement ridge debris, floor F1 NADIS

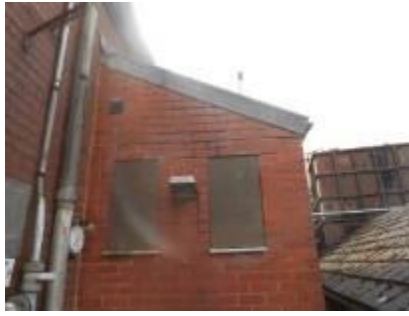
Pitched AC roof to WCs

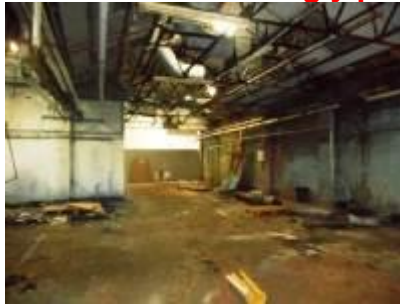
There are two strongly presumed AIB canopies at high level

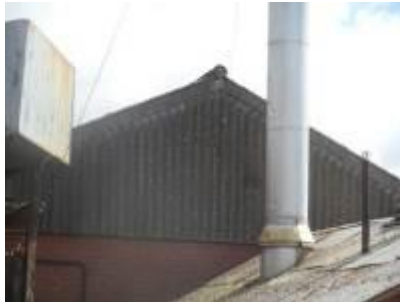
AC to right hand gable

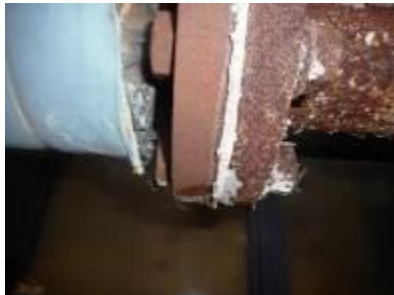
Sample GF4 06 Debris, pipe gasket F4 Chrysotile

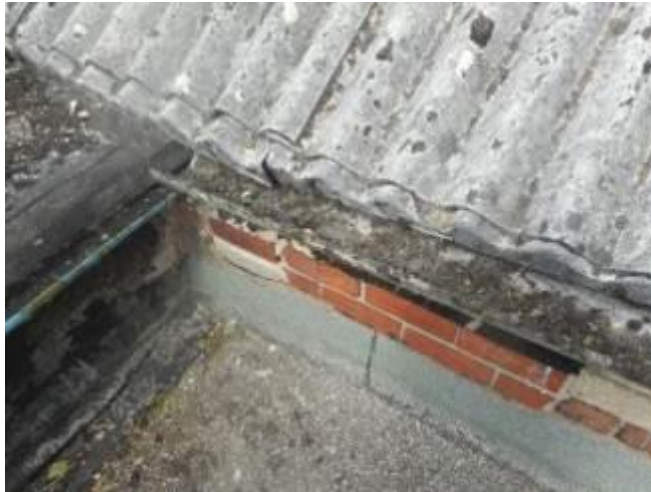
The asbestos cement roofs and gables are double skinned with a corrugated AC exterior and panelled AC interior. The eaves closures, ridge capping, and guttering to F8 are also asbestos cement.

AC roof, gutters and eaves

closures

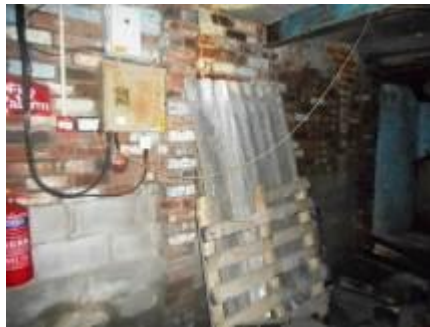
7 corrugated AC sheets

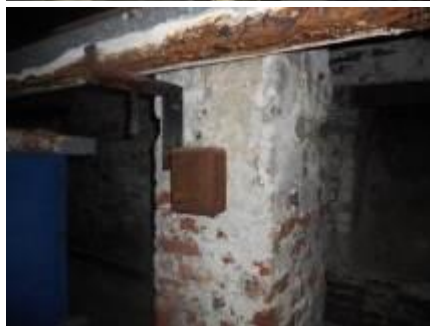
Presume ACMs to fuse unit

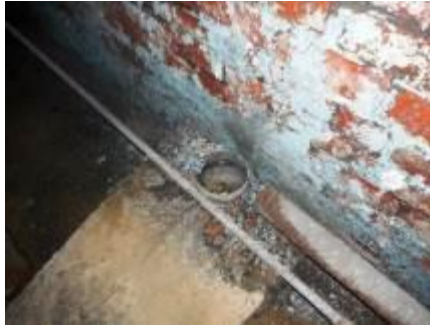
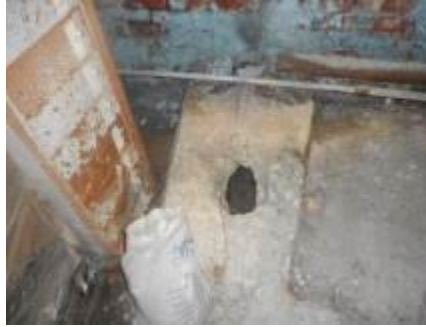
cement floor drain in concrete plinth

Asbestos

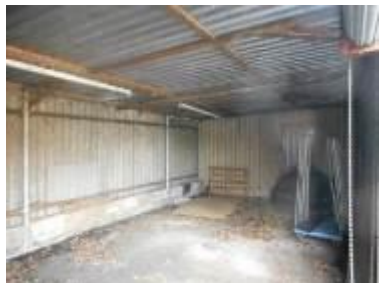
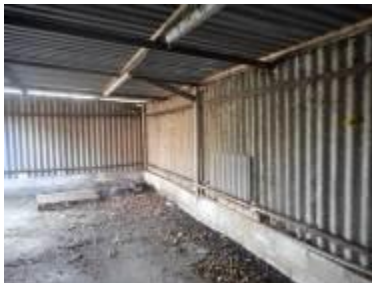
There are 17no. 2400mm x 1200mm AC sheets. Small areas of damage

panels

Corrugated AC wall

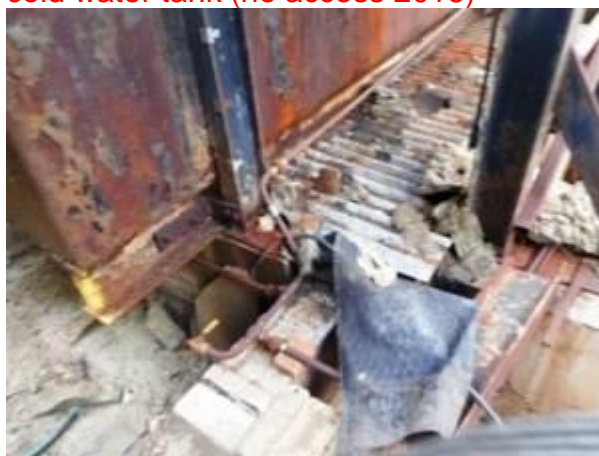
2004 Survey (page 35) reported asbestos cement to storage area under the cold water tank (no access 2016)

as 2004 Survey

Presume AC below cold water tank

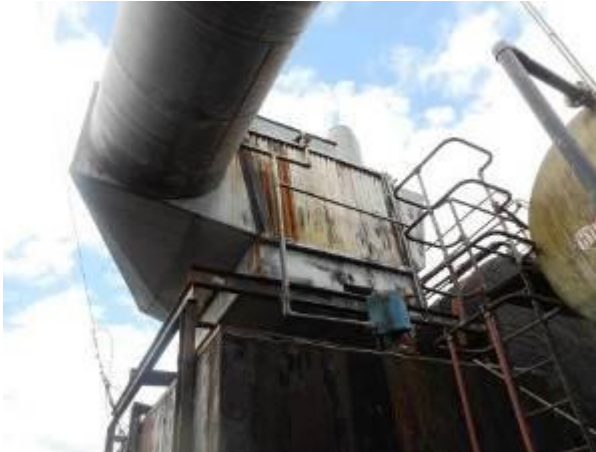
The ducting above the cold water tank connects to a rectangular chamber with asbestos cement walls

AC 'chamber' above water tank

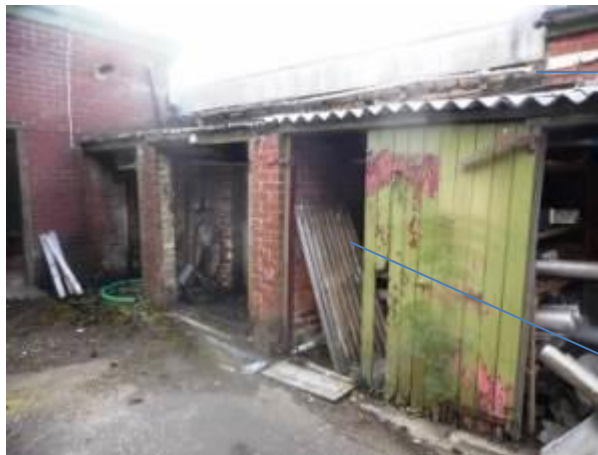
There is **6/7m of AC gutter in poor condition** to the adjacent building with **3m of AC downpipe** behind the end store adjacent to F7

AC gutter to adjoining building

Corrugated AC roofing sheet

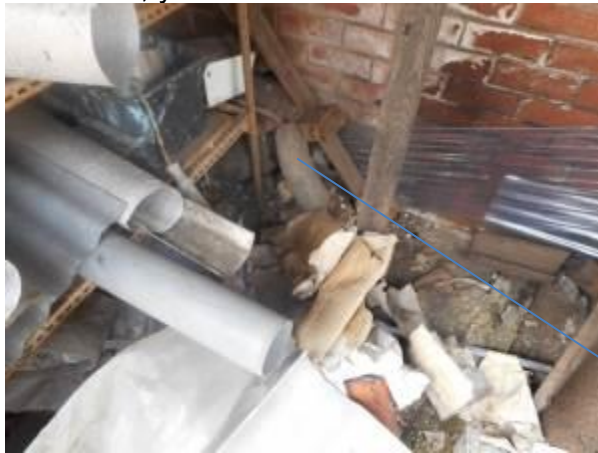
AC elbow rear centre

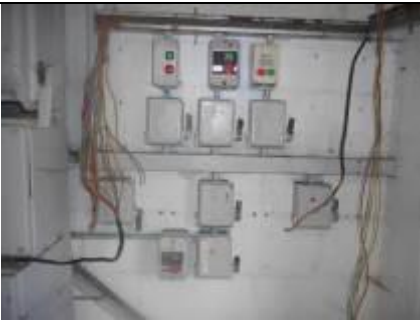
Material Risk Score Product type: Woven Chrysotile Extent of damage/deterioration: Low Surface treatment: Encapsulated within fuse unit Asbestos type: Chrysotile Material Risk Score	Risk Score 2 1 1 1 5 Risk Level: Low potential

Cylindrical fuses to later equipment should be presumed to contain asbestos

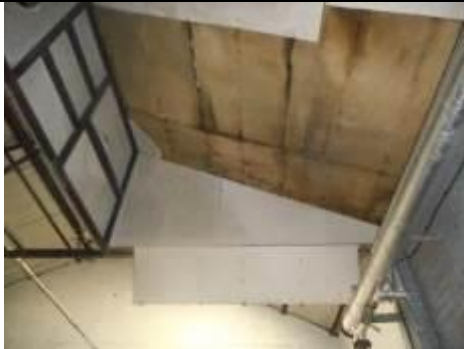
Material Risk Score Product type: AIB Extent of damage/deterioration: High Surface treatment: None Asbestos type: Amosite/Chrysotile Material Risk Score	Risk Score 2 3 2 2 9 Risk Level: Medium potential

Removal by HSE licensed contractor

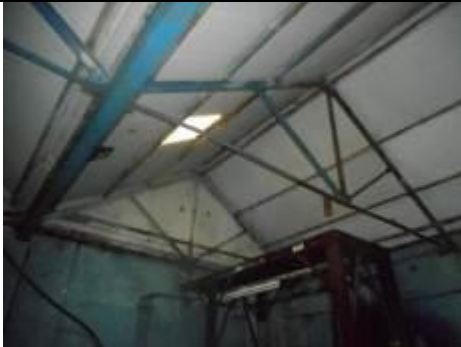
Material Risk Score Product type: AIB Extent of damage/deterioration: Low Surface treatment: None Asbestos type: Amosite/Chrysotile Material Risk Score	Risk Score 2 1 2 2 7 Risk Level: Medium potential

Removal by HSE licensed contractor

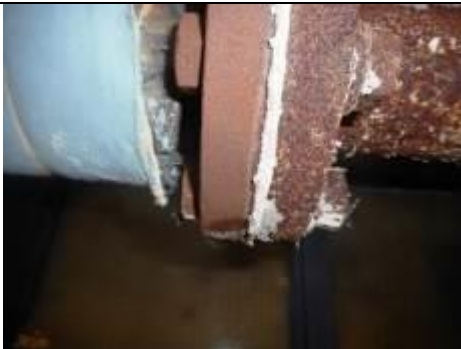
Material Risk Score Product type: Gaskets Extent of damage/deterioration: Medium Surface treatment: None Asbestos type: Chrysotile Material Risk Score	Risk Score 2 2 2 1 7 Risk Level: Medium potential

Remove and dispose of as asbestos waste under the appropriate HSE guidelines (CAR 2012)

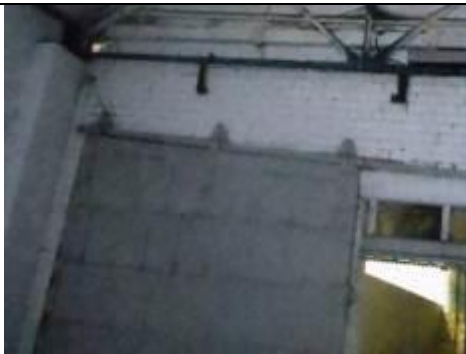
Material Risk Score Product type: Gaskets Extent of damage/deterioration: Medium Surface treatment: None, but encapsulated behind metal sheet Asbestos type: Chrysotile Material Risk Score	Risk Score 2 2 2 1 7 Risk Level: Medium potential

Remove intact and dispose of as asbestos waste under the appropriate HSE guidelines (CAR 2012)

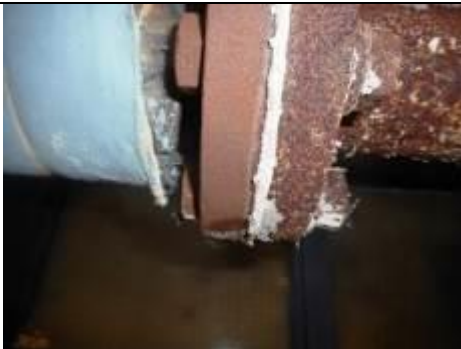
Material Risk Score Product type: Gaskets Extent of damage/deterioration: Medium Surface treatment: None Asbestos type: Chrysotile Material Risk Score	Risk Score 2 2 2 1 7 Risk Level: Medium potential

Remove and dispose of as asbestos waste under the appropriate HSE guidelines (CAR 2012)

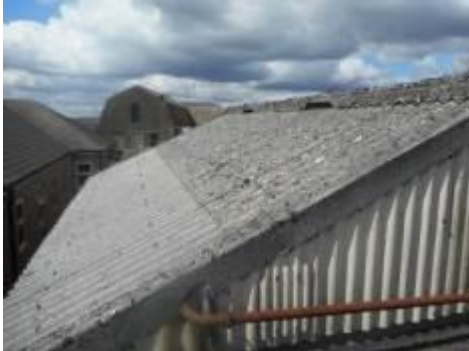
Material Risk Score Product type: Asbestos Cement Extent of damage/deterioration: Low - High Surface treatment: None Asbestos type: Chrysotile Material Risk Score	Risk Score 1 1-3 1 1 4-6 Risk Level: Low

Remove and dispose of as asbestos waste under the appropriate HSE guidelines (CAR 2012)
