Our ref: 17/163

RE: Little Padfield Farm, Glossop

Further to your instruction and my inspection of the subject property I can report as follows.

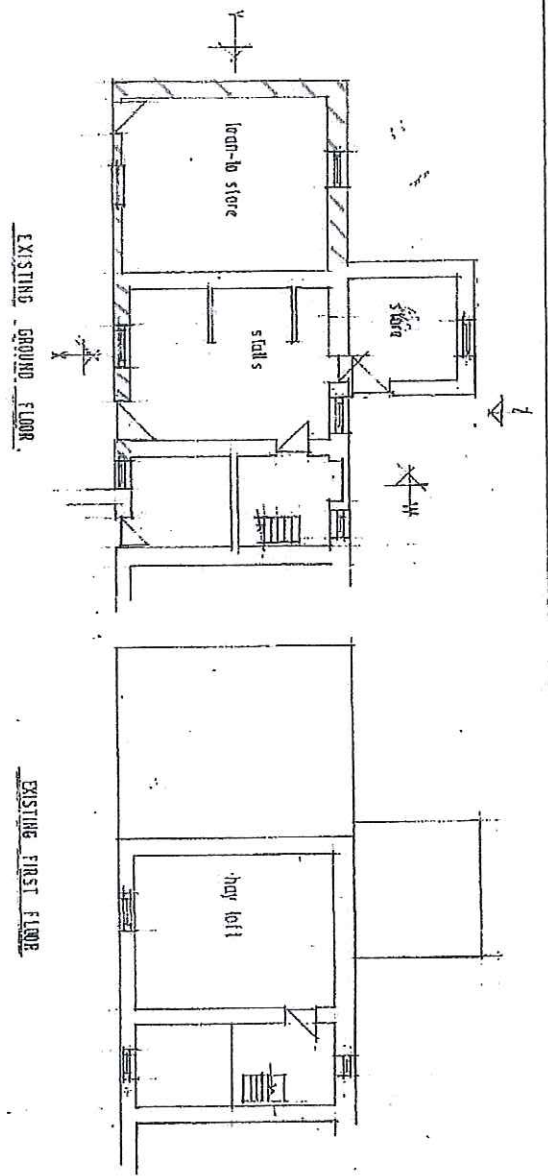
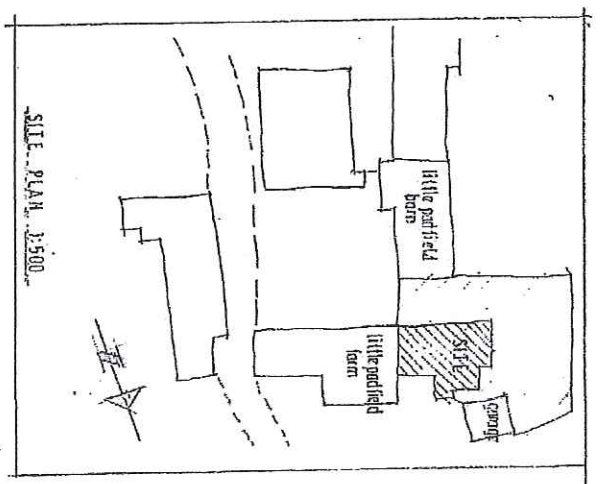
The elevations hatched in red on the attached sketch are considered to be structurally unsound, unsuitable for conversion and beyond repair.

The original wall to elevation X is exhibiting significant outward bowing, it has partially collapsed/settled and the original timber lintols are rotten and exhibit insect infestation throughout. This wall is in danger of imminent collapse and people should be prohibited from accessing the adjacent courtyard.

The blockwork wall to elevation X to the side of the lean to is not structurally suitable for conversion and would of course not aesthetically match the stone masonry to the adjacent properties.

The original gable wall to elevation Y is exhibiting significant outward lean and general structural movement caused by thrust from the mono pitch roof.

The side elevation wall to elevation Z has suffered from structural movement and a general historical lack of maintenance, it also is not suitable for conversion.

Rotten timbers to front section of roof to be replaced and re covered with ex. flans

Concrete block iron to with asbestos cement roof to be taken down and re built with natural stone walls and stone flag roof covering

Structurally unstable sections of wall taken down and rebuilt

Given the above it is my advice that these walls should be carefully demolished (*immediately in the case of the original wall to elevation X*) and re-built should the property be subject to conversion.
