# **Tree Survey BS 5837:2012**

George and Dragon, Glossop Road, Charlesworth

Project Reference: 1387

Published: February 2018

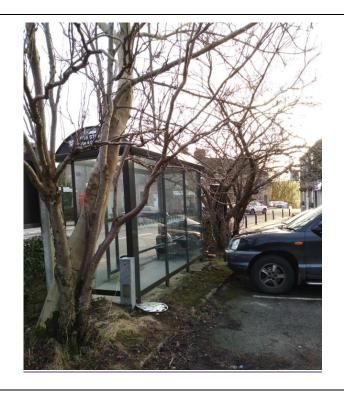
T1 is a multi-stemmed cherry *Prunus avium*, which is severely constrained by a self-seeded ash *Fraxinus excelsior* tree (T2) that has grown from the base of the cherry. The stems of the two trees are growing in to each other, meaning both are in poor structural condition. Also within this verge is another multi-stemmed cherry (T3), slightly larger than T1, and a hawthorn *Crataegus monogyna* (T4). All four of these trees have been assessed as retention category C as they are either impaired or unremarkable trees.

Photograph 1: Trees T1 & T2 on the left with T3 & T4 beyond

- The root protection areas (RPA) of T1 T4 are closest to the proposed location of the new houses, meaning the foundations of these buildings may extend slightly into their RPAs. However, this is considered to be a minor incursion, reduced further as the area in question is already hardstanding. Due to its poor growth form and negative impact on the adjacent cherry tree, the self-seeded ash (T2) should be considered for removal. The cherry (T1) appears to be a poor quality specimen and could also be considered for removal and replacement with a more suitable tree.

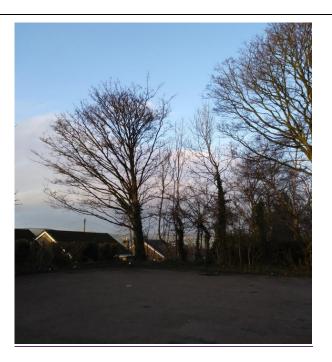
- The remaining trees are located around the boundary of the car park. Within the north-east edge are two tall sycamores *Acer pseudoplatanus* (T6 & T7), one of which is twin-stemmed near the base (T7). The remains of a hedgerow extend along this boundary and include some overgrown hawthorns and occasional holly *Ilex aquifolium* and elder *Sambucus nigra*. There is self-seeded ash within the boundary, including frequent saplings and occasional young trees (G13) and a section of Leyland cypress *Cupressus x leylandii* hedge (G12).

Photograph 3: Tree T7 and G13

- It is recommended that the majority of the young ash trees and saplings along the northeastern edge are removed, as they are growing closely to each other and are likely to develop problems as they mature.

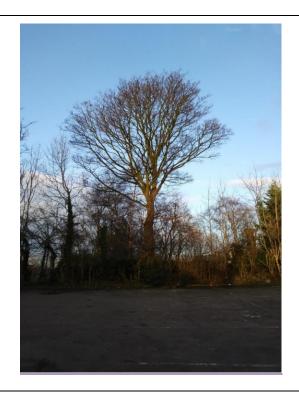
Photograph 2: Tree T6

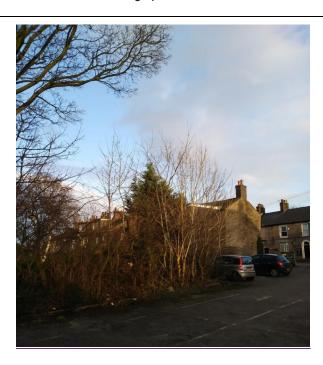
G13	Ash and hawthorn  Fraxinus excelsior Crataegus monogyna	Y	11.5	4.5	N = 3 E = 1.5 S = 4 W = 3	114 - 223	Fair	Poor	Self-seeded young ash trees and saplings extending along the majority of the boundary with remains of a hedgerow now growing as separate multi-stemmed hawthorns.  Recommend removal of majority of the ash saplings as they are poorly located which will cause problems as they develop.	40+	C2

Photograph 4: Young ash saplings in G13

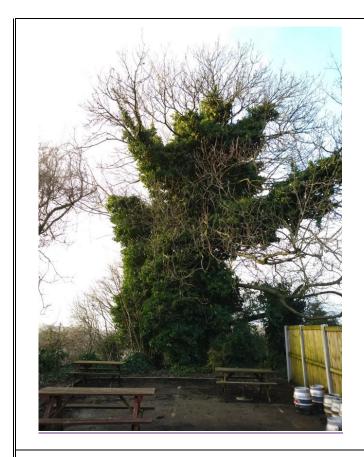
Т8	Ash Fraxinus excelsior	EM	19	2	N = 9 E = 11 S = 6.5 W = 6	923 \$	Good	Fair	Extensive ivy growth up the stem and into the canopy. Ivy growth meant full assessment was not possible. Overextended limbs into car park. Tree T8 is very close and canopies of the two trees are growing into each other.  May require crown raising over car park due to low growing branches.	40+	B1

- The remaining four trees are located in the boundary of the pub garden at the edge of a small public park. The largest tree is an ash (T8) with extensive ivy *Hedera helix* covering the main stem and extending into the canopy. A tall sycamore (T9) is located close to the ash and the canopies intersect, making it difficult to separate the two trees at this time of year. Nearby are two younger ash trees (T10 & T11) growing close to each other.

Photograph 5: Trees T8 & T9 from pub grounds

- The majority of the hardstanding is already used as a car park. The only tree that may require crown lifting is the large ash (T8), which has two low branches extending over the corner of the current car park.

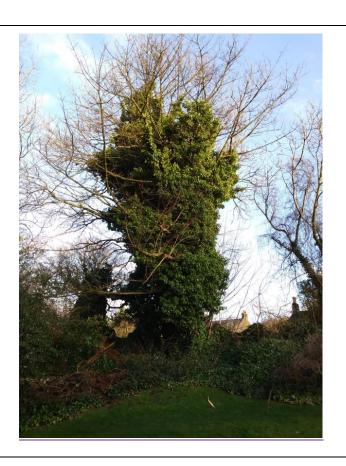
Photograph 6: Trees T8 & T9 from adjacent park
