Large Scale Elevation - WG15, WG16, WG17, WG18A and WG18B
Scale 1:25

Project No: P11606
Drawing No: AL[0]10

Client: High Peak Borough Council	
Project: Buxton Pavilion Gardens Phase 2.1 External refurbishment & repair to windows and ironworks Buxton, Derbyshire, SK17 6BE	
Title: Window works WG15, WG16, WG17, WG18A & WG18B	
Drawn By: MF	Scale: 1:25 on A1
Date: December 2017	Revison: A
Project No: P.11606	Drawing No: AL[0]10

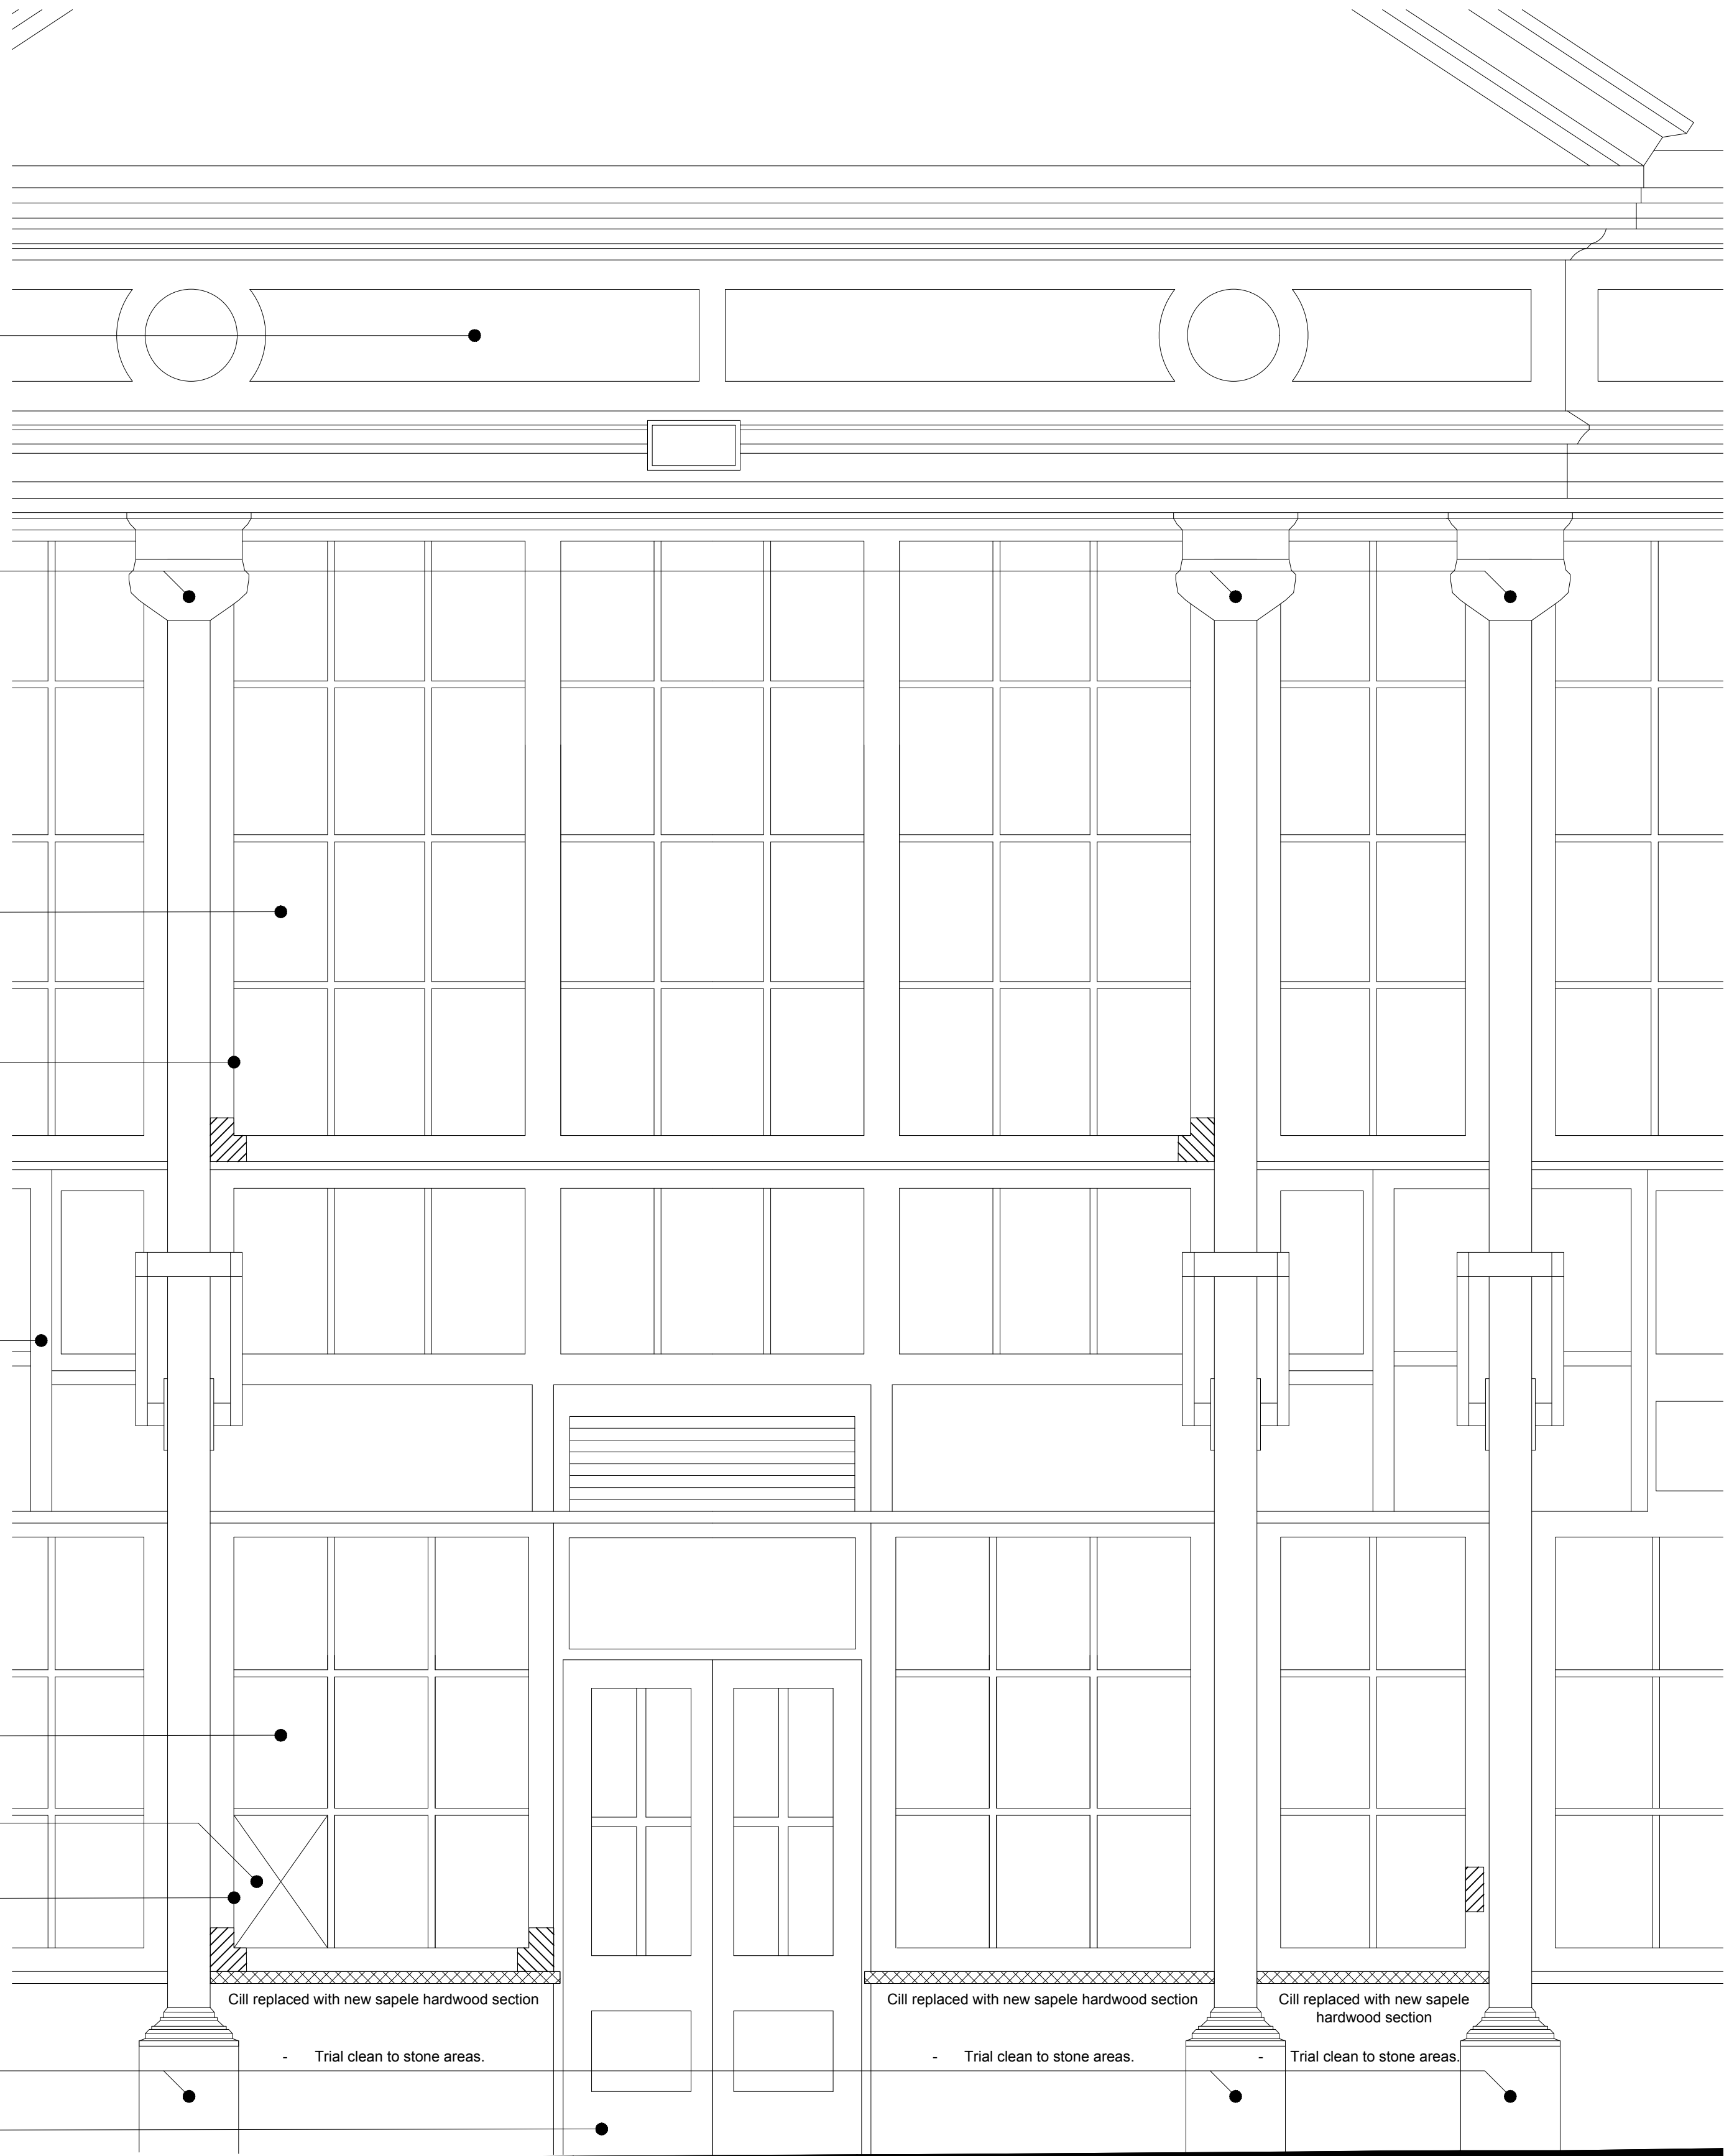
Note:
- Previous paint migration to glass to be removed.
- Trial clean to stone areas.

ISOLATED STONE REPAIR
(SEE GENERAL NOTE)

All paint to be removed to reveal bare timber using infra red lamps. Newly exposed timber to be painted with 2 No. coats of Dulux Weathershield Preservative Primer follow by 1 No. coat of Sikken Cetol BL Stain Blocking Primer followed by 2 No. coats of Dulux Trade Weathershield Quick Dry Exterior Satin. Colour: Natural Stone Dulux Heritage 1921Y10R.

Existing cast iron columns to be blast cleaned, degreased using a sharp solvent and sanded to a course texture, remove all loose/flaking material. Spot prime bare metal areas with a base coat of Tikkurila Temabond ST200 Primer, bring forward spot primed areas with an intermediate coat of Tikkurila Temacoat RM40 until flush, finally, apply 1 No. top coat Tikkaria Temadur 50. Colour: Tikkurila 360.30.05.

Windows: All paint to be removed using infra red lamps to reveal bare timber and sanded to smooth surface. Newly exposed timber to be painted with 2 No. coats of Dulux Weathershield Preservative Primer followed by 1 No. coat of Sikken Cetol BL Stain Blocking Primer followed by 2 No. coats of Dulux Trade Weathershield Quick Dry Exterior Satin. Colour: Natural Stone Dulux Heritage 1921Y10R.

Windows: All damaged putty to be removed and replaced with new inseed oil window putty.

All putty around glazing to be removed, new glazing fitted and replaced with new putty by 'Dry Seal'.

Existing cast iron columns to be blast cleaned, degreased using a sharp solvent and sanded to a course texture, remove all loose/flaking material. Spot prime bare metal areas with Dulux Weathershield Metal Primer, bring forward spot primed areas with Dulux Metalshield Satin until flush, finally, apply 2 No. top coats Dulux Metalshield Satin. Colour: Tikkurila 360.30.05.

Doors: All paint to be removed using infra red lamps to reveal bare timber and sanded to smooth surface. Newly exposed timber to be painted with 2 No. coats of Dulux Weathershield Preservative Primer followed by 1 No. coat of Sikken Cetol BL Stain Blocking Primer followed by 2 No. coats of Dulux Trade Weathershield Quick Dry Exterior Satin. Colour: Natural Stone Dulux Heritage 1921Y10R.

Windows: All silicon sealant to edges to be renewed.

Windows: All putty to be removed and replaced with new.
