STRUCTURAL ENGINEER'S REPORT

Royle House, All Saints R.C. Presbytery, Church Street, Glossop

Ref.19339-003SER

Date:16 June 2016

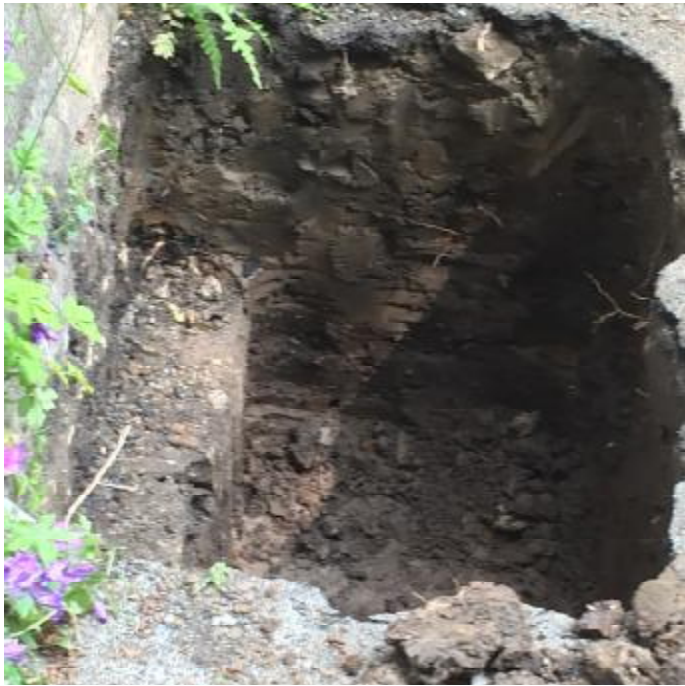
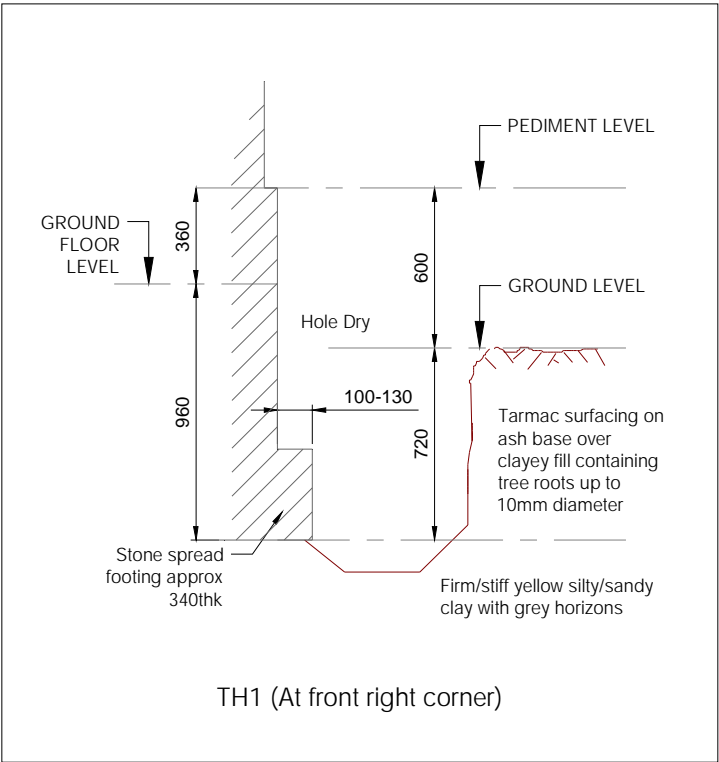
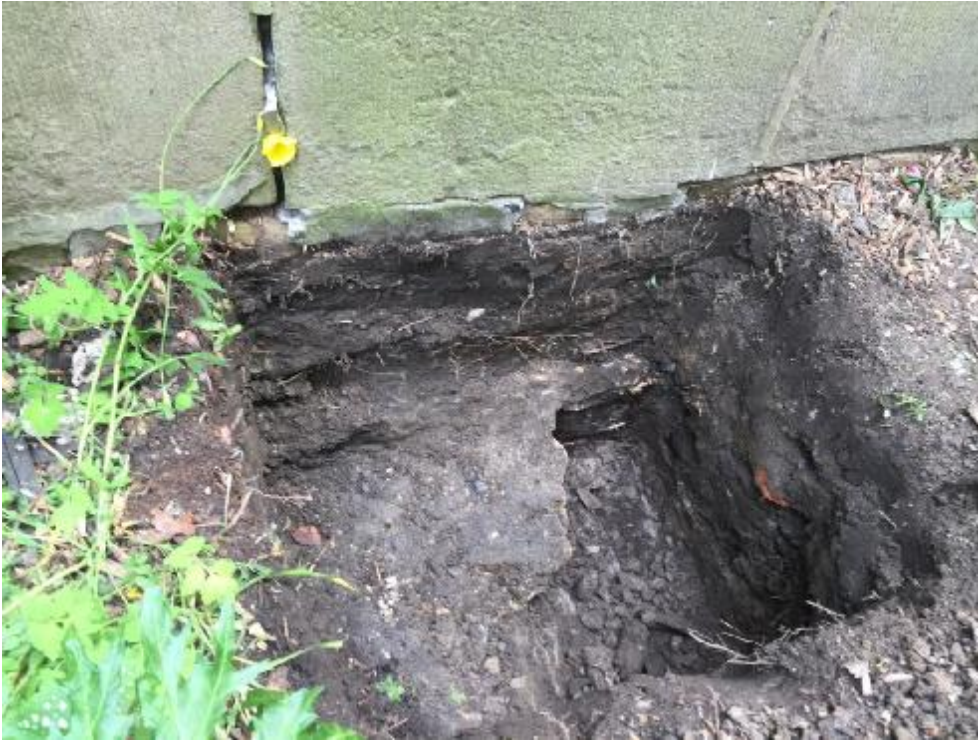
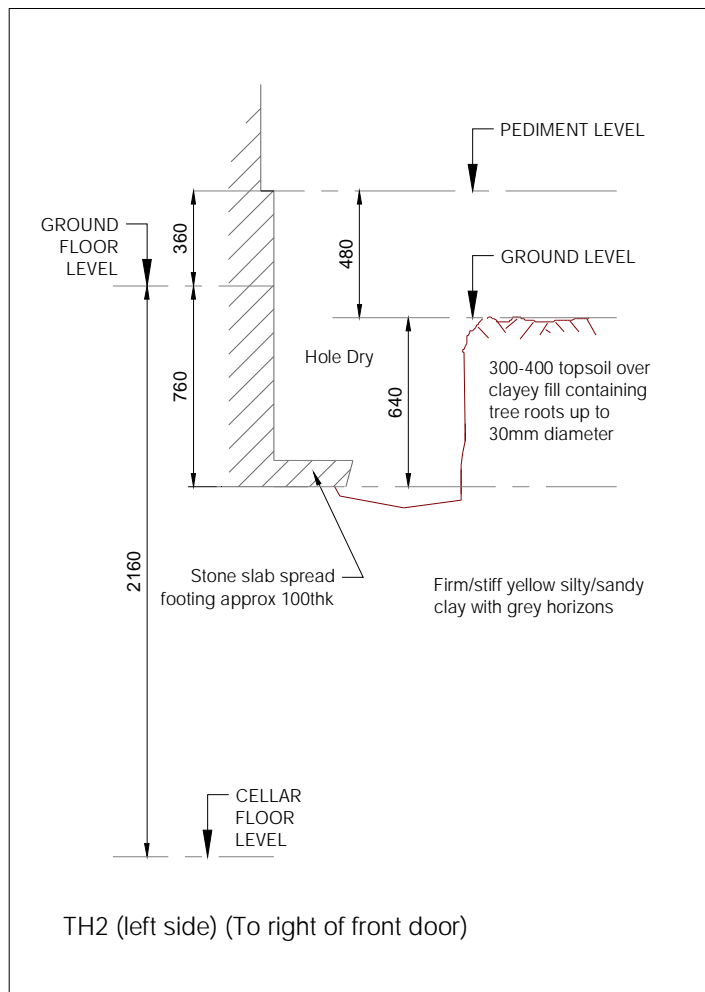
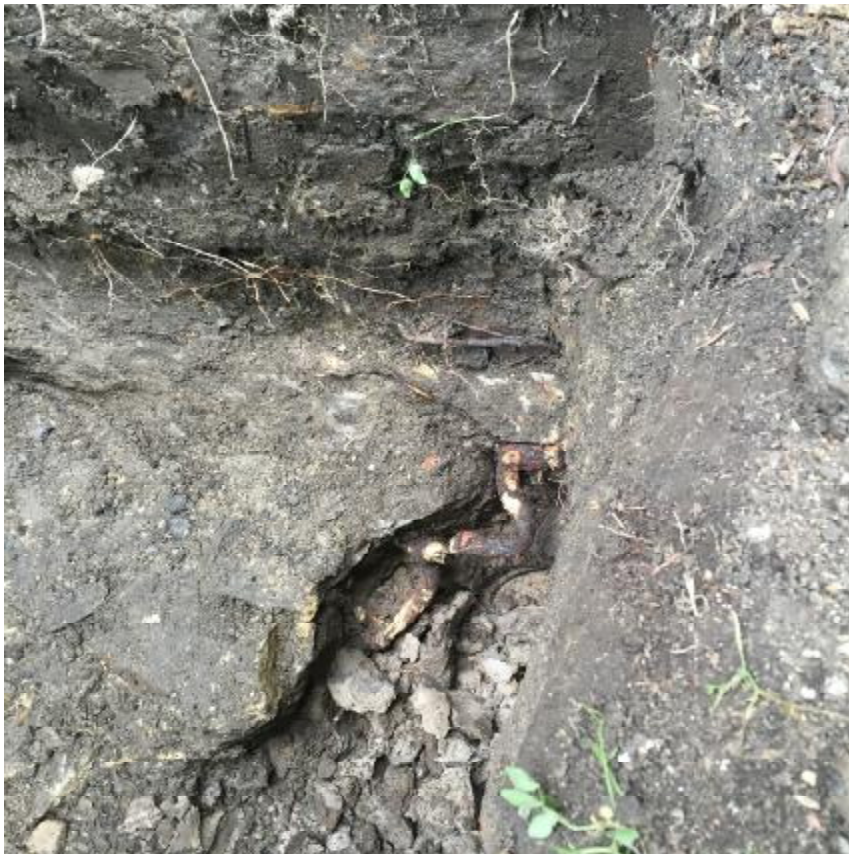
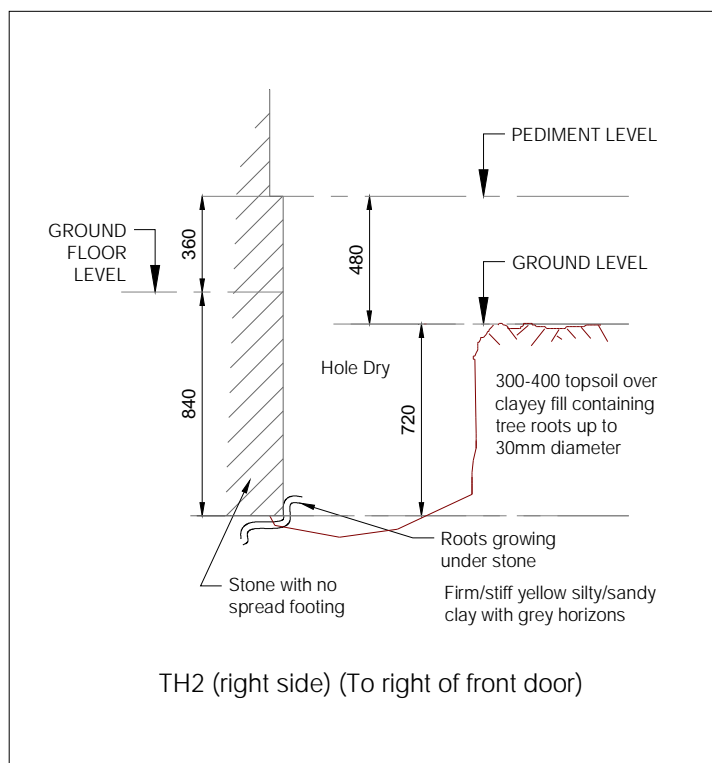
7. TRIAL HOLE INSPECTION

- 8.1 The front right hand side, (and to a lesser extent the rear), of the presbytery not built over the cellar have settled away from the part built over the cellar. The trial holes have confirmed that the cause of the major differential movement along the front wall is primarily a result of the foundations not over the cellar being shallow and affected by root penetration. The water demand of the nearby mature trees will, as a result of rainfall variations, cause shrinkage and swelling of the clay soil beneath the shallow foundations. It is also very likely that leaking drainage has caused softening of the bearing strata in places.

- 8.2 In order to guard against root damage, the recommended depth for foundations in this situation is a minimum of 1350mm below ground. The foundation depth found in the trial holes is only about 700 to 650mm below ground. This depth is also less than recommended to guard against frost heave in clay soils.

- 8.3 The spread of the foundations found in the trial holes was very inconsistent, and in some places non-existent. This creates an increased risk of differential foundation movement.

We therefore recommend that if underpinning is undertaken, it should be done using augered mini-piles and needle ground beams.
