Refurbishment Survey

Build DC Limited

Survey Reference Number: G-02394

Park Terrace Works
Park Terrace
Glossop
SK13 8HU

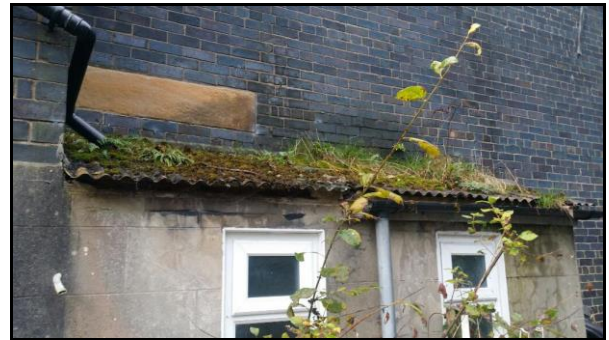
| Entry Number | 001 |

| Item Description | Roof: Cement |
| Estimated Extent | 6 m ² |

| Damage Extent | Low Damage | 1 | 7 – 9 | Medium |
| Asbestos Type | Chrysotile | 1 | 5 – 6 | Low |

| Material Category | Potential for fibre release | Very Low |

Remove if affected by works - Should this item be affected by the upcoming planned works then it should be removed in accordance with current legislation, if not then the item can be left in place. Asbestos warning stickers may be applied.

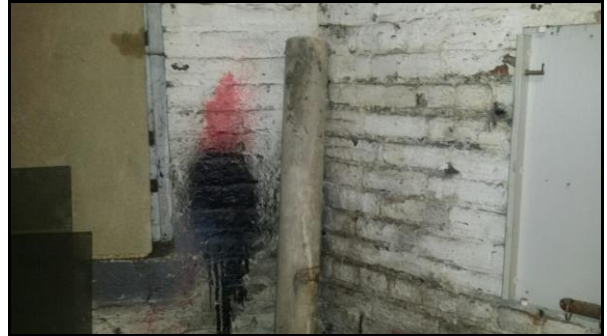
| Entry Number | 002 |

| Item Description | Pipework: Cement |
| Estimated Extent | 2 lin m |

| Damage Extent | Low Damage | 1 | 7 – 9 | Medium |
| Asbestos Type | Chrysotile | 1 | 5 – 6 | Low |

| Material Category | Potential for fibre release | Very Low |

Remove if affected by works - Should this item be affected by the upcoming planned works then it should be removed in accordance with current legislation, if not then the item can be left in place. Asbestos warning stickers may be applied.

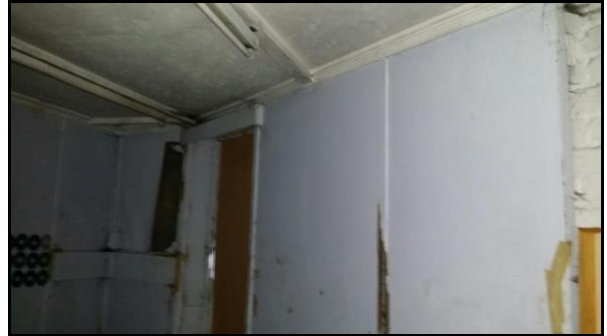
| Entry Number | 006 |

| Item Description | Walls: Cement |
| Estimated Extent | 20 m ² |

| Damage Extent | Medium Damage | 2 | 7 – 9 | Medium |
| Asbestos Type | Chrysotile | 1 | 5 – 6 | Low |

| Material Category | Potential for fibre release | Low |

Remove if affected by works - Should this item be affected by the upcoming planned works then it should be removed in accordance with current legislation, if not then the item can be left in place. Asbestos warning stickers may be applied.
