REFURBISHMENT SURVEY

GLOSSOP TOWN HALL
NORFOLK SQUARE
GLOSSOP
DERBYSHIRE

APRIL 2018

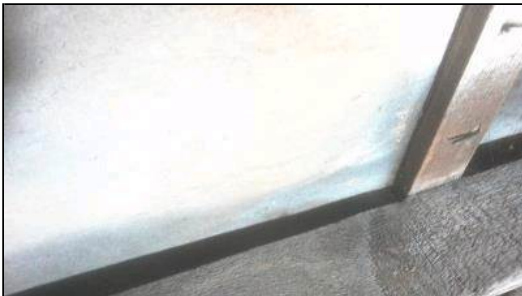
Location:		Glossop Town hall - Roof Void - Pitched Roof Area 7 - Residual spray insulation to underside of roof tiles

Item No:	000001	Laboratory sample no:	EF003511	
Accessibility:		Difficult		
Installation:		Sprayed coating (3)		
Approx extent (m² unless stated)		250		
Asbestos Type:		Amosite (2)		
Condition:	High damage (3)	Surface Treatment:	Unsealed (3)

Material Risk Assessment	11	Priority Risk Assessment (PA)	N/A	Total Risk	N/A
Recommendation:	Restrict access to area until ACM has been repaired or removed				
Comments:

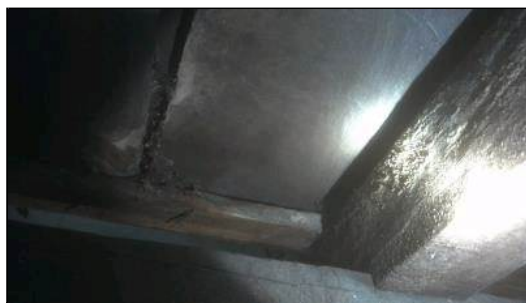
Location:		Glossop Town hall - Roof Void - Pitched Roof Area 7 - Residual spray insulation to roof trusses

Item No:	000002	Laboratory sample no:	EF003512	
Accessibility:		Difficult		
Installation:		Sprayed coating (3)		
Approx extent (m² unless stated)		250		
Asbestos Type:		Amosite (2)		
Condition:	High damage (3)	Surface Treatment:	Unsealed (3)

Material Risk Assessment	11	Priority Risk Assessment (PA)	N/A	Total Risk	N/A
Recommendation:	Restrict access to area until ACM has been repaired or removed				
Comments:

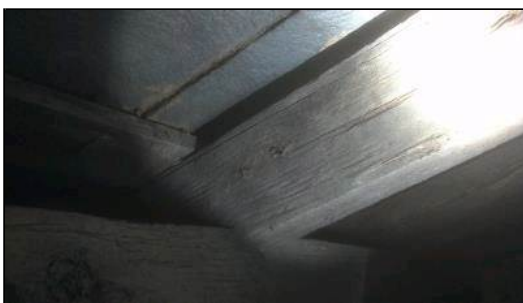
Location:		Glossop Town hall - Roof Void - Pitched Roof Area 7 - Residual spray insulation to roof trusses

Item No:	000004	Laboratory sample no:	EF003514	
Accessibility:		Difficult		
Installation:		Sprayed coating (3)		
Approx extent (m² unless stated)		100lm		
Asbestos Type:		Amosite (2)		
Condition:	High damage (3)		Surface Treatment:	
				Unsealed (3)

Material Risk Assessment	11	Priority Risk Assessment (PA)	N/A	Total Risk	N/A
Recommendation:	Restrict access to area until ACM has been repaired or removed				
Comments:

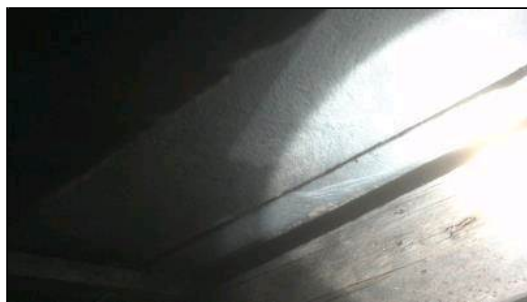
Location:		Glossop Town hall - Roof Void - Pitched Roof Area 7 - Residual spray insulation to underside of roof

Item No:	000005	Laboratory sample no:	EF003515	
Accessibility:		Difficult		
Installation:		Sprayed coating (3)		
Approx extent (m² unless stated)		150		
Asbestos Type:		Amosite (2)		
Condition:	High damage (3)	Surface Treatment:	Unsealed (3)

Material Risk Assessment	11	Priority Risk Assessment (PA)	N/A	Total Risk	N/A
Recommendation:	Restrict access to area until ACM has been repaired or removed				
Comments:

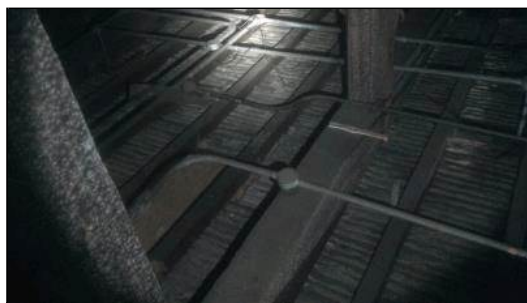
Location:		Glossop Town hall - Roof Void - Pitched Roof Area 7 - Spray insulation debris to floor

Item No:	000006	Laboratory sample no:	EF003516	
Accessibility:		Difficult		
Installation:		Debris (3)		
Approx extent (m² unless stated)		150		
Asbestos Type:		Amosite (2)		
Condition:	High damage (3)	Surface Treatment:	Unsealed (3)

Material Risk Assessment	11	Priority Risk Assessment (PA)	N/A	Total Risk	N/A
Recommendation:	Restrict access to area until ACM has been repaired or removed				
Comments:

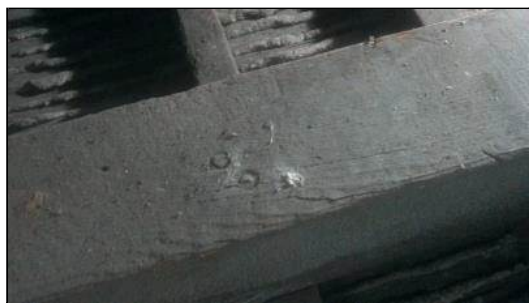
Location:		Glossop Town hall - Roof Void - Pitched Roof Area 7 - Residual spray insulation to beam

Item No:	000007	Laboratory sample no:	EF003517	
Accessibility:		Difficult		
Installation:		Debris (3)		
Approx extent (m² unless stated)		30lm		
Asbestos Type:		Amosite (2)		
Condition:	High damage (3)		Surface Treatment:

Material Risk Assessment	11	Priority Risk Assessment (PA)	N/A	Total Risk	N/A
Recommendation:	Restrict access to area until ACM has been repaired or removed				
Comments:

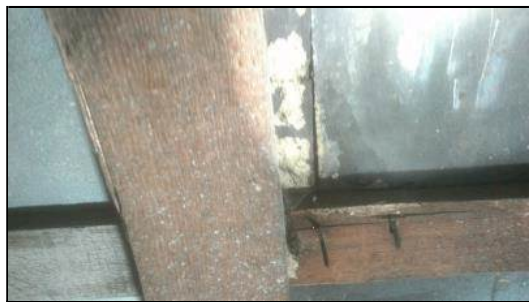
Location:		Glossop Town hall - Roof Void - Pitched Roof Area 7 - Residual spray insulation to underside of roof

Item No:	000008	Laboratory sample no:	EF003518	
Accessibility:		Difficult		
Installation:		Sprayed coating (3)		
Approx extent (m² unless stated)		150		
Asbestos Type:		Amosite (2)		
Condition:	High damage (3)	Surface Treatment:	Unsealed (3)

Material Risk Assessment	11	Priority Risk Assessment (PA)	N/A	Total Risk	N/A
Recommendation:	Restrict access to area until ACM has been repaired or removed				
Comments:

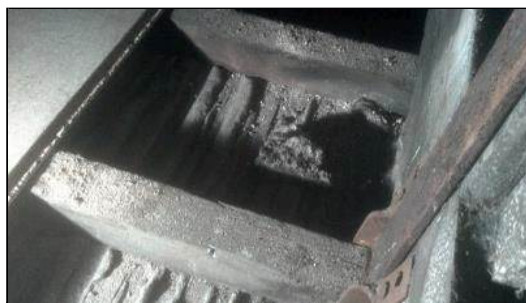
Location:		Glossop Town hall - Roof Void - Pitched Roof Area 7 - Spray Insulation debris to floor

Item No:	000009	Laboratory sample no:	EF003519	
Accessibility:		Difficult		
Installation:		Debris (3)		
Approx extent (m² unless stated)		150		
Asbestos Type:		Amosite (2)		
Condition:	High damage (3)	Surface Treatment:	Unsealed (3)

Material Risk Assessment	11	Priority Risk Assessment (PA)	N/A	Total Risk	N/A
Recommendation:	Restrict access to area until ACM has been repaired or removed				
Comments:

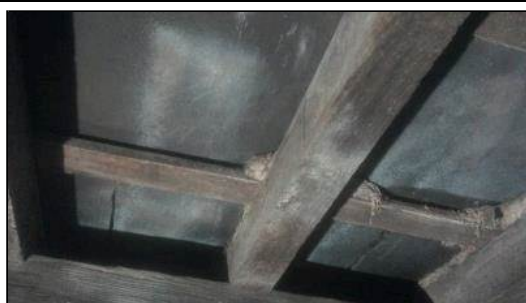
Location:		Glossop Town hall - Roof Void - Pitched Roof Area 7 - Residual spray insulation to beams

Item No:	000010	Laboratory sample no:	EF003520	
Accessibility:		Difficult		
Installation:		Residual insulation (3)		
Approx extent (m² unless stated)		100lm		
Asbestos Type:		Amosite (2)		
Condition:	High damage (3)	Surface Treatment:	Unsealed (3)

Material Risk Assessment	11	Priority Risk Assessment (PA)	N/A	Total Risk	N/A
Recommendation:	Restrict access to area until ACM has been repaired or removed				
Comments:

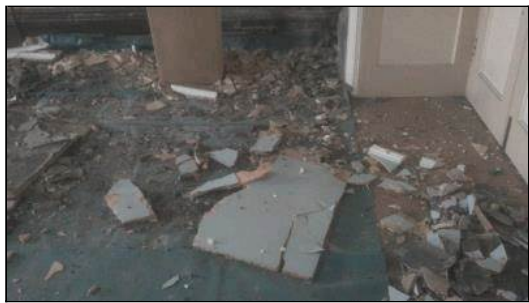
Location:	Glossop Town hall - First floor - F5 - Courtroom 2 - Debris to damaged areas on floor

Item No:	000011	Laboratory sample no:	EF003521	
Accessibility:	N/A			
Installation:	Debris			
Approx extent (m ² unless stated)	N/A			
Asbestos Type:	NAD			
Condition:	N/A	Surface Treatment:	N/A

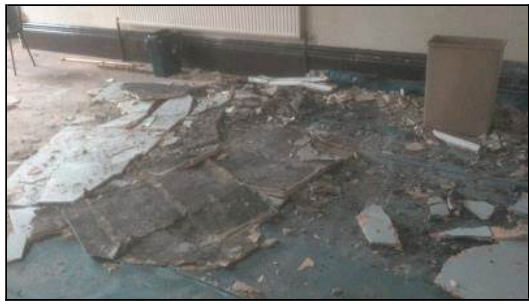
Location:	Glossop Town hall - First floor - F5 - Courtroom 2 - Debris to floor

Item No:	000012	Laboratory sample no:	EF003522	
Accessibility:	N/A			
Installation:	Debris			
Approx extent (m ² unless stated)	N/A			
Asbestos Type:	NAD			
Condition:	N/A	Surface Treatment:	N/A

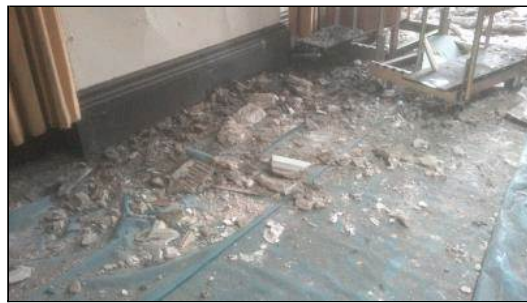
Location:		Glossop Town hall - First floor - F5 - Courtroom 2 - Debris to floor

Item No:	000013	Laboratory sample no:	EF003523	
Accessibility:		N/A		
Installation:		Debris		
Approx extent (m² unless stated)		N/A		
Asbestos Type:		NAD		
Condition:	N/A	Surface Treatment:	N/A

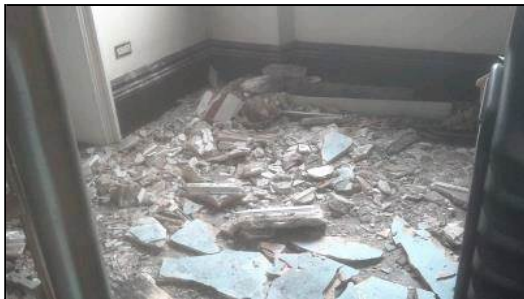
Location:		Glossop Town hall - First floor - F5 - Courtroom 2 - Debris to floor

Item No:	000014	Laboratory sample no:	EF003524	
Accessibility:		Easy		
Installation:		Debris (3)		
Approx extent (m² unless stated)		20		
Asbestos Type:		Amosite (2)		
Condition:		High damage (3)	Surface Treatment:

Material Risk Assessment	11	Priority Risk Assessment (PA)	N/A	Total Risk	N/A
Recommendation:	Restrict access to area until ACM has been repaired or removed				
Comments:

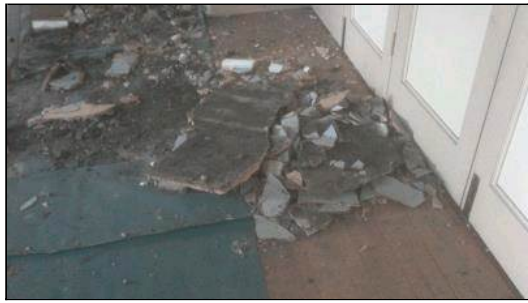
Location:	Glossop Town hall - First floor - F5 - Courtroom 2 - Debris to floor

Item No:	000015	Laboratory sample no:	EF003525	
Accessibility:	N/A			
Installation:	Debris			
Approx extent (m² unless stated)	N/A			
Asbestos Type:	NAD			
Condition:	N/A	Surface Treatment:	N/A

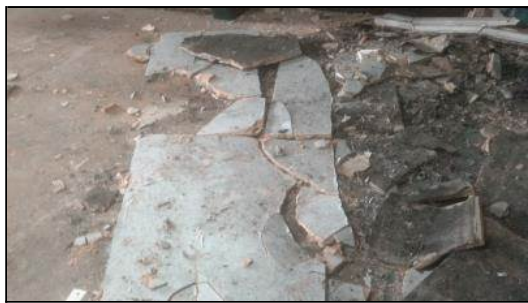
Location:	Glossop Town hall - First floor - F5 - Courtroom 2 - Debris to floor

Item No:	000016	Laboratory sample no:	EF003526	
Accessibility:	N/A			
Installation:	Debris			
Approx extent (m² unless stated)	N/A			
Asbestos Type:	NAD			
Condition:	N/A	Surface Treatment:	N/A
