## REFURBISHMENT SURVEY

GLOSSOP TOWN HALL  
NORFOLK SQUARE  
GLOSSOP  
DERBYSHIRE

JUNE 2018

Report prepared for:	AEW Architects and Designers Ltd The Zenith Building Spring Gardens Manchester M2 1AB
Report reference:	J118436
Issue date:	June 2018
Survey completed by: Daniel Gantt Senior Surveyor

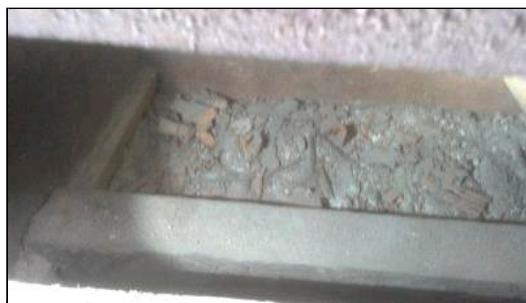
Location:		Glossop town hall - Second floor - S7 - Office - Debris beneath floorboards in rear left corner

Item No:	000001	Laboratory sample no:	EF003939	
Accessibility:		Easy		
Installation:		Debris (3)		
Approx extent (m² unless stated)		8		
Asbestos Type:		Amosite (2)		
Condition:	High damage (3)	Surface Treatment:	Unsealed (3)

Material Risk Assessment	11	Priority Risk Assessment (PA)	N/A	Total Risk	N/A
Recommendation:	Restrict access to area until ACM has been repaired or removed				
Comments:

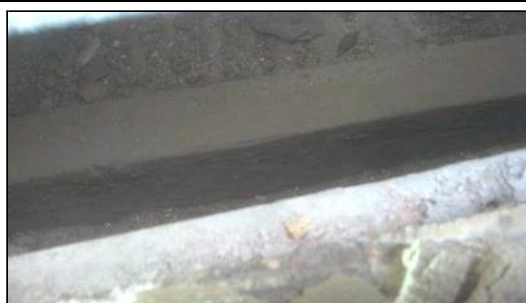
Location:		Glossop town hall - Second floor - S7 - Office - Debris beneath floor in rear right corner

Item No:	000002	Laboratory sample no:	EF003940	
Accessibility:		Difficult		
Installation:		Debris (3)		
Approx extent (m² unless stated)		12		
Asbestos Type:		Amosite (2)		
Condition:	High damage (3)		Surface Treatment:	Unsealed (3)

Material Risk Assessment	11	Priority Risk Assessment (PA)	N/A	Total Risk	N/A
Recommendation:	Restrict access to area until ACM has been repaired or removed				
Comments:	MDF boards on timber joists

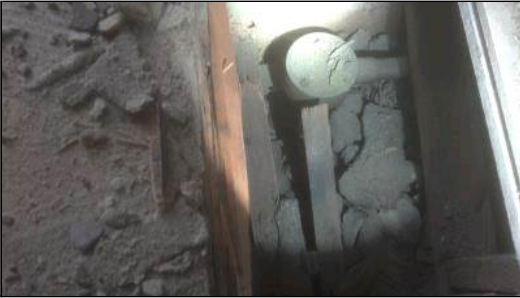
Location:		Glossop town hall - Second floor - S7 - Office - Debris to front, near window

Item No:	000003	Laboratory sample no:	EF003941	
Accessibility:	Difficult			
Installation:	Debris (3)			
Approx extent (m² unless stated)	12			
Asbestos Type:	Amosite (2)			
Condition:	High damage (3)	Surface Treatment:	Unsealed (3)

Material Risk Assessment	11	Priority Risk Assessment (PA)	N/A	Total Risk	N/A
Recommendation:	Restrict access to area until ACM has been repaired or removed				
Comments:	Floorboards and timber joists

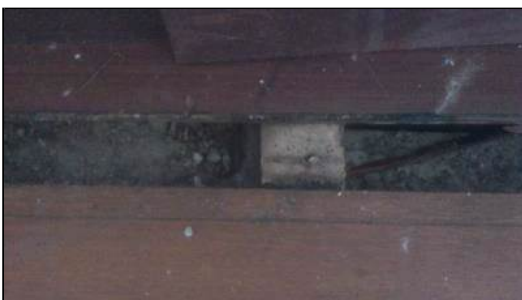
Location:		Glossop town hall - First floor - F14 - Courtroom 1 - Paper packing to joists beneath floorboards

Item No:	000005	Laboratory sample no:	EF003943	
Accessibility:		N/A		
Installation:		Paper / cardboard		
Approx extent (m² unless stated)		N/A		
Asbestos Type:		NAD		
Condition:	N/A	Surface Treatment:	N/A

Material Risk Assessment	0	Priority Risk Assessment (PA)	N/A	Total Risk	
Recommendation:	None				
Comments: Timber joists, timber floorboards, plasterboard and timber panels visible beneath flooring

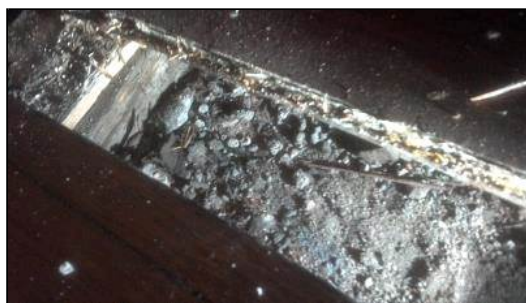
Location:		Glossop town hall - First floor - F14 - Courtroom 1 - Debris within floor void

Item No:	000006	Laboratory sample no:	EF003944	
Accessibility:		N/A		
Installation:		Debris		
Approx extent (m² unless stated)		N/A		
Asbestos Type:		NAD		
Condition:	N/A	Surface Treatment:	N/A

Material Risk Assessment	0	Priority Risk Assessment (PA)	N/A	Total Risk	
Recommendation:	None				
Comments: Timber floorboards, metal pipes, timber joists, timber floorboards to base

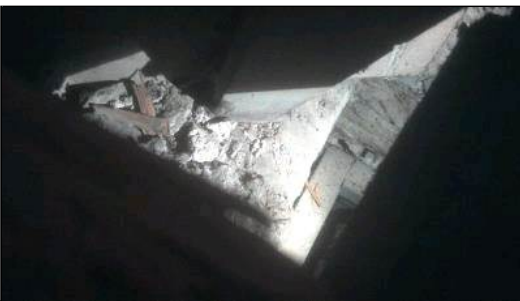
Location:		Glossop town hall - First floor - F14 - Courtroom 1 - Debris to rear right corner

Item No:	000007	Laboratory sample no:	EF003945	
Accessibility:	N/A			
Installation:	Debris			
Approx extent (m² unless stated)		N/A		
Asbestos Type:	NAD			
Condition:	N/A	Surface Treatment:	N/A

Material Risk Assessment	0	Priority Risk Assessment (PA)	N/A	Total Risk	
Recommendation:	None				
Comments: Timber floorboards and joists, large void present beneath

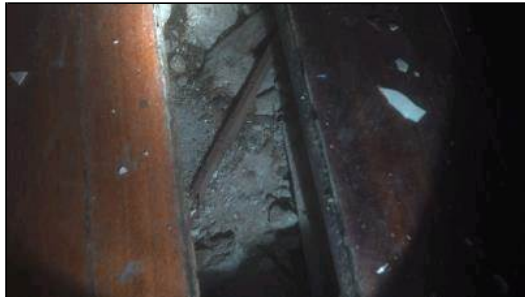
Location:		Glossop town hall - First floor - F14 - Courtroom 1 - Debris beneath floorboards in front left corner

Item No:	000008	Laboratory sample no:	EF003946	
Accessibility:		N/A		
Installation:		Debris		
Approx extent (m² unless stated)		N/A		
Asbestos Type:		NAD		
Condition:	N/A	Surface Treatment:	N/A

Material Risk Assessment	0	Priority Risk Assessment (PA)	N/A	Total Risk	
Recommendation:	None				
Comments: Timber floorboards, timber joists, timber boards to base of void

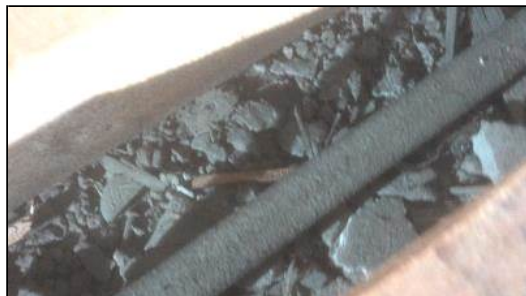
Location:		Glossop town hall - First floor - F5 - Courtroom 2 - Debris beneath timber floorboards in front left corner

Item No:	000009	Laboratory sample no:	EF003947	
Accessibility:		N/A		
Installation:		Debris		
Approx extent (m² unless stated)		N/A		
Asbestos Type:		NAD		
Condition:	N/A	Surface Treatment:	N/A

Material Risk Assessment	0	Priority Risk Assessment (PA)	N/A	Total Risk	
Recommendation:	None				
Comments: Timber floorboards on timber joists, plasterboard to base of void

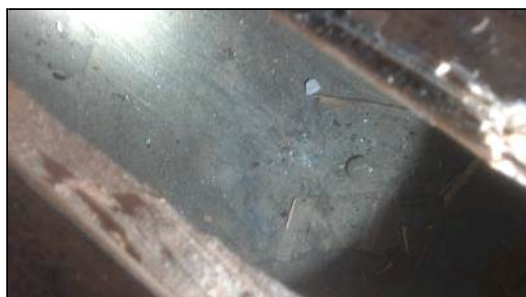
Location:		Glossop town hall - First floor - F5 - Courtroom 2 - Debris within floor boards middle right side next to kitchen

Item No:	000010	Laboratory sample no:	EF003948	
Accessibility:		N/A		
Installation:		Debris		
Approx extent (m² unless stated)		N/A		
Asbestos Type:		NAD		
Condition:	N/A	Surface Treatment:	N/A

Material Risk Assessment	0	Priority Risk Assessment (PA)	N/A	Total Risk	
Recommendation:	None				
Comments: Timber Floorboards and timber joists, plasterboard to base of void

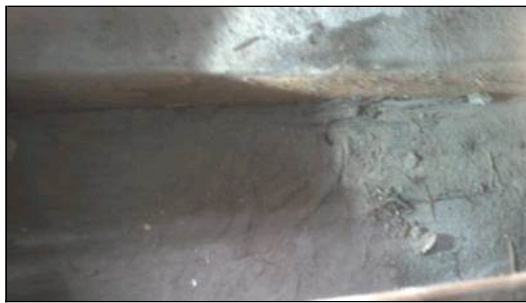
Location:	Glossop town hall - First floor - F5 - Courtroom 2 - Debris to rear corner next to kitchen

Item No:	000011	Laboratory sample no:	EF003949	
Accessibility:	N/A			
Installation:	Debris			
Approx extent (m <sup>2</sup> unless stated)	N/A			
Asbestos Type:	NAD			
Condition:	N/A	Surface Treatment:	N/A

Material Risk Assessment	0	Priority Risk Assessment (PA)	N/A	Total Risk	
Recommendation:	None				
Comments:

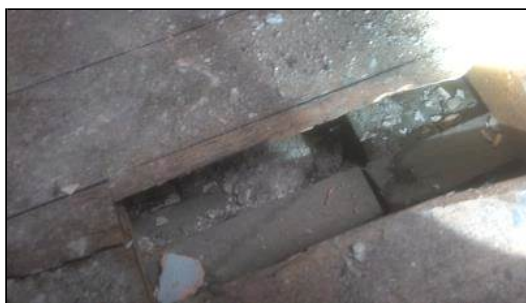
Location:	Glossop town hall - First floor - F5 - Courtroom 2 - Debris from within floor void, centre of room

Item No:	000012	Laboratory sample no:	EF003950	
Accessibility:	N/A			
Installation:	Debris			
Approx extent (m <sup>2</sup> unless stated)	N/A			
Asbestos Type:	NAD			
Condition:	N/A	Surface Treatment:	N/A

Material Risk Assessment	0	Priority Risk Assessment (PA)	N/A	Total Risk	
Recommendation:	None				
Comments:	Timber floorboards on timber joists, plasterboard to base of void

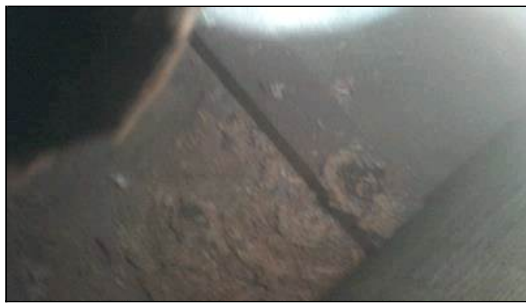
Location:	Glossop town hall - First floor - F12 - Waiting room - Debris beneath floorboards

Item No:	000013	Laboratory sample no:	EF003951	
Accessibility:	N/A			
Installation:	Debris			
Approx extent (m² unless stated)	N/A			
Asbestos Type:	NAD			
Condition:	N/A	Surface Treatment:	N/A

Material Risk Assessment	0	Priority Risk Assessment (PA)	N/A	Total Risk	
Recommendation:	None				
Comments: MDF boards on timber joists, plasterboard to base of void

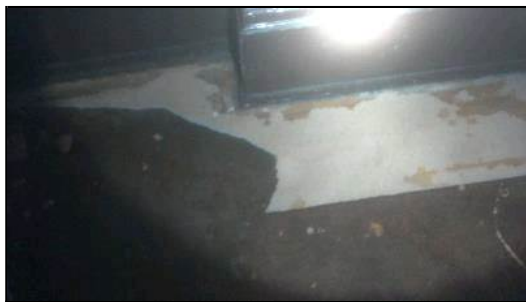
Location:	Glossop town hall - First floor - F12 - Waiting room - Grey linoleum and paper lining beneath dark red linoleum

Item No:	000014	Laboratory sample no:	EF003952	
Accessibility:	N/A			
Installation:	Linoleum			
Approx extent (m² unless stated)	N/A			
Asbestos Type:	NAD			
Condition:	N/A	Surface Treatment:	N/A

Material Risk Assessment	0	Priority Risk Assessment (PA)	N/A	Total Risk	
Recommendation:	None				
Comments:

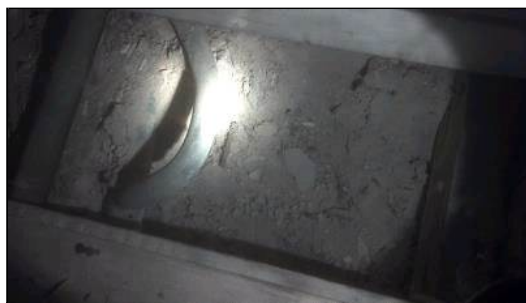
Location:		Glossop town hall - First floor - F2.1 - Store - Debris beneath timber floorboards

Item No:	000015	Laboratory sample no:	EF003953	
Accessibility:		N/A		
Installation:		Debris		
Approx extent (m² unless stated)		N/A		
Asbestos Type:		NAD		
Condition:	N/A	Surface Treatment:	N/A

Material Risk Assessment	0	Priority Risk Assessment (PA)	N/A	Total Risk	
Recommendation:	None				
Comments: Concrete to base of sub floor

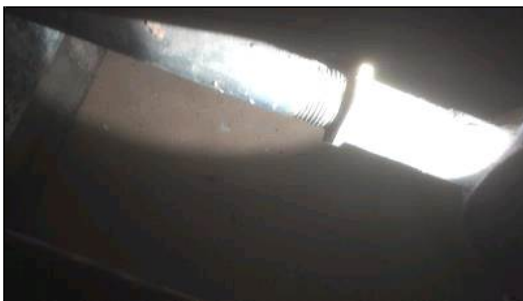
Location:		Glossop town hall - First floor - F2.1 - Store - Debris within floor void

Item No:	000016	Laboratory sample no:	EF003954	
Accessibility:		Difficult		
Installation:		Debris (3)		
Approx extent (m² unless stated)		8		
Asbestos Type:		Amosite (2)		
Condition:	High damage (3)	Surface Treatment:	Unsealed (3)

Material Risk Assessment	11	Priority Risk Assessment (PA)	N/A	Total Risk	N/A
Recommendation:	Restrict access to area until ACM has been repaired or removed				
Comments: Concrete to base of sub floor

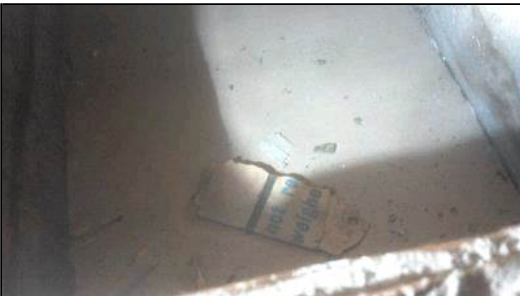
Location:		Glossop town hall - First floor - F13 - Lobby to mayors parlour - Debris beneath floorboards, near stairs door

Item No:	000017	Laboratory sample no:	EF003955	
Accessibility:	N/A			
Installation:	Debris			
Approx extent (m² unless stated)	N/A			
Asbestos Type:	NAD			
Condition:	N/A	Surface Treatment:	N/A

Material Risk Assessment	0	Priority Risk Assessment (PA)	N/A	Total Risk	
Recommendation:	None				
Comments:

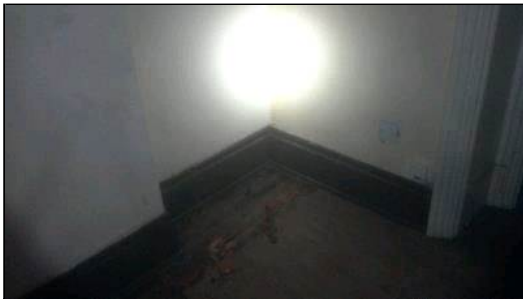
Location:		Glossop town hall - First floor - F13 - Lobby to mayors parlour - Debris beneath timber floor in corner

Item No:	000018	Laboratory sample no:	EF003956	
Accessibility:		Difficult		
Installation:		Debris (3)		
Approx extent (m² unless stated)		8		
Asbestos Type:		Amosite (2)		
Condition:	High damage (3)	Surface Treatment:	Unsealed (3)

Material Risk Assessment	11	Priority Risk Assessment (PA)	N/A	Total Risk	N/A
Recommendation:	Restrict access to area until ACM has been repaired or removed				
Comments:

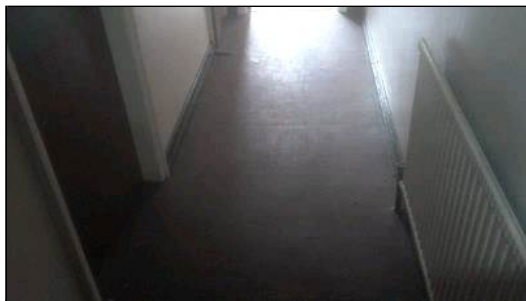
Location:	Glossop town hall - First floor - F7 - Corridor - Paper lining beneath dark red linoleum

Item No:	000019	Laboratory sample no:	EF003957	
Accessibility:	N/A			
Installation:	Paper / cardboard			
Approx extent (m² unless stated)	N/A			
Asbestos Type:	NAD			
Condition:	N/A	Surface Treatment:	N/A

Material Risk Assessment	0	Priority Risk Assessment (PA)	N/A	Total Risk	
Recommendation:	None				
Comments:

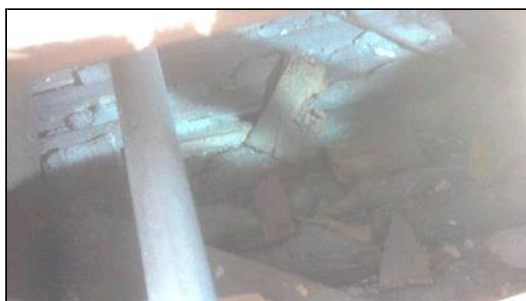
Location:	Glossop town hall - Second floor - 001 - Ladies W.C - Debris beneath timber floor boards

Item No:	000020	Laboratory sample no:	EF003958	
Accessibility:	N/A			
Installation:	Debris			
Approx extent (m² unless stated)	N/A			
Asbestos Type:	NAD			
Condition:	N/A	Surface Treatment:	N/A

Material Risk Assessment	0	Priority Risk Assessment (PA)	N/A	Total Risk	
Recommendation:	None				
Comments:	Modern vinyl floor, plywood board, timber floor boards, timber joists, lath and plaster to base of floor void

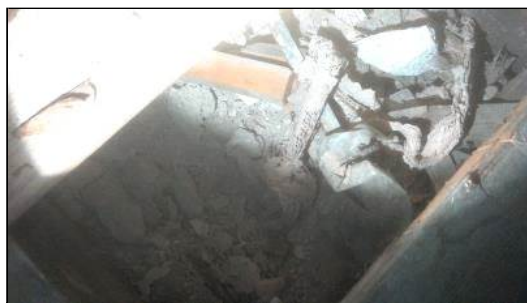
Location:		Glossop town hall - Second floor - 002 - Mens W.C - Debris beneath timber floor boards

Item No:	000021	Laboratory sample no:	EF003959	
Accessibility:		Difficult		
Installation:		Debris (3)		
Approx extent (m² unless stated)		4		
Asbestos Type:		Chrysotile (1)		
Condition:	High damage (3)	Surface Treatment:	Unsealed (3)

Material Risk Assessment	10	Priority Risk Assessment (PA)	N/A	Total Risk	N/A
Recommendation:	Restrict access to area until ACM has been repaired or removed				
Comments: Modern vinyl floor, plywood board, timber floor boards, timber joists, lath and plaster to base of floor void
