Asbestos Demolition Survey

Denhills

Ashbourne Lane

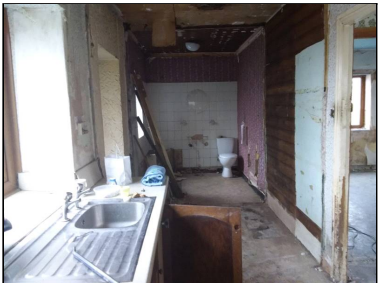
Survey Date:	Lead Surveyor	Survey Type	Floor	Analysis
	30 Mar 2022	Kevin Carney	Demolition Survey	Ground Floor	N/A
	Building	Room	Item	Quantity	
	Denhills, Ashbourne Lane	Kitchen G01	No suspect materials found	N/A	
	Sample No (S,SP,P,As)	Product Type	Surface Treatment	Condition	Accessibility
	Visual (P)	N/A	N/A	N/A	N/A
	Material Risk Score				
	N/A				
Recommended action		No further action required			
Surveyor comments		N/A

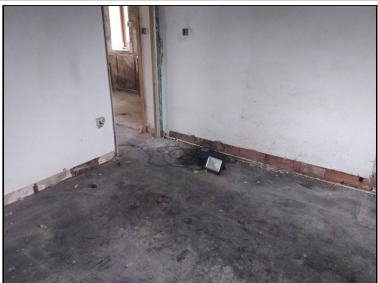
Survey Date:	Lead Surveyor	Survey Type	Floor	Analysis
	30 Mar 2022	Kevin Carney	Demolition Survey	Ground Floor	N/A
	Building	Room	Item	Quantity	
	Denhills, Ashbourne Lane	Bedroom 1 G02	No suspect materials found	N/A	
	Sample No (S,SP,P,As)	Product Type	Surface Treatment	Condition	Accessibility
	Visual (P)	N/A	N/A	N/A	N/A
	Material Risk Score				
	N/A				
Recommended action		No further action required			
Surveyor comments		N/A

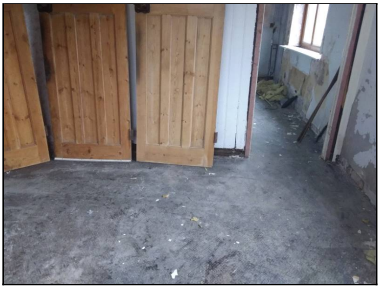
Survey Date:	Lead Surveyor	Survey Type	Floor	Analysis
	30 Mar 2022	Kevin Carney	Demolition Survey	Ground Floor	N/A
	Building	Room	Item	Quantity	
	Denhills, Ashbourne Lane	Bedroom 2 G03	No suspect materials found	N/A	
	Sample No (S,SP,P,As)	Product Type	Surface Treatment	Condition	Accessibility
	Visual (P)	N/A	N/A	N/A	N/A
	Material Risk Score				
	N/A				
Recommended action	No further action required				
Surveyor comments	N/A

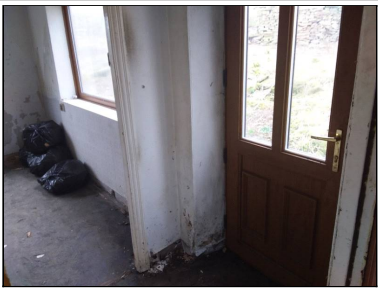
Survey Date:	Lead Surveyor	Survey Type	Floor	Analysis
	30 Mar 2022	Kevin Carney	Demolition Survey	Ground Floor	N/A
	Building	Room	Item	Quantity	
	Denhills, Ashbourne Lane	Lobby G04	No suspect materials found	N/A	
	Sample No (S,SP,P,As)	Product Type	Surface Treatment	Condition	Accessibility
	Visual (P)	N/A	N/A	N/A	N/A
	Material Risk Score				
	N/A				
Recommended action	No further action required				
Surveyor comments	N/A

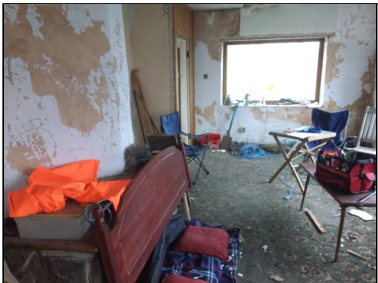
Survey Date:	Lead Surveyor	Survey Type	Floor	Analysis
	30 Mar 2022	Kevin Carney	Demolition Survey	Ground Floor	N/A
	Building	Room	Item	Quantity	
	Denhills, Ashbourne Lane	Lounge G05	No suspect materials found	N/A	
	Sample No (S,SP,P,As)	Product Type	Surface Treatment	Condition	Accessibility
	Visual (P)	N/A	N/A	N/A	N/A
	Material Risk Score				
	N/A				
Recommended action	No further action required				
Surveyor comments	N/A

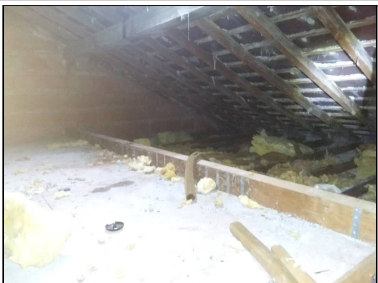
Survey Date:	Lead Surveyor	Survey Type	Floor	Analysis
	30 Mar 2022	Kevin Carney	Demolition Survey	Roof Void	N/A
	Building	Room	Item	Quantity	
	Denhills, Ashbourne Lane	Roof Void R01	No suspect materials found	N/A	
	Sample No (S,SP,P,As)	Product Type	Surface Treatment	Condition	Accessibility
	Visual (P)	N/A	N/A	N/A	N/A
	Material Risk Score				
	N/A				
Recommended action	No further action required				
Surveyor comments	N/A

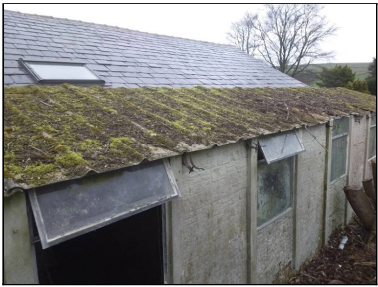
Survey Date:	Lead Surveyor	Survey Type	Floor	Analysis
	30 Mar 2022	Kevin Carney	Demolition Survey	External	Chrysotile (1)
	Building	Room	Item	Quantity	
	Denhills, Ashbourne Lane	Garage E01	Cement Sheets Roof	36m ²	
	Sample No (S,SP,P,As)	Product Type	Surface Treatment	Condition	Accessibility
	KC001402 (S)	Asbestos Cement (1)	Surface Sealed (1)	Low Damage (1)	Occasionally likely to be disturbed
	Material Risk Score				
	4				
Recommended action	A - Urgent Removal				
Surveyor comments	N/A

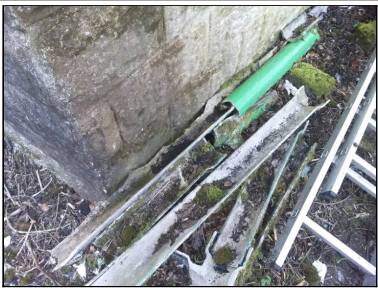
Survey Date:	Lead Surveyor	Survey Type	Floor	Analysis
	30 Mar 2022	Kevin Carney	Demolition Survey	External	Chrysotile (1)
	Building	Room	Item	Quantity	
	Denhills, Ashbourne Lane	External E02	Cement Rainwater goods Rear of property	7lm	
	Sample No (S,SP,P,As)	Product Type	Surface Treatment	Condition	Accessibility
	As KC001402 (SP)	Asbestos Cement (1)	Surface Sealed (1)	High Damage (3)	Easily disturbed
	Material Risk Score				
	6				
Recommended action	A - Urgent Removal				
Surveyor comments	N/A
