**REPORT ON STRUCTURAL CONDITION  
OF  
85 & 87 GREEN LANE  
BUXTON, DERBYSHIRE  
FOR  
MRS D BENNETT**

**Job No. 1877**

## **85 & 87 GREEN LANE, BUXTON, DERBYSHIRE**

### **REPORT ON STRUCTURAL CONDITION**

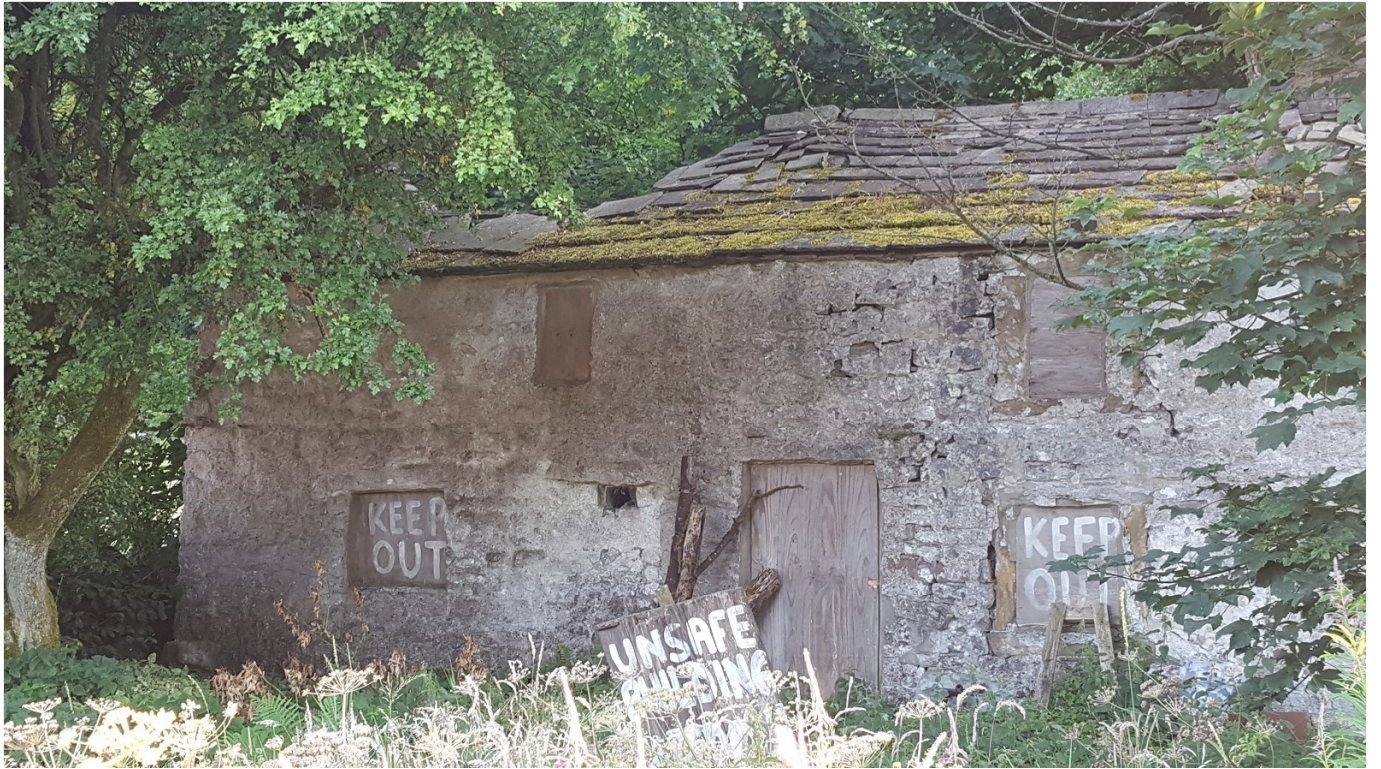
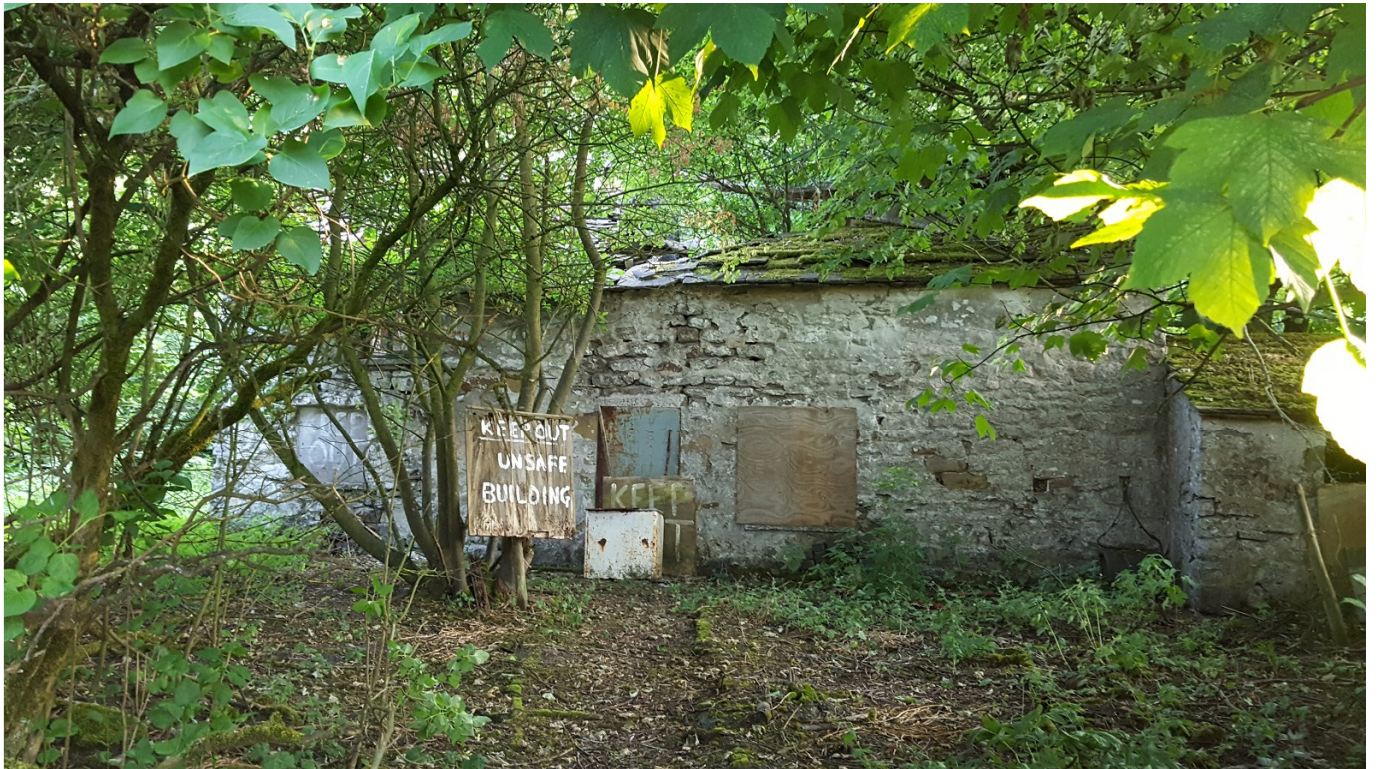
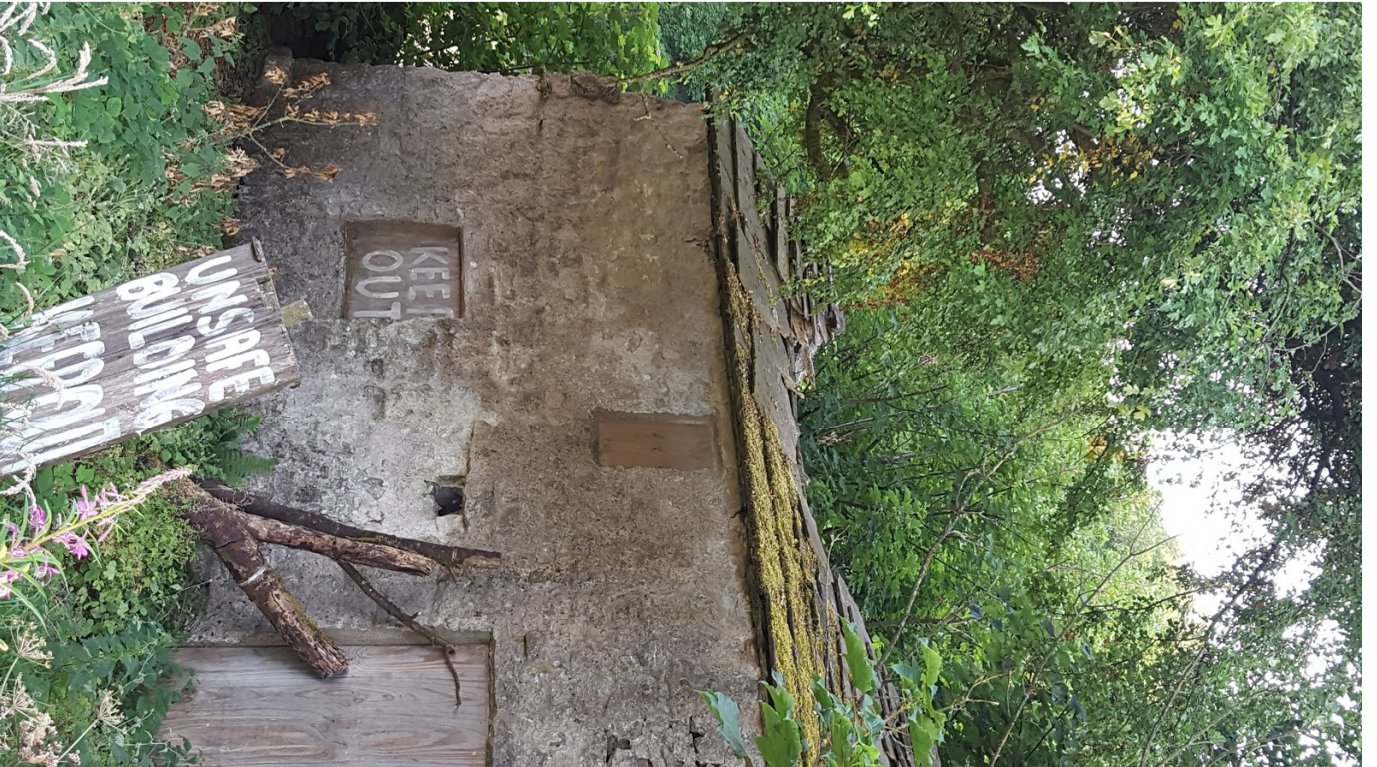
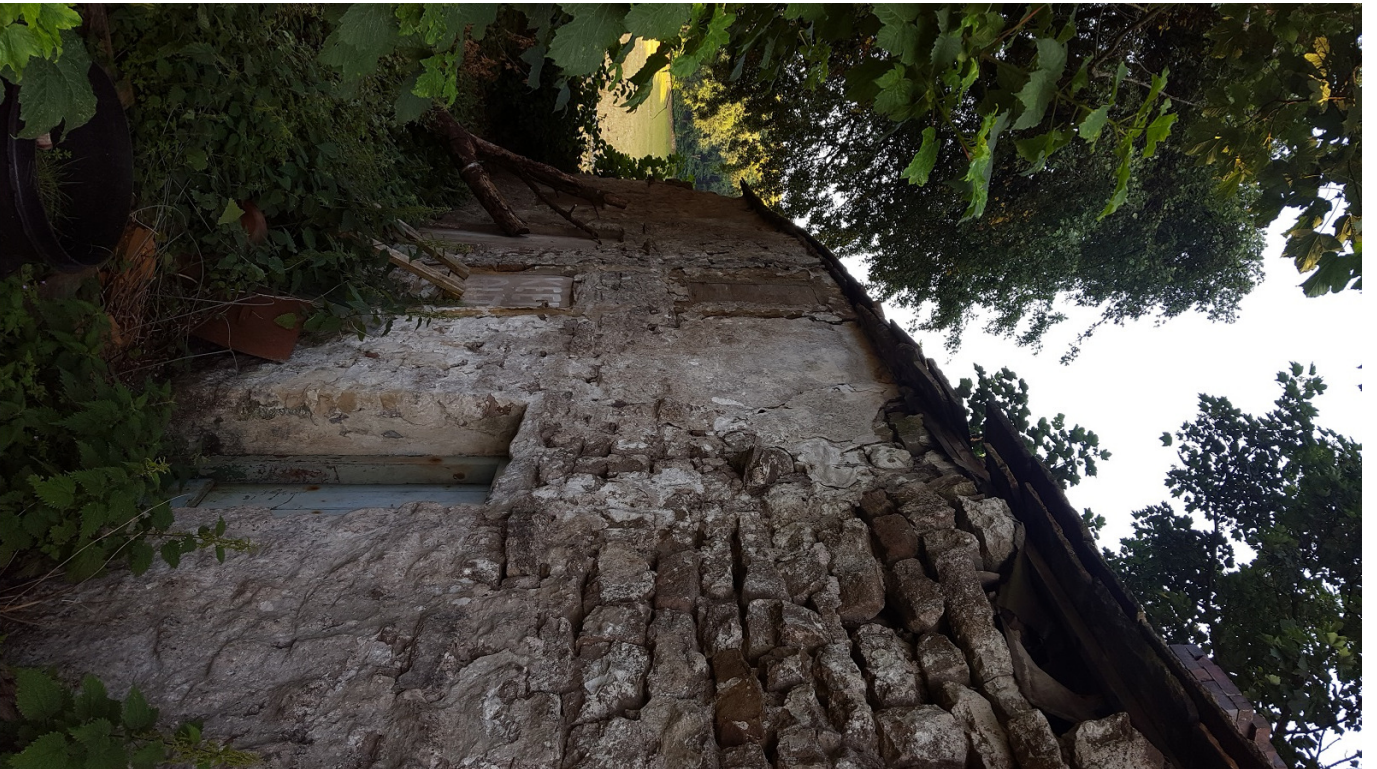
#### **INTRODUCTION – (see photographs 1 to 4 in Appendix A)**

Both properties, which are detached two-storey stone built cottages with small single storey lean-to extensions, are situated adjacent the car park for Poole's Cavern, Buxton.

The external walls are of random limestone construction some 500/600mm thick with stone lintels to most door and window openings. The walls of no 85 having been lime-wash rendered and painted white in the past. The roofs, which are in a partial state of collapse, are of traditional pitched timber construction with a stone slate covering with no gutters remaining. The ground floors appear to be of solid construction (although difficult to full determine), the remains of upper floors are of timber board, joist and beam construction and are once again in a partial state of collapse. No foundations are in evidence.
