# Asbestos Refurbishment Survey

SK17 6SY MANCHESTER ROAD

Surveyed On: 20 Oct 2022

| Project | barn survey |

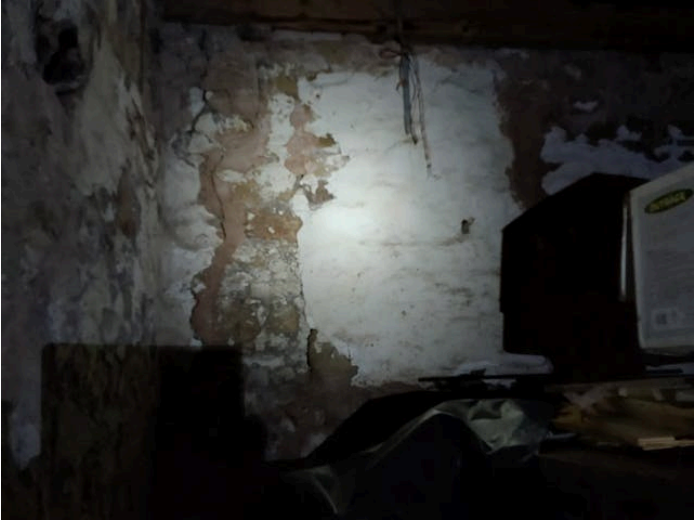
Main Building > 0 > 001 wall > wall

| Building / Level / Location | Item | Material | Access / Notes | Material Score | Recommendation | Page |
|---|---|---|---|---|---|---|
| Main Building / 0 / 001 wall | wall | cement | | 0<br>None | | 9 |

| Material | cement | Extent | 6x20m |
| Strategy / Sample Id | Sample / 001 | Fibre Type | NADIS |

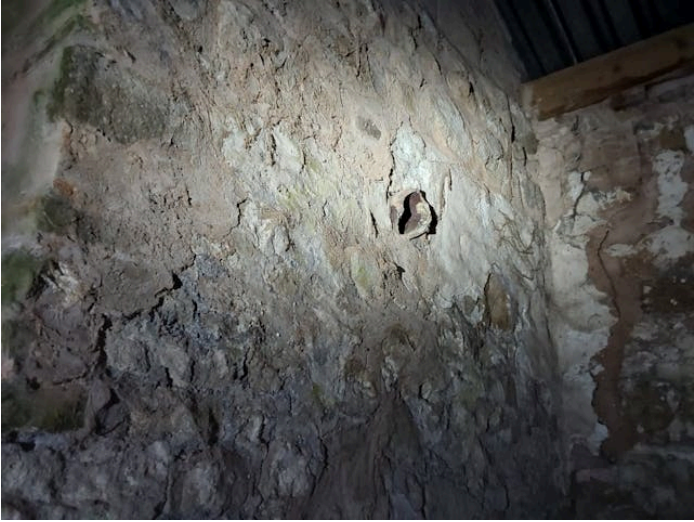
Main Building > 0 > 002 pipe > pipe

| Building / Level / Location | Item | Material | Access / Notes | Material Score | Recommendation | Page |
|---|---|---|---|---|---|---|
| Main Building / 0 / 002 pipe | pipe | Cement | | 0<br>None | | 10 |

| Material | Cement | Extent | 0.3m |
| Strategy / Sample Id | Sample / 002 | Fibre Type | NADIS |

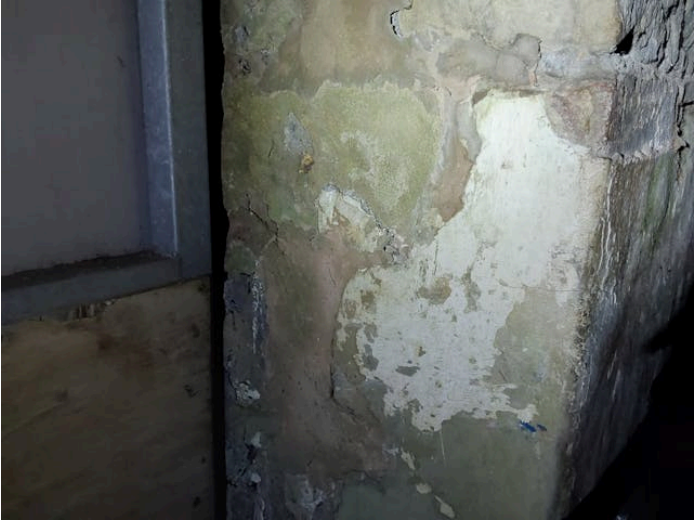
Main Building > 0 > 003 wall by gate > wall

| Building / Level / Location | Item | Material | Access / Notes | Material Score | Recommendation | Page |
|---|---|---|---|---|---|---|
| Main Building / 0 / 003 wall by gate | wall | cement | | 0<br>None | | 11 |

| Material | cement | Extent | 0.25x3m |
| Strategy / Sample Id | Sample / 003 | Fibre Type | NADIS |
