**STRUCTURAL  
ENGINEER'S REPORT  
FOR  
Northern Glass Works,  
Manor Park Road,  
Glossop,  
SK13 7SH**

### **1.3 Purpose of Report**

The scope of the Report will be with reference to existing structural movements and structural defects in the load bearing elements of the property.

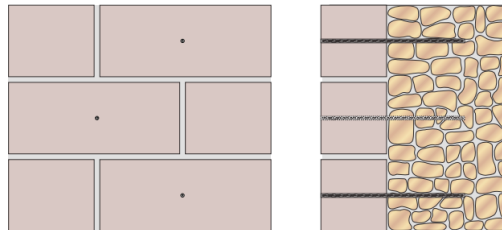
RF04

- 7.3** There has been historic movement of the rear wall that is evidenced by the bowing at lower level, the installation of pattress ties, and the construction of the blockwork inner leaf at ground floor level. The render finish to the wall is now cracked around the pattress tie positions, as well as cracking under the ground floor windows and a vertical crack at the junction between the main rear building and the left hand extension. It is assumed that the pattress ties were installed to restrain the wall to prevent bowing or separation of the leaves of the wall. There were no current indications that this was not performing adequately although there was some cracking of the render adjacent to the ties considered due to differential in thermal movement between the steel pattress and the render finish and stone beneath. The pattress plates were starting to rust and are in need of some maintenance. It is recommended that consideration be given to either cleaning down of the plates with a wire brush to remove any loose material and then repainting in a protective paint such as Fosroc Galvafrid, or alternatively, a more modern technique of using chemical ties, such as Helifix ChemTies, to secure the stone leaves together could be used and this would mean that the pattress ties could be removed. We would also recommend that additional ties are installed to further secure the wall to the first floor. This use of chemical ties would also be recommended for the lower level of wall where the bowing is quite significant. The lower level should be tied within the next 12-18 months. Details of the ChemTies are given in the repair appendix. All installations of such ties should be done by an accredited installer.

Repair to Rear Wall -bowing and separation  
Option 1

## Repair of Stone-Faced Random Stone Walls using CemTies through Stone Faces

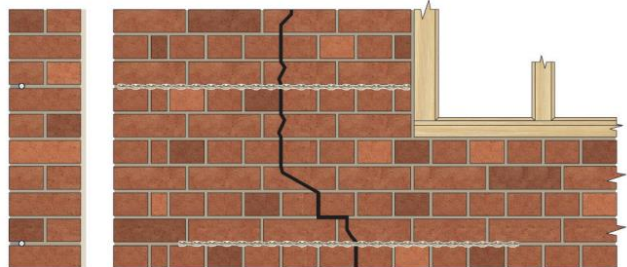
- 7.2** There were numerous cracks to the internal face of the front wall of the main rear building at first floor to roof level. There was also a diagonal crack at the left hand end of the external elevation of this wall that reciprocated cracking internally. There was further cracking on the rear wall, particularly to the right hand side, and some of the ceiling plaster finish was sagging and a section missing. The internal plaster finishes are considered to be old and plaster become more brittle with age, especially with the drying out of the internal environment due to the installation of central heating, which can lead to cracking of the finish. It is noted that there has also been a roof leak which has contributed to the deterioration of the ceiling plaster finish at the front right. We would recommend that the plaster be removed and then the walls reinspected to determine if there is any true underlying structural cracking. We would suggest making an allowance for some crack stitching repair works to the upper left side of the front wall, both internally and externally, and some crack stitching above and to the left of the right hand window in the rear wall internally. A crack stitching repair example is provided in the Repair Appendix at the end of this report.

# Crack Stitching a Solid Wall using HeliBars
