## **A.J.S ARCHITECTURE**

### **CONDITION SURVEY AND REPORT:**

## **CONVERSION OF FORMER WHITE LION PUBLIC HOUSE AND ASSOCIATED OUTBUILDINGS TO REAR TO FORM 13 APARTMENTS.**

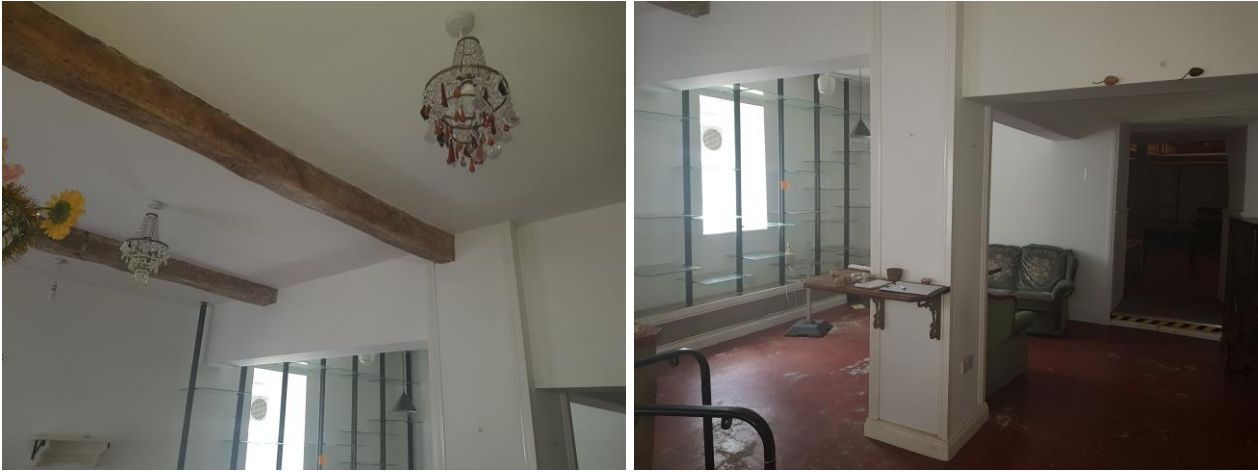
## **CONDITION SURVEY AND RELATIONSHIP TO THE PROPOSED GROUND FLOOR:**

The existing front part of this building is in general in relatively good condition. These rooms have of course been the main part of the pub for the bulk of the life of the building and have thus always been maintained to a reasonable basic standard, the upshot of this has however meant that almost all original features have been removed during the course of the buildings life.

The refurbishment works in these spaces will relate to the requirement of Building Regulations and in the main, thermal upgrade works to both the walls, floors and ceilings. The base floor is a later addition concrete screed construction – dating back only a few decades and certainly of no character in context of the listing, with this in mind, the intention will be to break up the floor and upgrade to meet the basic requirements of Building Regulations with a new dpm, insulation and screed to the same base level we see today. The walls and ceilings to the ground floor have been plasterboarded over the last few years and thus retain no original features. Once again the need to meet Building Regulations would not be outweighed by the requirement to retain original features throughout this space (as there are none) and hence these elements will be upgraded to meet both Part L and Part E

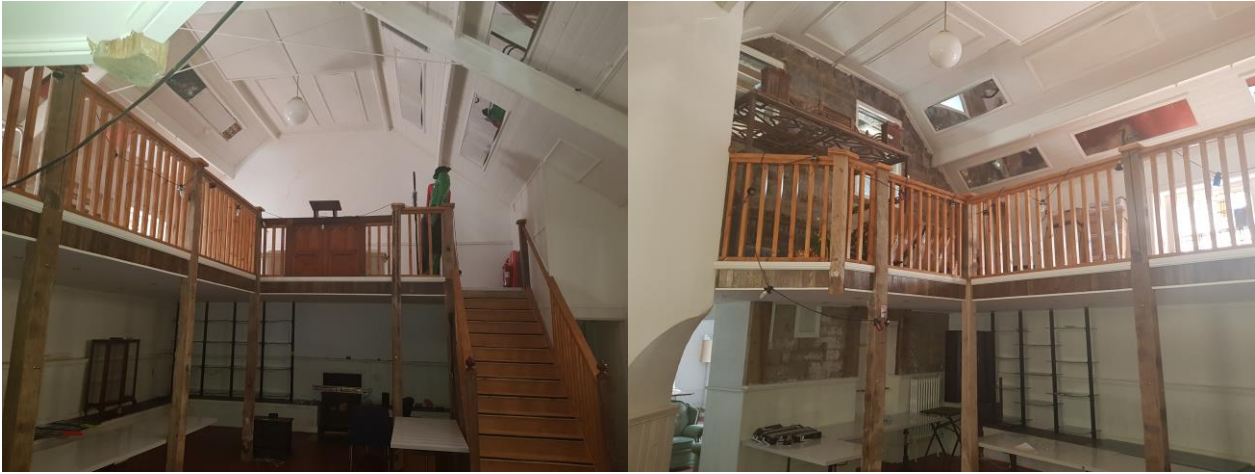
To the rear part of the ground floor is what was the original function room, this area has, within the last couple of years seen new structure applied to allow for the activities of the Artisan Market. This has been in the form of an independent mezzanine level with timber supports at ground floor – these structures are to be removed to take the building back to an open shell up to roof level to allow for the conversion to 2 maisonette apartments. This room has once again been modernised over the years in terms of fabric – walls and floors etc but still retains the original window openings (although this part of the building is in itself a much later addition). These windows are to be retained as part of the conversion with making good as required, where new doors are to be inserted they are to be done so as to retain the original opening in an increased depth.

To upper part of this room a new first floor construction will be on hangers against the existing structural walls so as not to disrupt the original built form. The floors, walls and ceilings in this area are again later additions and thus the need to meet Building Regulations will be met both in terms of Part L upgrades to the floor as elsewhere, dry lining to the walls (they are modern plasterboard finishes) and insulation and membrane works to the roofline – the panelling and detailing to be carefully removed (other than the faced mirror finishes) to be reinstated as /if required. All new structure will be with new compliant studwork and will not disrupt the original structure

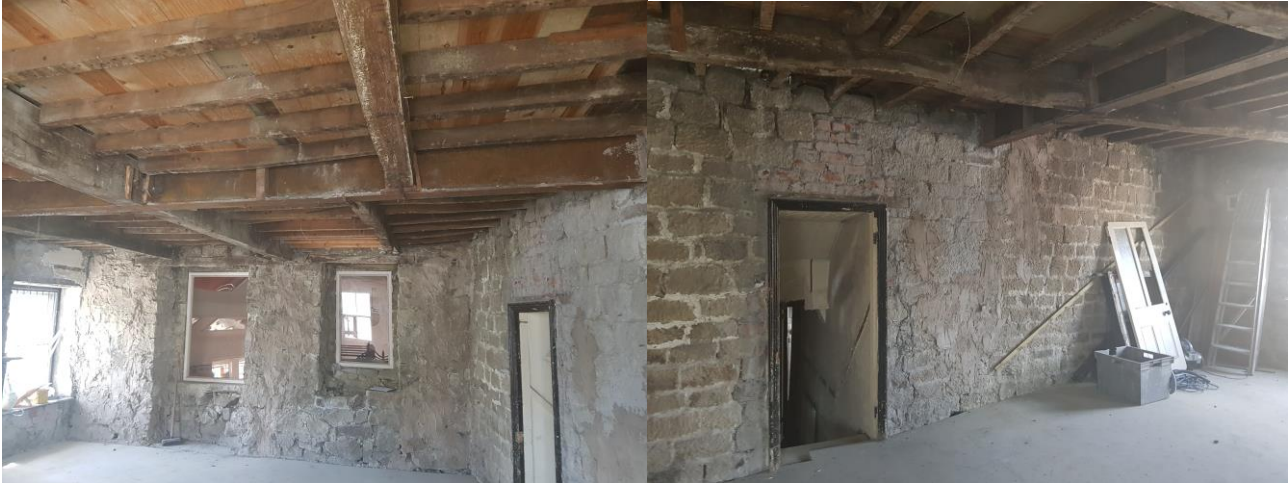
## CONDITION SURVEY AND RELATIONSHIP TO THE PROPOSED FIRST FLOOR:

Over the last few decades major works have had to take place to the front left hand side room at first floor. These have included the patch repair of various areas of external and party wall structure where movement has clearly caused historical structural issues, these do now largely seem to be rectified although there is still an area for concern where elevational movement is evident around the front first floor windows. This movement may well be historical but the use of angle irons to strap front elevation wall back to the side elevation are suggested and further structural engineer recommendation should be sought in this area as no responsibility can be accepted for issues going forward. The two original windows to the rear of the room will be removed and blocked up to retain the profile of the original opening.

The ceiling structure over this room has been substantially upgraded several decades ago to both allow for greater loadings as the use of the public house changed and also to take into account the diminished structural integrity of original timbers thereto. Although now something of a mix of new and old timbers this ceiling appears to have very little movement in and its continued use seems acceptable for the domestic use. The use of a structural engineer to clarify same should be sought however as no responsibility can be accepted for issues going forward.

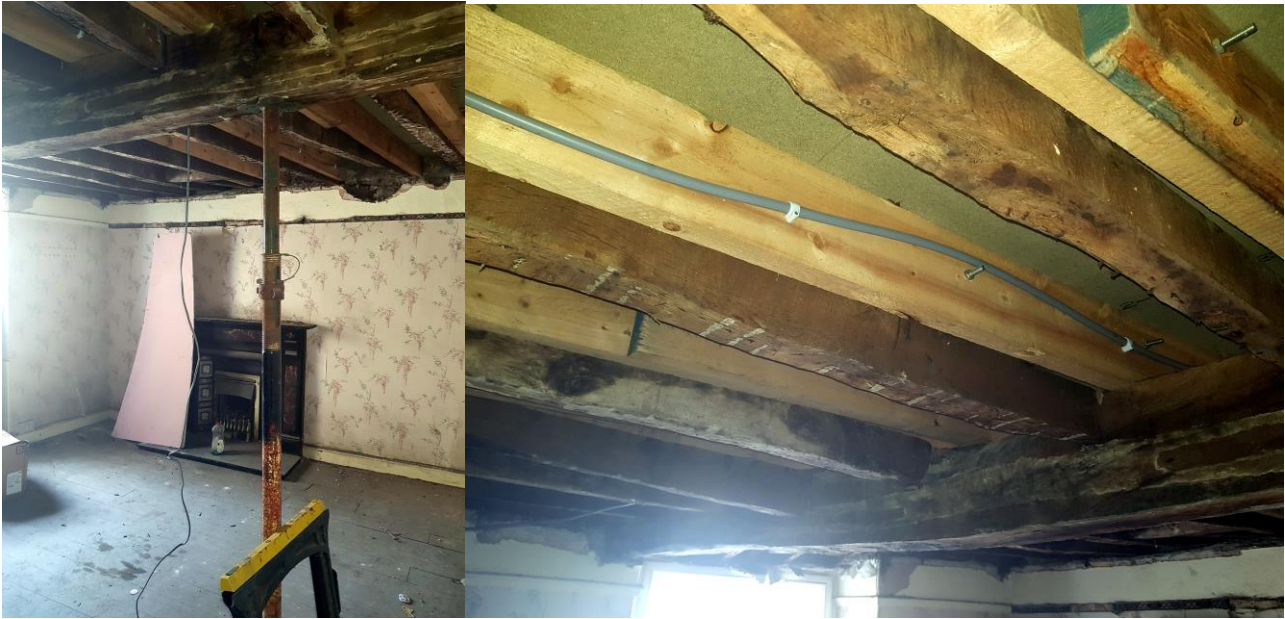
The middle room at first floor has suffered from considerable structural issues in terms of the original timber ceiling joists over resulting in the need for the original oak supporting beam to have broken its back with a significant fracture thereto which is currently requiring the support from an Acrow. This beam is now beyond any retention either for support or character and must be replaced to provide structural purpose back to the ceiling in question. The replacement of the original with a new oak cross beam would seem to be acceptable if supported by structural calculations thereto. Not with standing this, much of the original ceiling structure has been backed up with later addition ceiling/floor joists (seen within the relevant pictures) to take away the structural use of the original structure meaning this has become largely redundant. There is a clear case for the replacement of the existing floor structure or at the very least, the treatment of all areas against any continued dry rot and wood worm thereto.

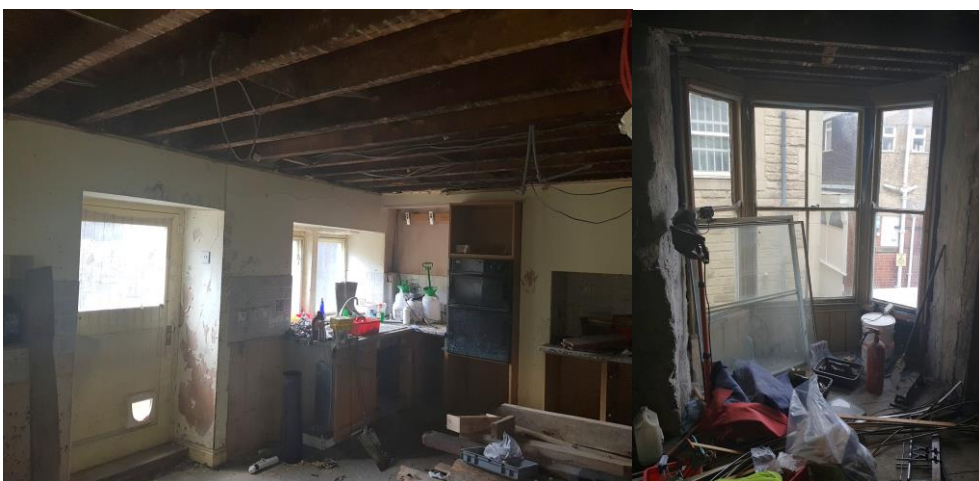
To the right side of building at first floor are the remains of what was clearly the domestic use of the building – the kitchen areas still being evident in part to the rear. The structural condition of this part of the room is again relatively sound.

This part of the building is to form two maisonettes to front and rear with new interconnecting staircases within the footprint of the respective apartments. To the rear existing furnishings are still in place but clearly represent latter additions to the building – likely dating back to the 1970's. The removal of these elements will allow for compliant structure as elsewhere without impact to the building as a whole. The ceilings to both the front and rear rooms have been removed as they have throughout the building and indicate that the existing timber structure appears to be adequate for the purpose of the conversion with the doubling up of every other joist suggested to add back strength to the floors in question.

The only required structural alteration to allow for the conversion in this area is building up of the connecting door between the two rooms front and rear. This door is unlikely to be original to the building due to the significant change of level between these spaces and the restricted head height within the opening between the two.

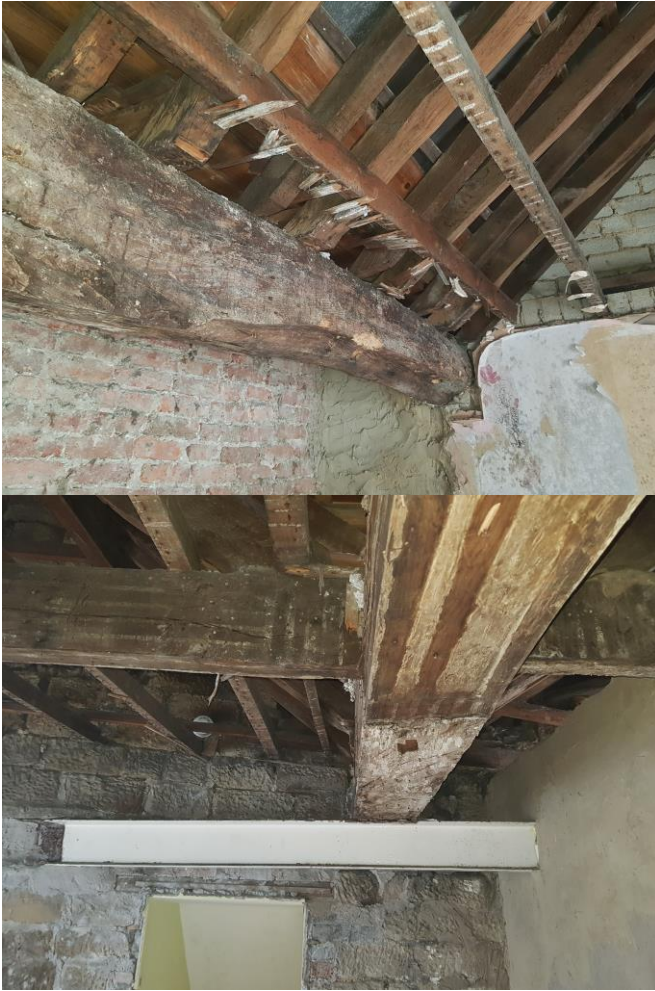
The central part of this unit has significant issues in terms of the floor structure that is to form the dividing floor to the maisonette unit it creates upto the third floor space over. The floor is both rotten and also inadequate in terms of timber depth to span the room. It is currently not safe to walk on this dividing floor over and its replacement is the only way to ensure this part of the building can be fit for purpose. This can of course be allowed for by doubling up with new joists adjacent to the existing but as trimming is required for the new staircase within the apartment between the two levels, a more sensible approach leans towards the removal of the floor structure thereto and the replacement with new throughout.

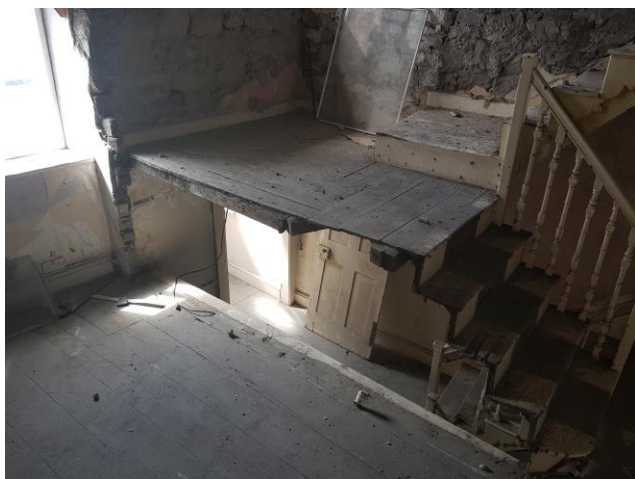
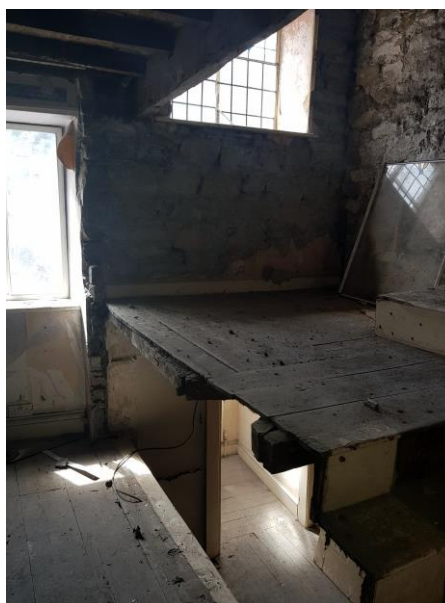
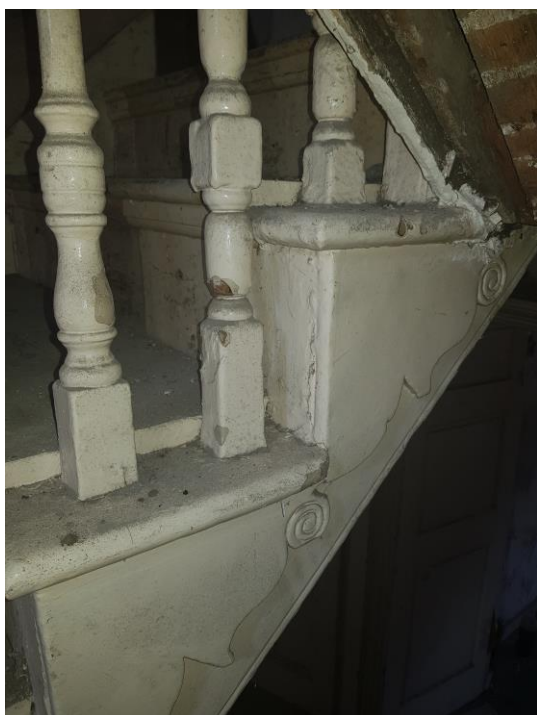
An existing staircase is in place within the centre of the building but over the decades this has become structurally unsafe, to the point where in places no supporting structure is even in place to hold the structure up.

The retention of this stairs is clearly not a desirable or viable option in terms of the layout of the proposed domestic use. The proposed does however retain the area encompassing the landing and staircase as the zone for the proposed new provision. All windows thereto will be retained relating to existing with a new access point from the rear courtyard level following the proposed removal of the later addition lean-to seen today.

New works are to retain the detailing of the existing staircase seen today but in a new compliant structure.

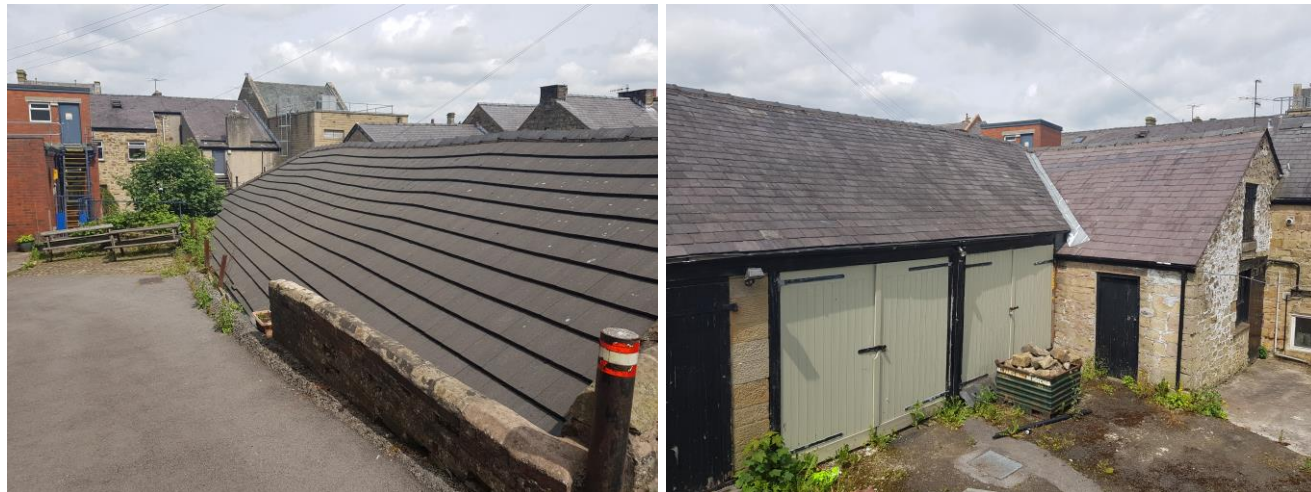
The stable buildings are in general of sound structure other than the internal facing elevation to the rear of Boots, which requires major making good or a rebuild as existing. In order to allow for a good standard of accommodation within the roof space it is intended to lift the roof by some 500mm or so. This can easily be achieved without detriment to the original building and in many ways will act as the catalyst for much needed enhancement of the building in question. Roof coverings that are completely out of character sit to the rear of the buildings throughout and it is evident that there is some movement to the roof structure in place. The new works will allow for the removal of same and the increase in height through the use of attic roof trusses. These works will allow for a new roofline in natural blue/grey slate to match with cast guttering on rise and fall brackets.

All new stonework is to match existing in random limestone with gritstone detailing with all existing pointing raked out to allow for bag/brush pointing throughout.

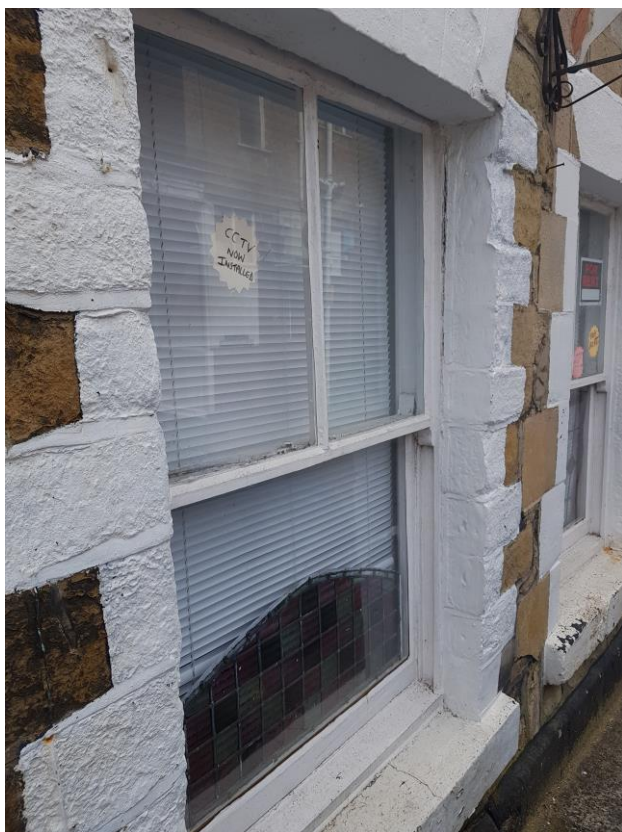
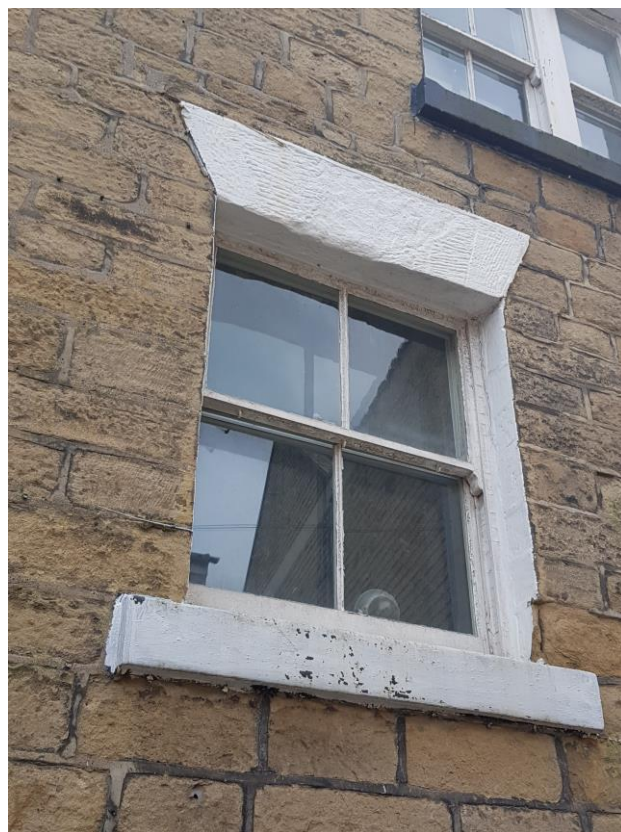
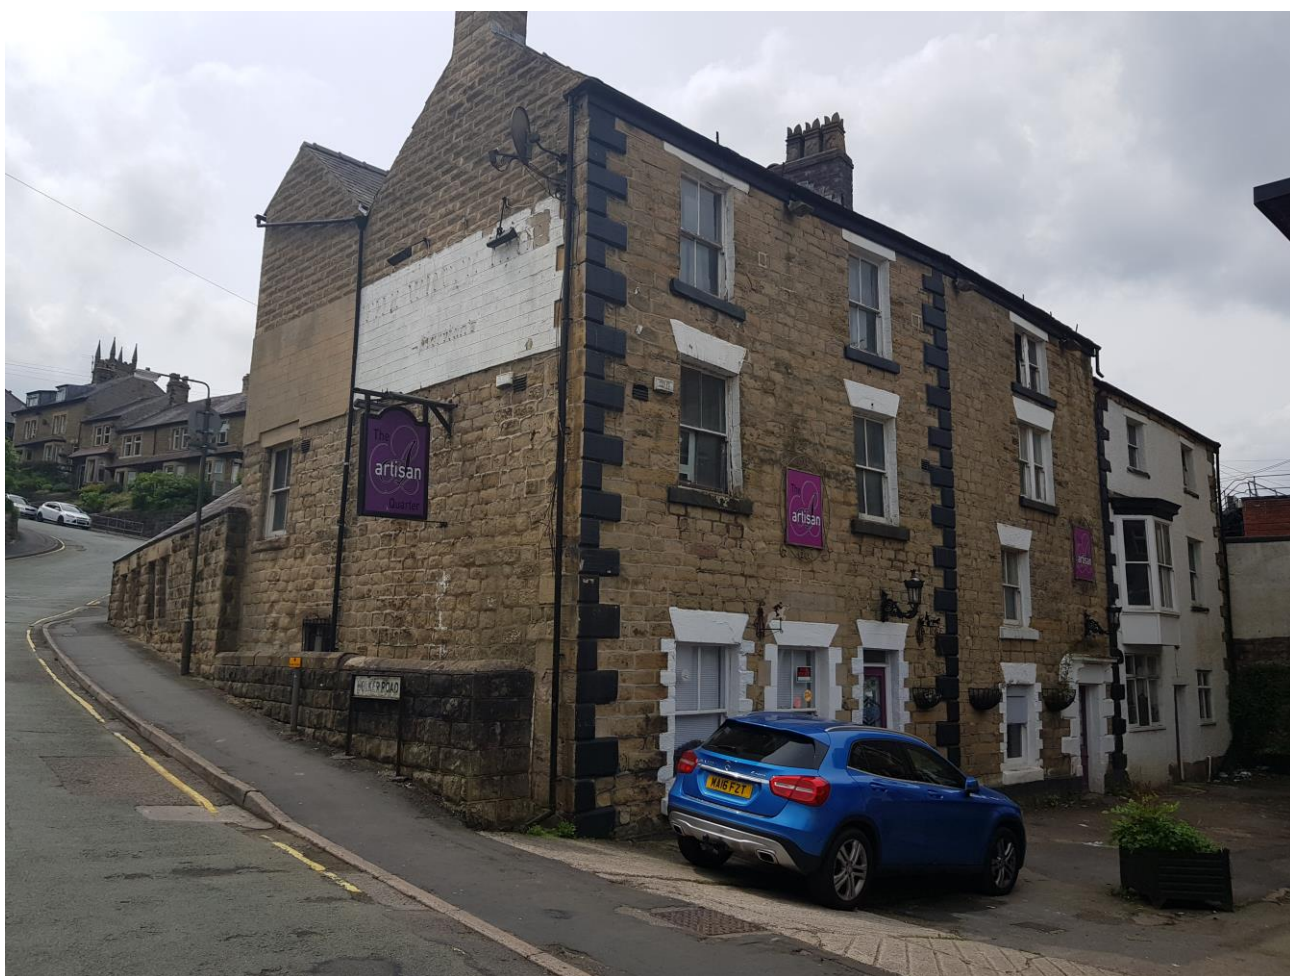
**CONDITION SURVEY AND RELATIONSHIP TO THE PROPOSED  
ELEVATION WORKS, ROOF AND JOINERY:**

In the main the front elevation of the building consists of single glazed softwood sliding sash windows. A good percentage of these could be refurbished, stripped down, treated and redecorated to an acceptable standard, this doesn't however address the desire of the client to offer good quality accommodation that meets the needs of Building Regulations in thermal efficiency and compliance. The suggestion is to replace all joinery items with new narrow casement hardwood double glazed sliding sash units that are designed to meet the requirement of conservation and listed building standards. These windows will allow for a significantly improved elevation appearance that still respects the requirements of the listing and also the desired thermal improvements.

Numerous companies now make narrow casement double glazed units that allow for glazing bars and frame thicknesses to meet the requirements of Conservation and Listed Building standards and be accepted by same, samples will be provided by condition.

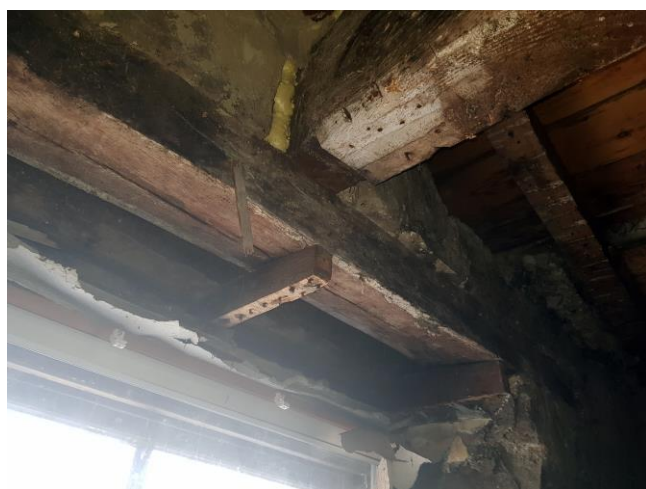
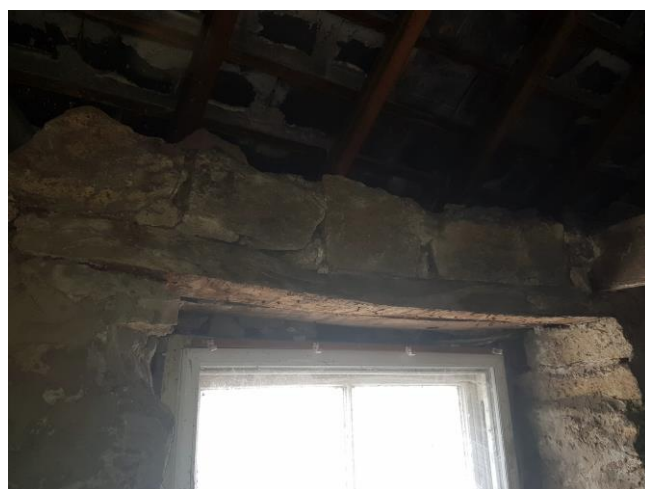
To the rear many windows are poor quality softwood plain casement units that are without doubt not original in either style or form to the original building. Their retention does not to enhance the appearance of the building or to respect its listing, thus all windows to the rear will be replaced with new sliding sash hardwood units as outlined above.

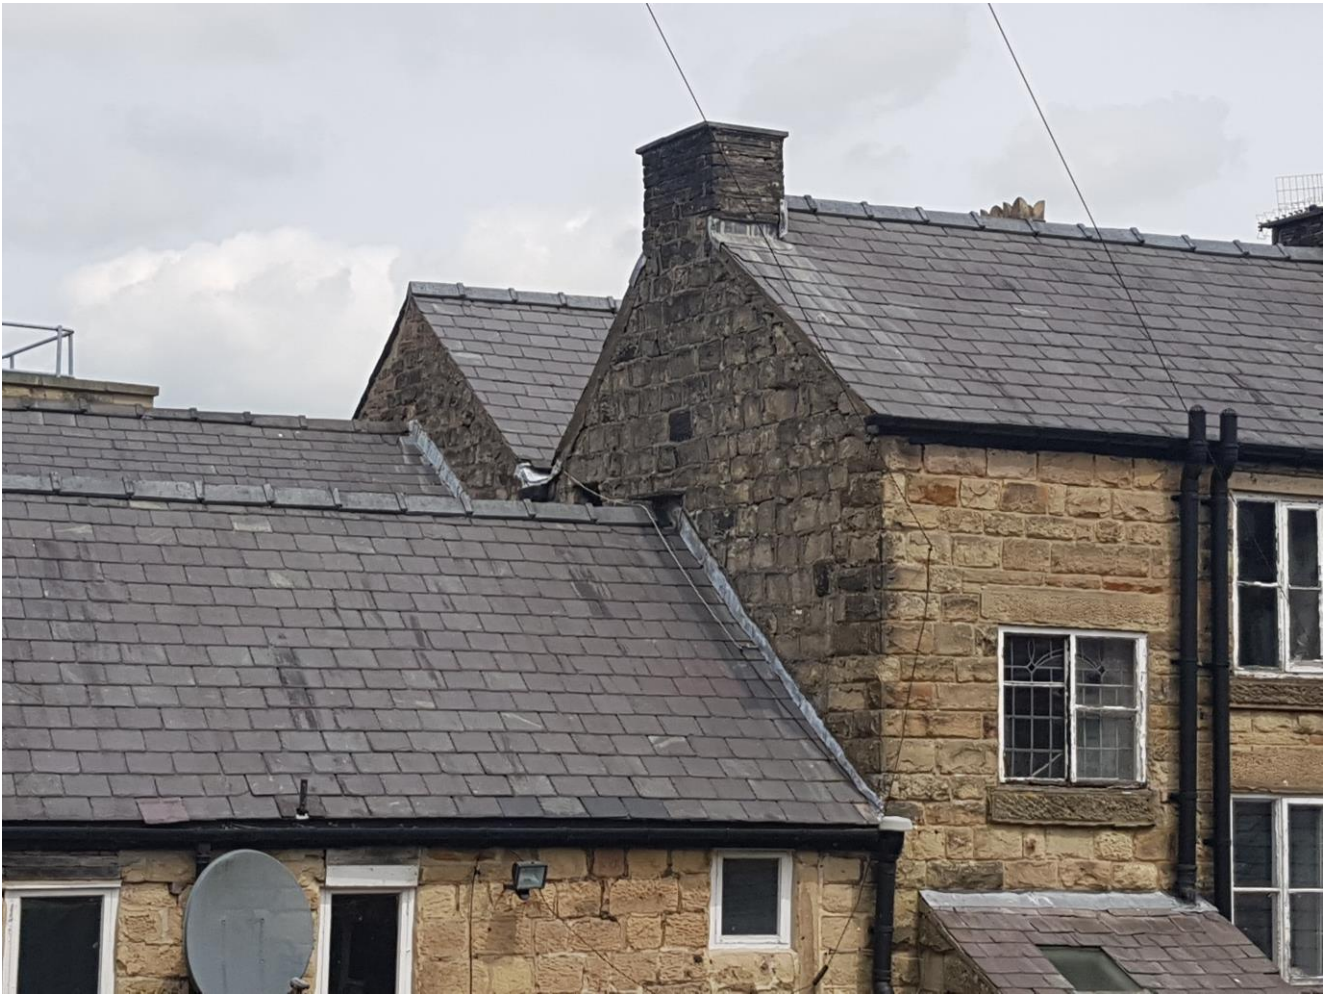
## CONDITION SURVEY AND RELATIONSHIP TO THE PROPOSED ROOF WORKS:

In general, the roof coverings and structure within are of a reasonable condition, they do not however in any way meet the requirements of Building Control in order to meet the proposed desire to expose character purlin and rafter features within by opening up rooms to the rake of the roofline. No roofing membranes are in place within the building (other than one very small area to the rear) and this requires rectifying to allow for both insulation and damp separation needs. In order to achieve the required standard thereto, all roof coverings are to be carefully removed and retained to be re-laid. The exposed roof structure is then to receive new timber battens with any remedial works required to be undertaken at the same time and a new Tyvek breathable membranes – at this time the secret valleys will also be replaced with all new lead work in code 5. Existing natural slate roof coverings will then be put back to the roof structure with any replacement in reclaim to match. New cast guttering will be put in place on rise and fall brackets to replace the plastic in place to date. In order to meet the requirements of Building Regulations and allow for exposed roof structure features within, the existing roofline will be insulated with either kingspan or Superquilt and under drawn with new plasterboard and skim to the rake.
