## **A.J.S ARCHITECTURE**

## **CONDITION SURVEY AND REPORT: JUNE' 2017**

# **CONVERSION OF FORMER WHITE LION PUBLIC HOUSE AND ASSOCIATED OUTBUILDINGS TO REAR TO FORM 13 APARTMENTS.**

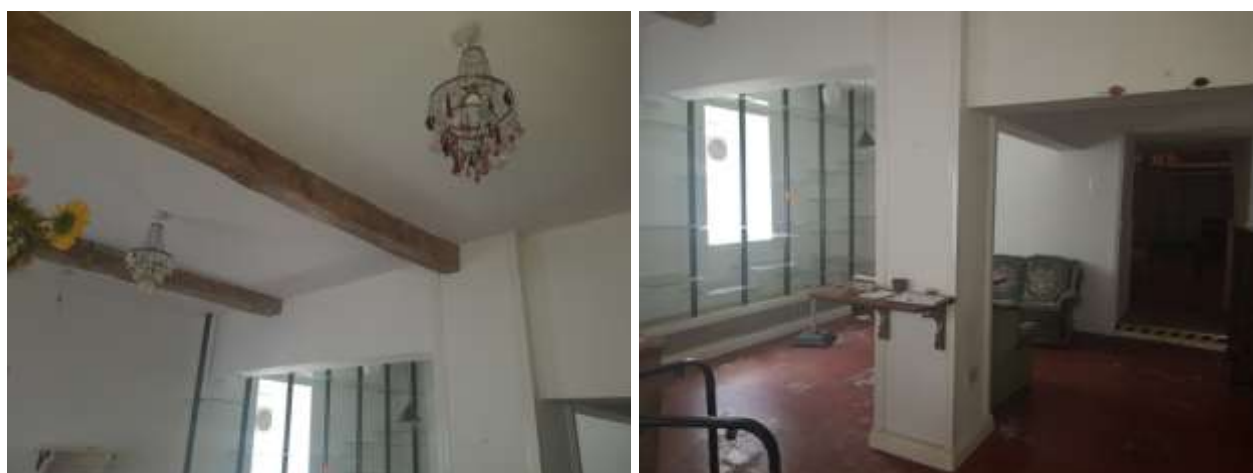
The ground floor of the building is to provide 2 ground floor apartments and the lower part of 2 maisonettes to the rear – former function room. In general the conversion of the building in this area requires little in the way of structural alteration to the front part of the building with the building up of two doorways, which will be recessed to retain the original opening form. Floor levels will also be altered adjacent to the cellar to aid the relationship between rooms, but these works relate to floor changes that have clearly taken place over the decades anyway. In other areas new studwork is to be used to create the defined domestic spaces within each apartment.

The existing front part of this building is in general in relatively good condition. These rooms have of course been the main part of the pub for the bulk of the life of the building and have thus always been maintained to a reasonable basic standard, the upshot of this has however meant that almost all original features have been removed during the course of the buildings life.

The refurbishment works in these spaces will relate to the requirement of Building Regulations and in the main, thermal upgrade works to both the walls, floors and ceilings. The base floor is a later addition concrete screed construction – dating back only a few decades and certainly of no character in context of the listing, with this in mind, the intention will be to break up the floor and upgrade to meet the basic requirements of Building Regulations with a new dpm, insulation and screed to the same base level we see today. The walls and ceilings to the ground floor have been plasterboarded over the last few years and thus retain no original features. Once again the need to meet Building Regulations would not be outweighed by the requirement to retain original features throughout this space (as there are none) and hence these elements will be upgraded to meet both Part L and Part E

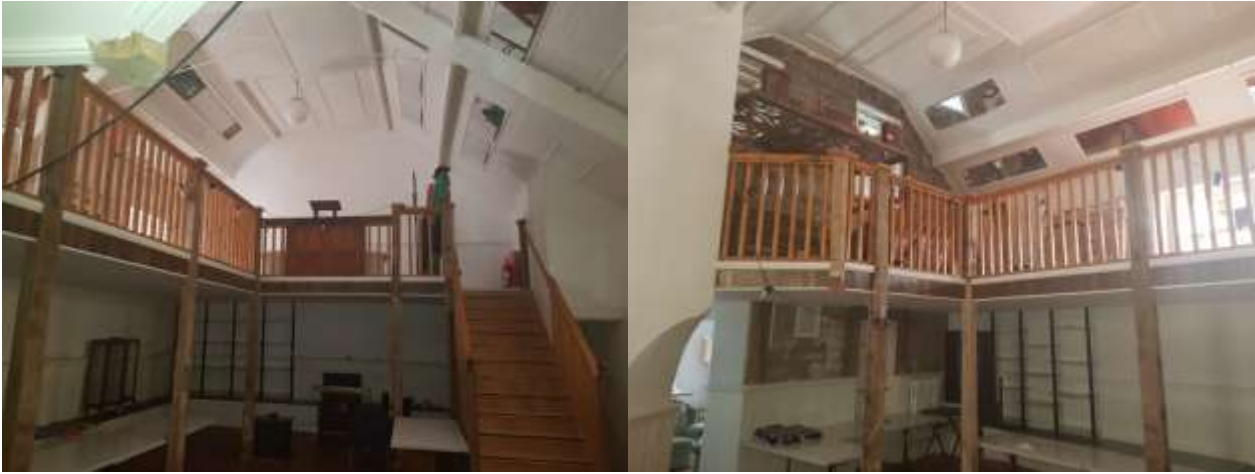
To the rear part of the ground floor is what was the original function room, this area has, within the last couple of years seen new structure applied to allow for the activities of the Artisan Market. This has been in the form of an independent mezzanine level with timber supports at ground floor – these structures are to be removed to take the building back to an open shell up to roof level to allow for the conversion to 2 maisonette apartments. This room has once again been modernised over the years in terms of fabric – walls and floors etc but still retains the original window openings (although this part of the building is in itself a much later addition). These windows are to be retained as part of the conversion with making good as required, where new doors are to be inserted they are to be done so as to retain the original opening in an increased depth.

To upper part of this room a new first floor construction will be on hangers against the existing structural walls so as not to disrupt the original built form. The floors, walls and ceilings in this area are again later additions and thus the need to meet Building Regulations will be met both in terms of Part L upgrades to the floor as elsewhere, dry lining to the walls (they are modern plasterboard finishes) and insulation and membrane works to the roofline – the panelling and detailing to be carefully removed (other than the faced mirror finishes) to be reinstated as /if required. All new structure will be with new compliant studwork and will not disrupt the original structure

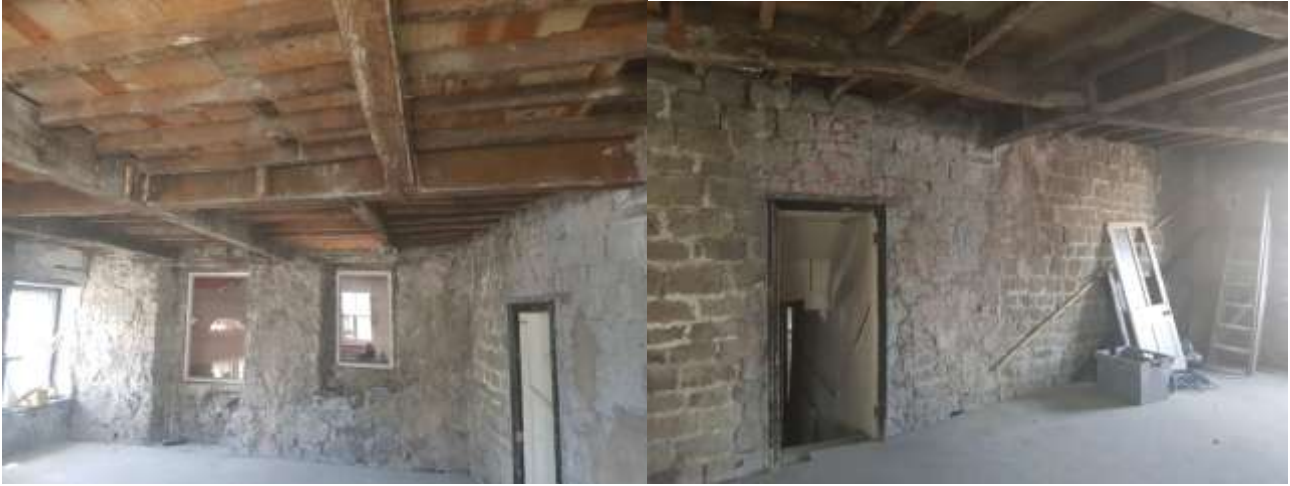
Over the last few decades major works have had to take place to the front left hand side room at first floor. These have included the patch repair of various areas of external and party wall structure where movement has clearly caused historical structural issues, these do now largely seem to be rectified although there is still an area for concern where elevational movement is evident around the front first floor windows. This movement may well be historical but the use of angle irons to strap front elevation wall back to the side elevation are suggested and further structural engineer recommendation should be sought in this area as no responsibility can be accepted for issues going forward. The two original windows to the rear of the room will be removed and blocked up to retain the profile of the original opening.

The ceiling structure over this room has been substantially upgraded several decades ago to both allow for greater loadings as the use of the public house changed and also to take into account the diminished structural integrity of original timbers thereto. Although now something of a mix of new and old timbers this ceiling appears to have very little movement in and its continued use seems acceptable for the domestic use. The use of a structural engineer to clarify same should be sought however as no responsibility can be accepted for issues going forward.

All plasterboard finishes have been removed in this room and once again there is no remaining original character that will be required to retain and thus the requirements of building control should be met both in terms of Part L, Part B and also Part E.

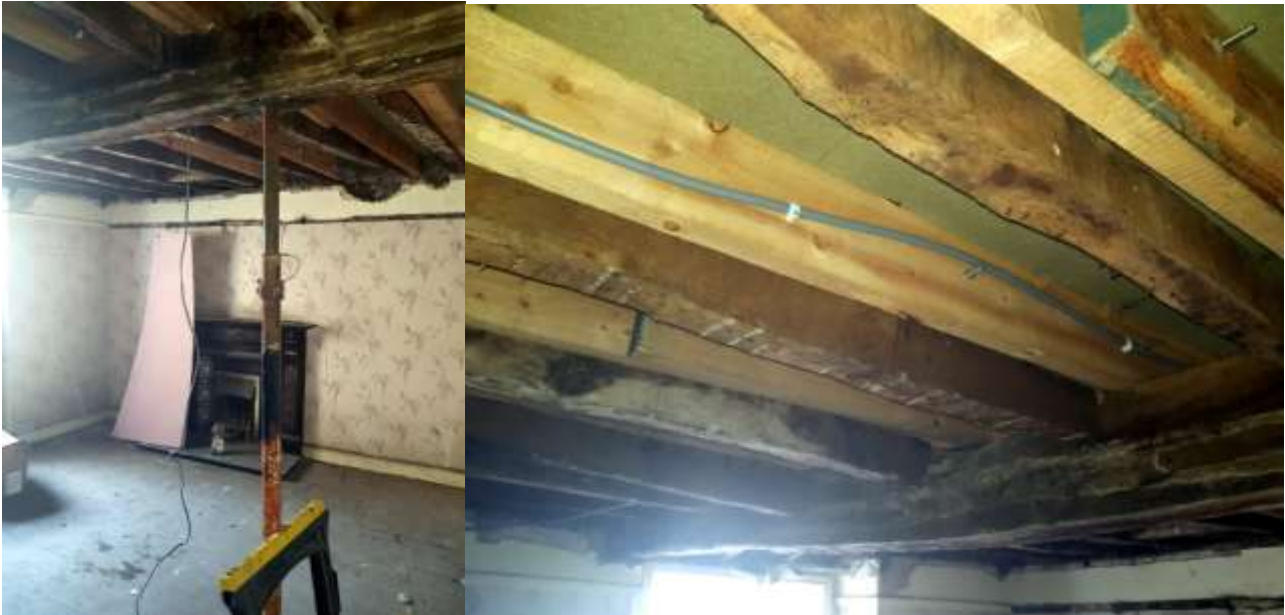
The middle room at first floor has suffered from considerable structural issues in terms of the original timber ceiling joists over resulting in the need for the original oak supporting beam to have broken its back with a significant fracture thereto which is currently requiring the support from an Acrow. This beam is now beyond any retention either for support or character and must be replaced to provide structural purpose back to the ceiling in question. The replacement of the original with a new oak cross beam would seem to be acceptable if supported by structural calculations thereto. Not with standing this, much of the original ceiling structure has been backed up with later addition ceiling/floor joists (seen within the relevant pictures) to take away the structural use of the original structure meaning this has become largely redundant. There is a clear case for the replacement of the existing floor structure or at the very least, the treatment of all areas against any continued dry rot and wood worm thereto.

To the walls, original wallpaper finishes dating back to the 60's are still in place but these are clearly of no retainable character and should be removed to ascertain the condition of plasterboard finished below. It is known that these will be plaster finish back to the original stonework. The wall is of no real significance and again it is argued that the requirements of Building Regulations should be met in these areas.

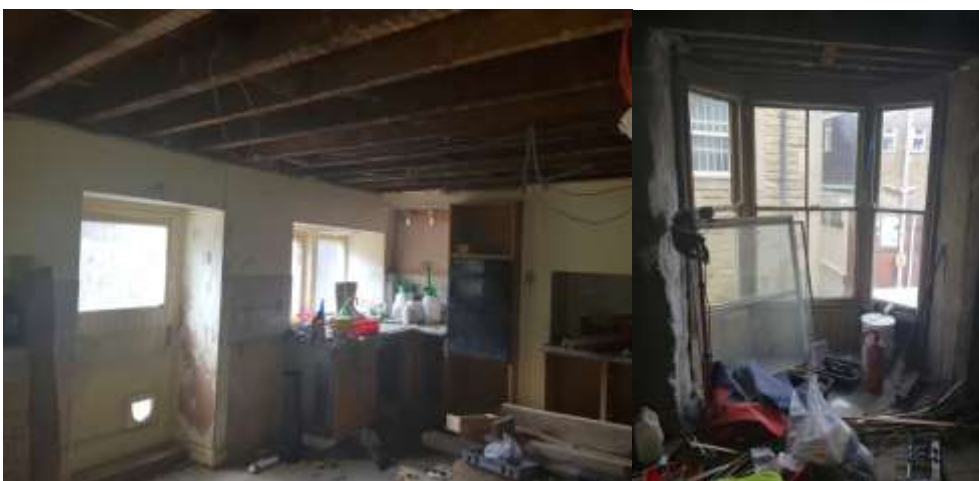
To the right side of building at first floor are the remains of what was clearly the domestic use of the building – the kitchen areas still being evident in part to the rear. The structural condition of this part of the room is again relatively sound.

This part of the building is to form two maisonettes to front and rear with new interconnecting staircases within the footprint of the respective apartments. To the rear existing furnishings are still in place but clearly represent latter additions to the building – likely dating back to the 1970's. The removal of these elements will allow for compliant structure as elsewhere without impact to the building as a whole. The ceilings to both the front and rear rooms have been removed as they have throughout the building and indicate that the existing timber structure appears to be adequate for the purpose of the conversion with the doubling up of every other joist suggested to add back strength to the floors in question.

The only required structural alteration to allow for the conversion in this area is building up of the connecting door between the two rooms front and rear. This door is unlikely to be original to the building due to the significant change of level between these spaces and the restricted head height within the opening between the two.

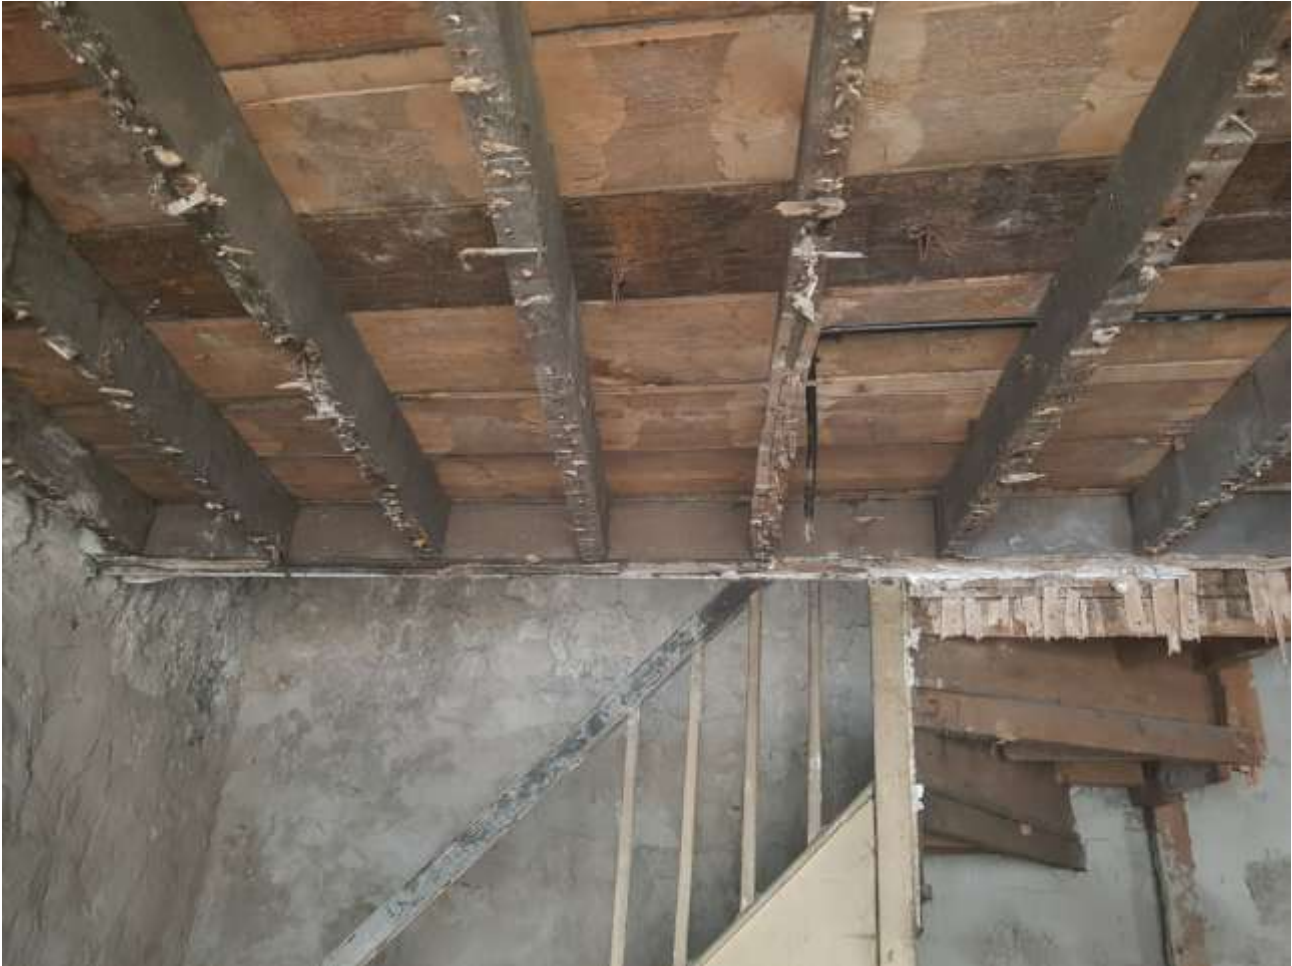
The front room is again of reasonable condition with some structural works already having taken place to allow for movement within the gable wall thereto. These works seem to have prevented further structural problems thereto. The staircase to the floor above, which will form the upper part of the maisonette, is clearly only a make shift addition rather than any permanent provision to provide access thereto and as such will be replaced with a new purpose made unit. This will also allow for remedial works to take place to the floor structure thereto. Although the timber joists are of reasonable condition they are clearly not of sufficient depth to allow for any permanent domestic use over and certain joists appear to have broken their back, hence the works suggest on doubling up of the floor with new joists either side to allow for the intended use. As before, the fact that all ceiling and wall finishes have been removed will allow for the Building Regulation compliant works to take place without any detriment to the listed status thereto.

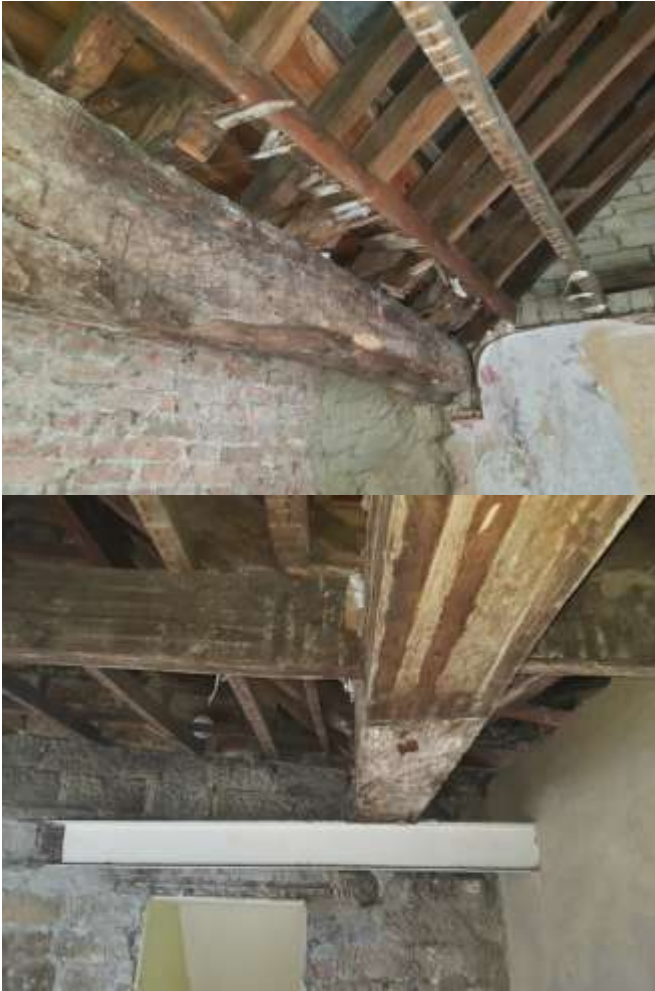
The left hand side at first floor will once again form a one bedroom apartment using the original area thereto. These rooms currently open up into the roof space and the timber structure thereto as all ceilings have been removed to allow for remedial works some years ago. This has allowed all timber to be revealed to show a structure that is of relatively good condition. Main feature purlins are in place throughout this space and these are intended to be exposed as feature areas within the proposed layout. All timbers are to be treated accordingly and the rake of the ceiling insulated to comply with Building Regulations. There are several issues with support structure in this room sitting directly over poor condition timber lintols but this item will be covered elsewhere.

The main problem in this space, as throughout the second and third floors, is the existing secret valley. This valley clearly has certain structural and weather tight issues which require addressing. It is intending to replace the full length of the valleys with new insulated and damp proofed lay boards to take plyboard and leaded valleys over. These works are to be undertaken in accordance with the general re-roof of the property which is intended, and will be covered as an item elsewhere in this document.

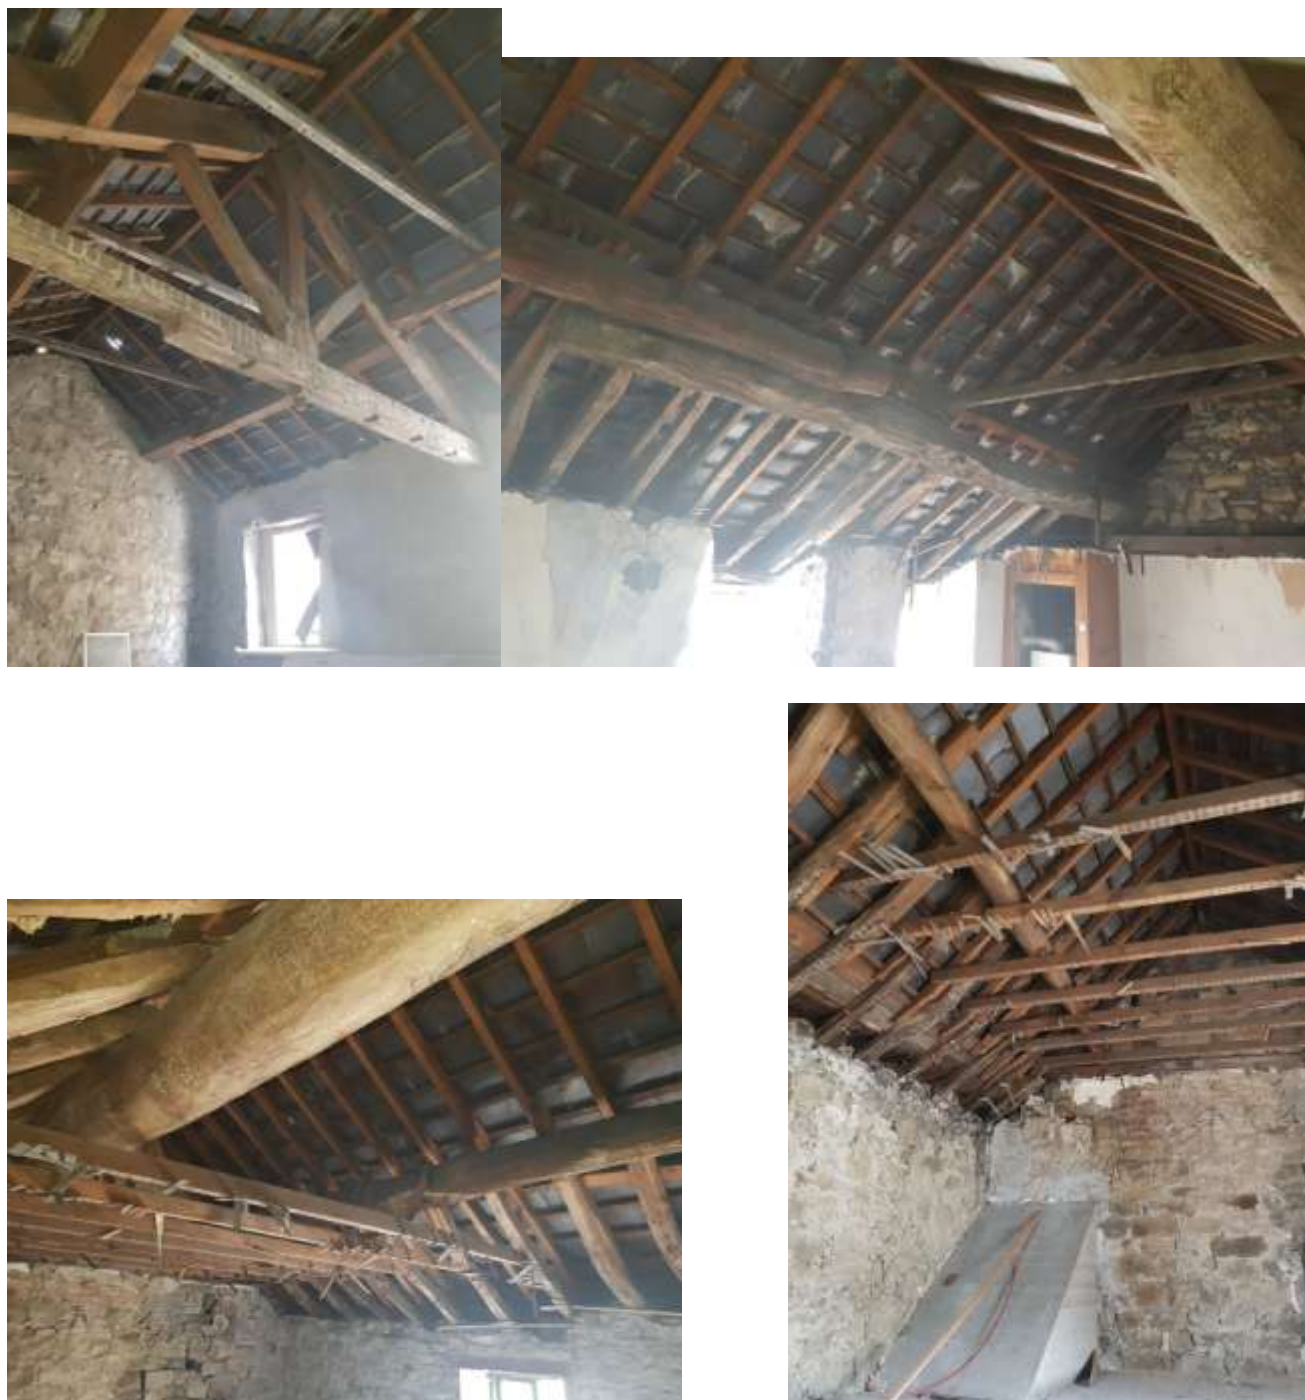
The central part of this unit has significant issues in terms of the floor structure that is to form the dividing floor to the maisonette unit it creates upto the third floor space over. The floor is both rotten and also inadequate in terms of timber depth to span the room. It is currently not safe to walk on this dividing floor over and its replacement is the only way to ensure this part of the building can be fit for purpose. This can of course be allowed for by doubling up with new joists adjacent to the existing but as trimming is required for the new staircase within the apartment between the two levels, a more sensible approach leans towards the removal of the floor structure thereto and the replacement with new throughout.

The roof structure over at third floor is once again of a relatively sound nature if somewhat haphazard in form. Existing purlins thereto are worthy of retention as exposed feature following the remedial treatment of all existing timbers.

To the right hand side of the second floor, once again all roof timbers are exposed. This clearly indicates that although the roof timber layouts are somewhat haphazard, they are relatively sound in nature and all original timber may be retained (it is clear that the building has been re-roofed in this area over the decades). Original purlins and king post trusses are in place in these areas and again following remedial timber treatment they are worthy of retention.

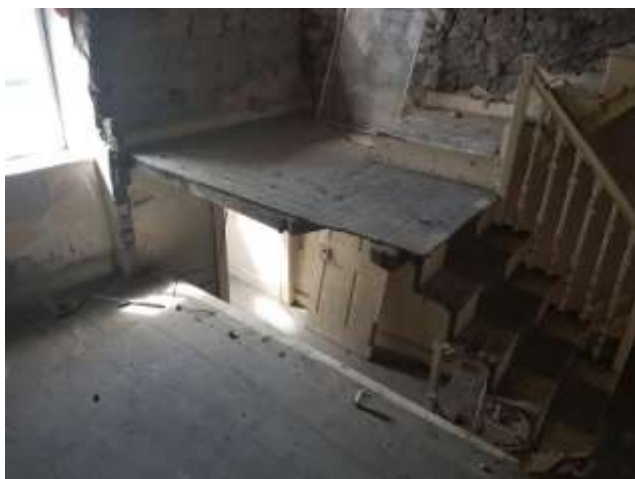
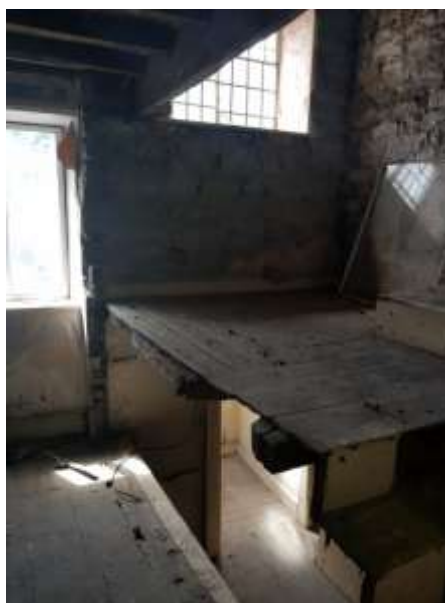
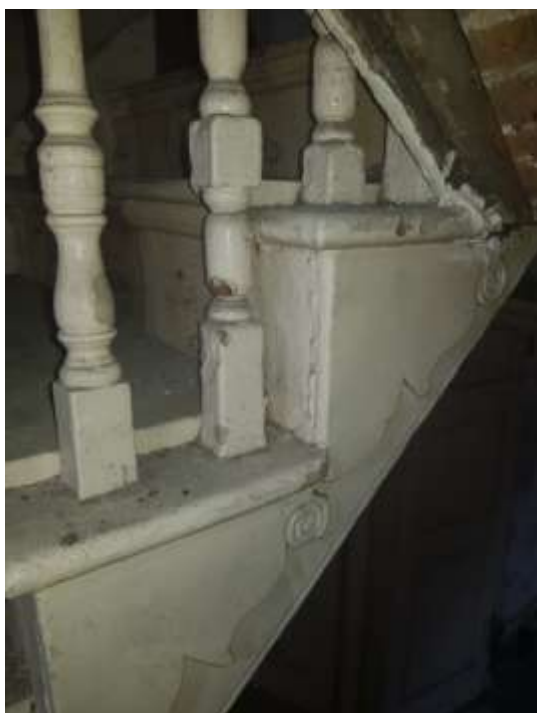
An existing staircase is in place within the centre of the building but over the decades this has become structurally unsafe, to the point where in places no supporting structure is even in place to hold the structure up.

The retention of this stairs is clearly not a desirable or viable option in terms of the layout of the proposed domestic use. The proposed does however retain the area encompassing the landing and staircase as the zone for the proposed new provision. All windows thereto will be retained relating to existing with a new access point from the rear courtyard level following the proposed removal of the later addition lean-to seen today.

New works are to retain the detailing of the existing staircase seen today but in a new compliant structure.

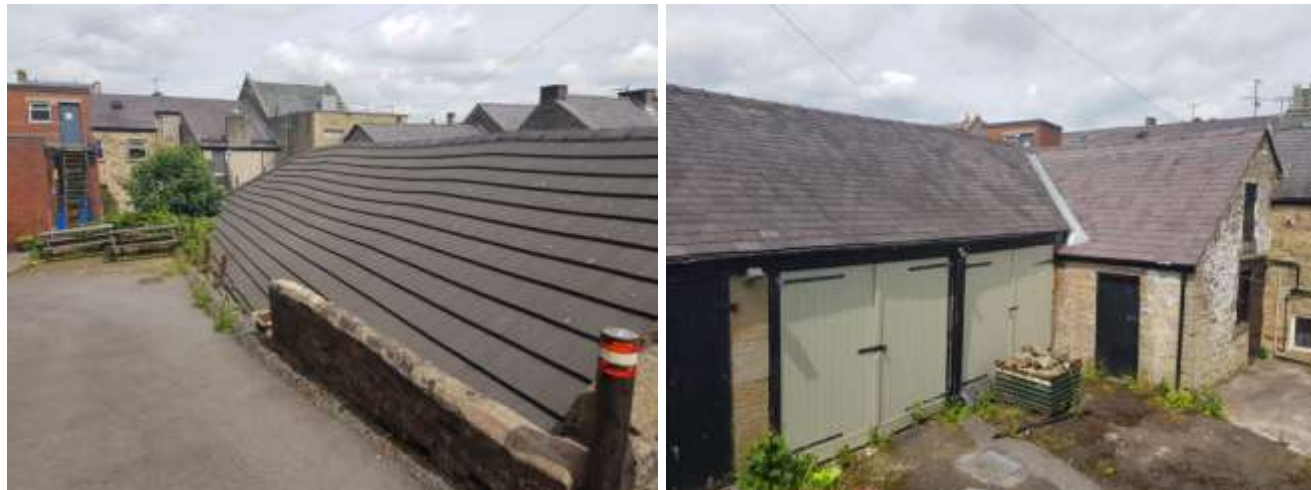
The stable buildings are in general of sound structure other than the internal facing elevation to the rear of Boots, which requires major making good or a rebuild as existing. In order to allow for a good standard of accommodation within the roof space it is intended to lift the roof by some 500mm or so. This can easily be achieved without detriment to the original building and in many ways will act as the catalyst for much needed enhancement of the building in question. Roof coverings that are completely out of character sit to the rear of the buildings throughout and it is evident that there is some movement to the roof structure in place. The new works will allow for the removal of same and the increase in height through the use of attic roof trusses. These works will allow for a new roofline in natural blue/grey slate to match with cast guttering on rise and fall brackets.

All new stonework is to match existing in random limestone with gritstone detailing with all existing pointing raked out to allow for bag/brush pointing throughout.

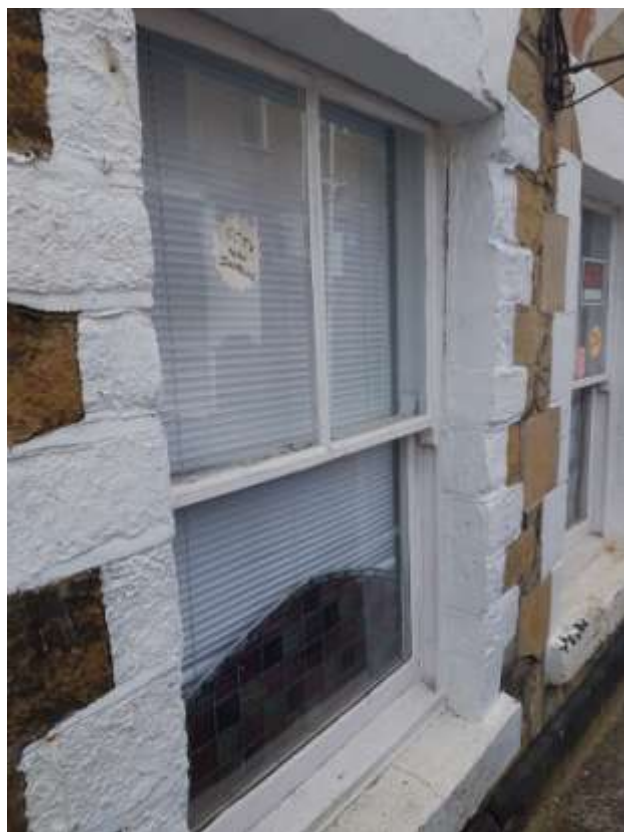
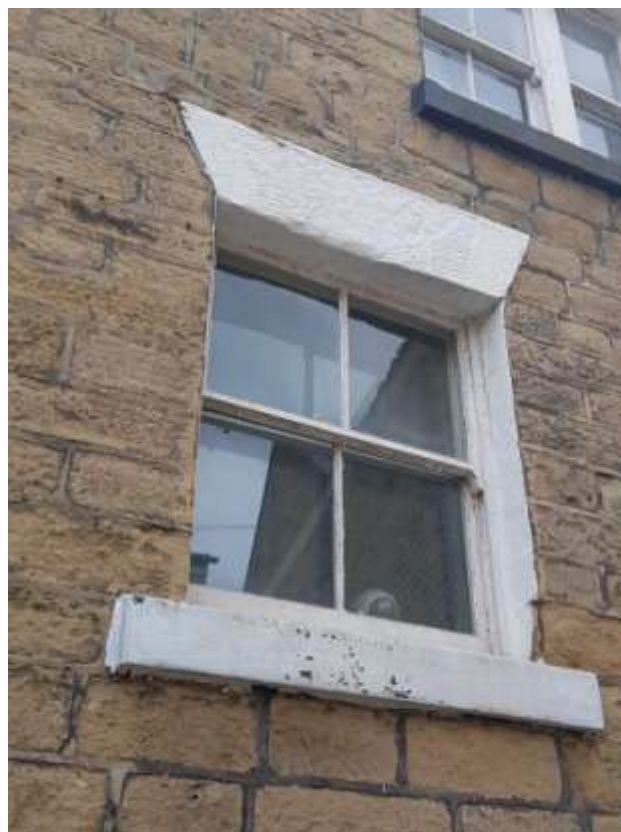
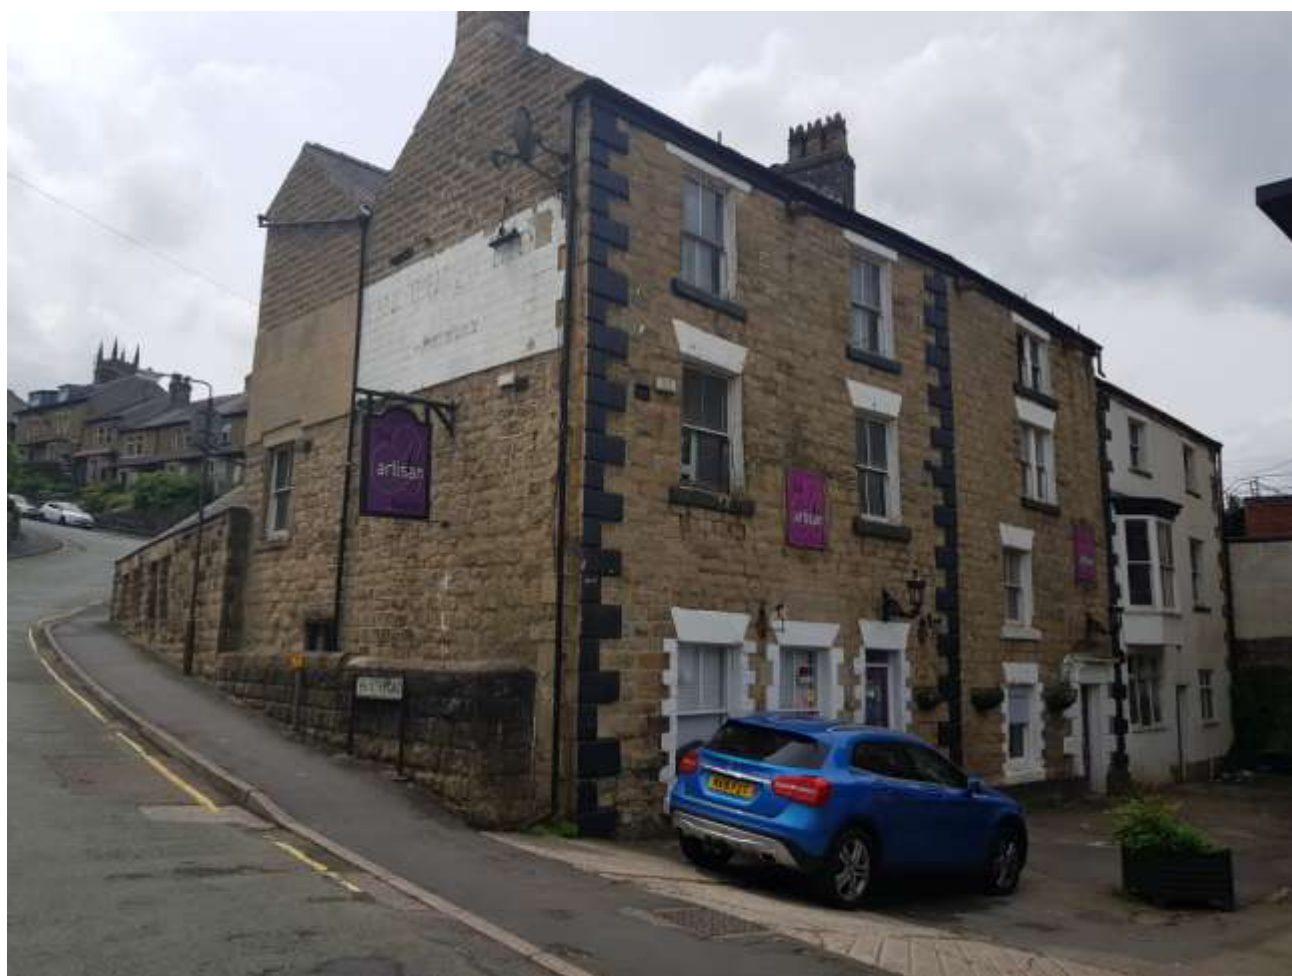
In the main the front elevation of the building consists of single glazed softwood sliding sash windows. A good percentage of these could be refurbished, stripped down, treated and redecorated to an acceptable standard, this doesn't however address the desire of the client to offer good quality accommodation that meets the needs of Building Regulations in thermal efficiency and compliance. The suggestion is to replace all joinery items with new narrow casement hardwood double glazed sliding sash units that are designed to meet the requirement of conservation and listed building standards. These windows will allow for a significantly improved elevation appearance that still respects the requirements of the listing and also the desired thermal improvements.

Numerous companies now make narrow casement double glazed units that allow for glazing bars and frame thicknesses to meet the requirements of Conservation and Listed Building standards and be accepted by same, samples will be provided by condition.

Internally all existing windows have timber lintels over that in many cases are either rotten or providing substantially inadequate support over. The retention of these units is however respected due to the general requirements of the building as a listed structure. With this in mind, the intention is to treat all existing lintels but provide steel plate support below to allow their retained use without the concerns of structural integrity.

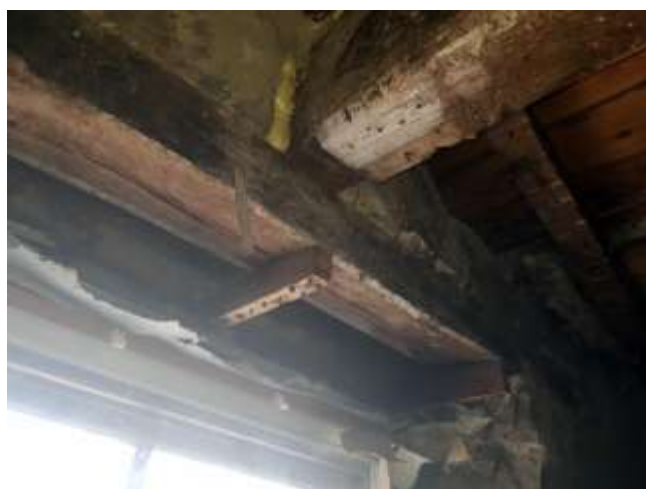
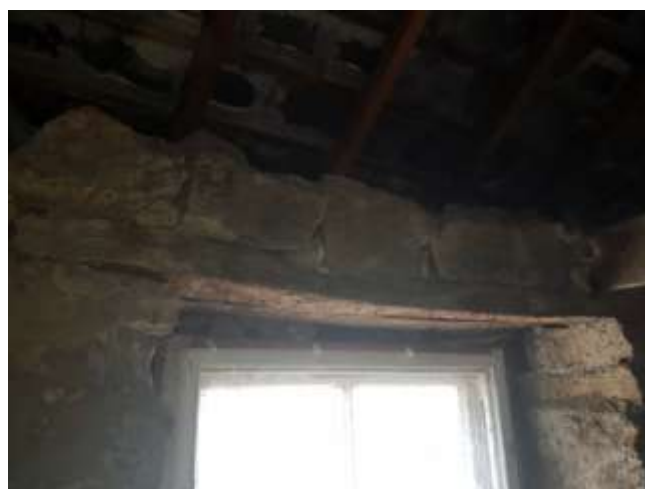
To the rear many windows are poor quality softwood plain casement units that are without doubt not original in either style or form to the original building. Their retention does not to enhance the appearance of the building or to respect its listing, thus all windows to the rear will be replaced with new sliding sash hardwood units as outlined above.

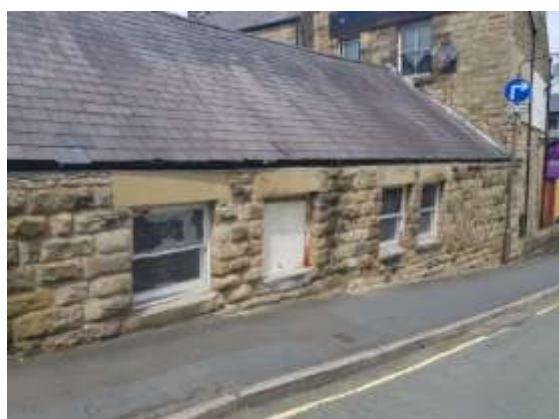
The function room building will retain the original windows that are in place to the side elevations. These units will be refurbished, treated and made good as required. Internally all units will be thermally upgraded through the use of secondary glazing.

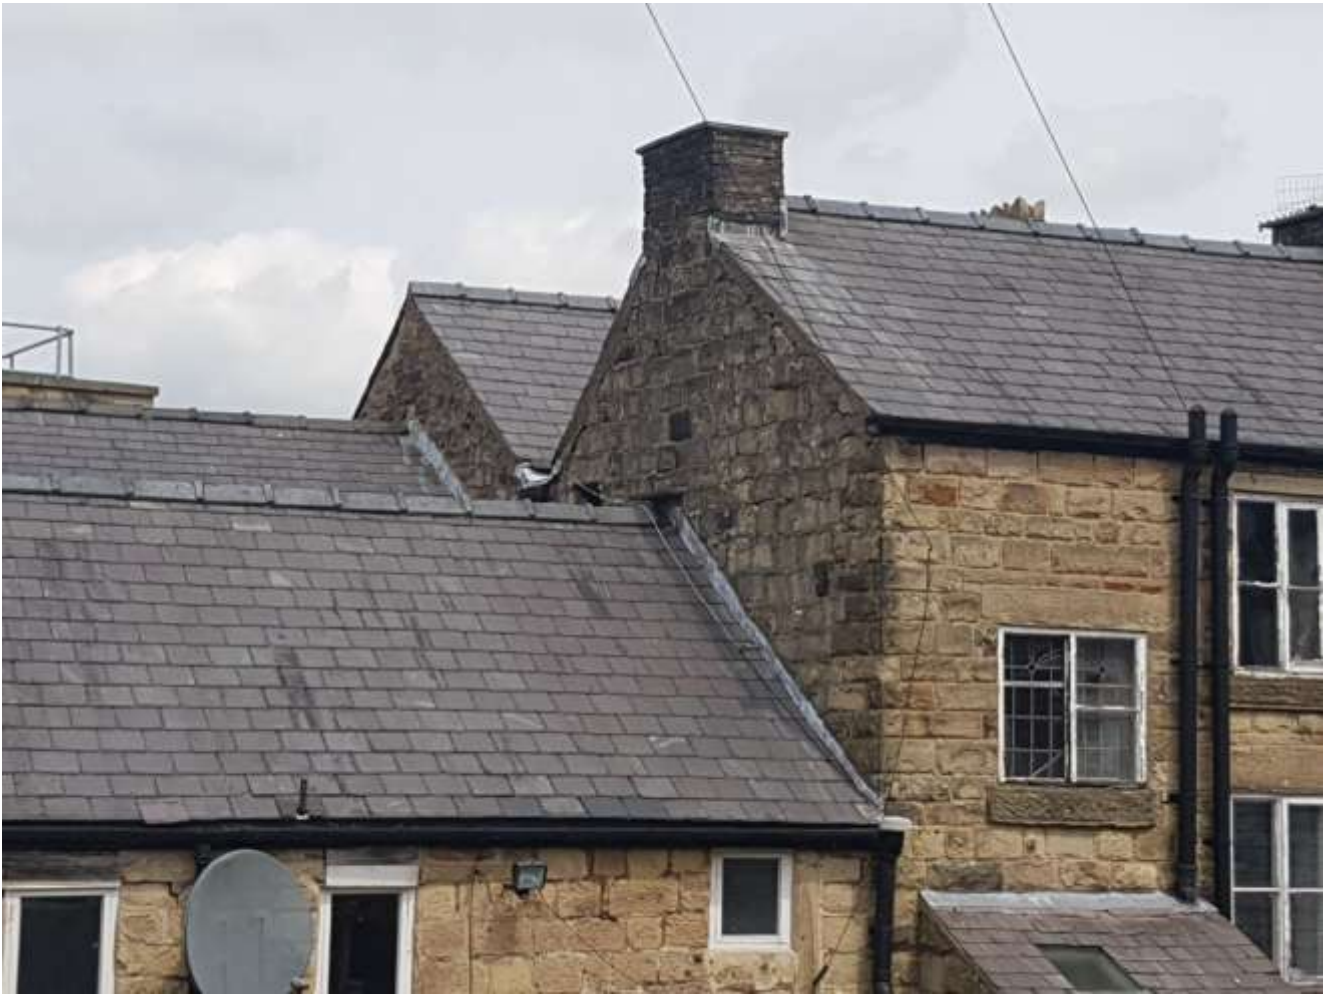
In general, the roof coverings and structure within are of a reasonable condition, they do not however in any way meet the requirements of Building Control in order to meet the proposed desire to expose character purlin and rafter features within by opening up rooms to the rake of the roofline. No roofing membranes are in place within the building (other than one very small area to the rear) and this requires rectifying to allow for both insulation and damp separation needs. In order to achieve the required standard thereto, all roof coverings are to be carefully removed and retained to be re-laid. The exposed roof structure is then to receive new timber battens with any remedial works required to be undertaken at the same time and a new Tyvek breathable membranes – at this time the secret valleys will also be replaced with all new lead work in code 5. Existing natural slate roof coverings will then be put back to the roof structure with any replacement in reclaim to match. New cast guttering will be put in place on rise and fall brackets to replace the plastic in place to date. In order to meet the requirements of Building Regulations and allow for exposed roof structure features within, the existing roofline will be insulated with either kingspan or Superquilt and under drawn with new plasterboard and skim to the rake.
