**6 Hall Bank, Buxton SK17 6EW**

**Replacement Windows to Front Elevation**

**Design and Access Statement**

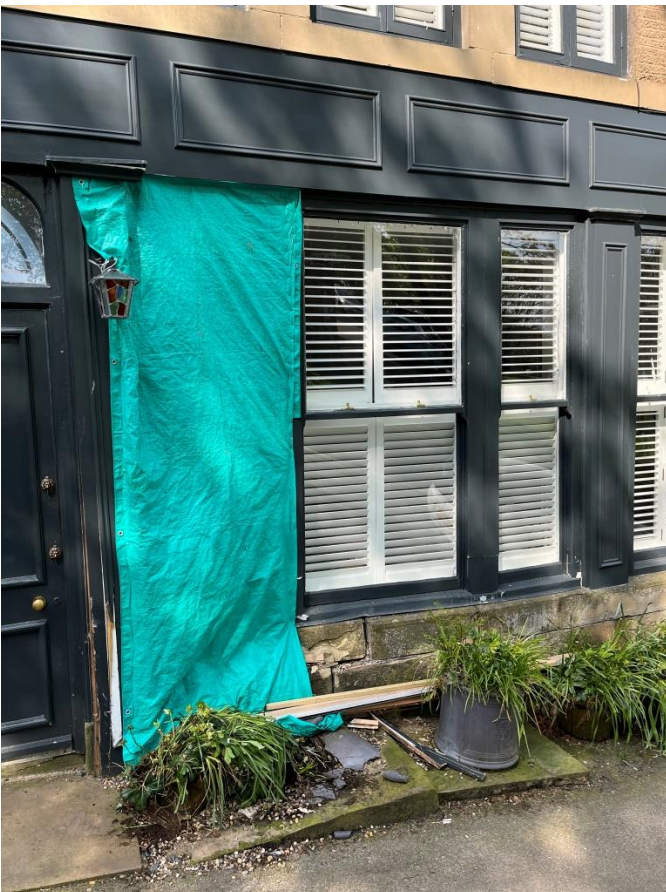
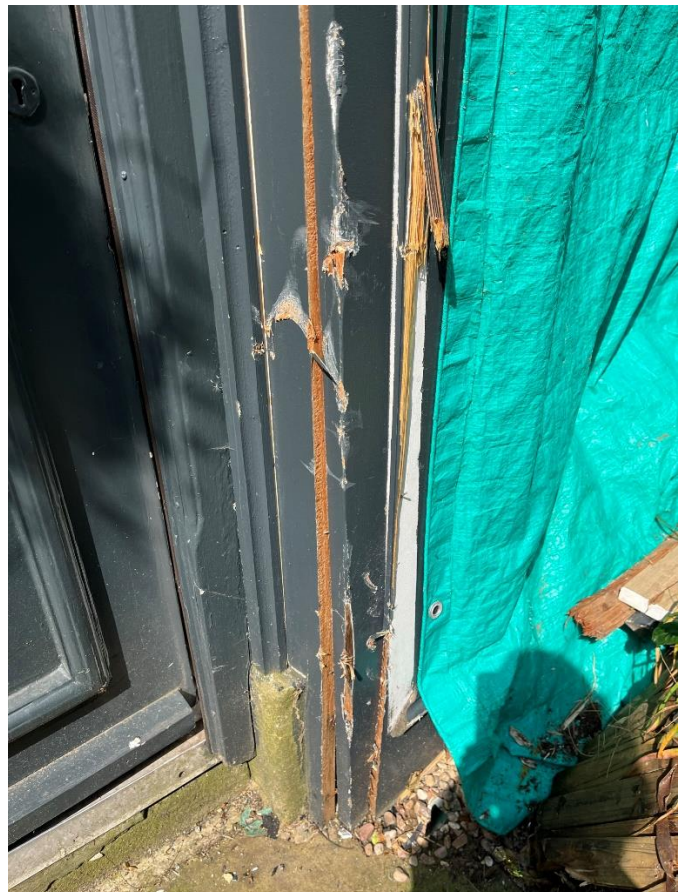
A car pulled out of the access opposite, didn't stop and crashed into the front of the building. This has damaged some of the windows and stonework below to the extent that they cannot be repaired. This application is to replace the damaged areas with construction to match the original.

The area of the building which needs repair is shown on the photograph below. The left hand window and the stonework below have been extensively damaged, and the two windows to the right of this shown on the photograph have been pushed in and are connected to the left hand window. These also need to be replaced.

These windows need replacing because they have been damaged beyond repair by a car impact. The job when complete will look the same as the original situation. Given the nature of the building and the proposal, we believe this to be an acceptable proposal and request that listed building consent be granted.

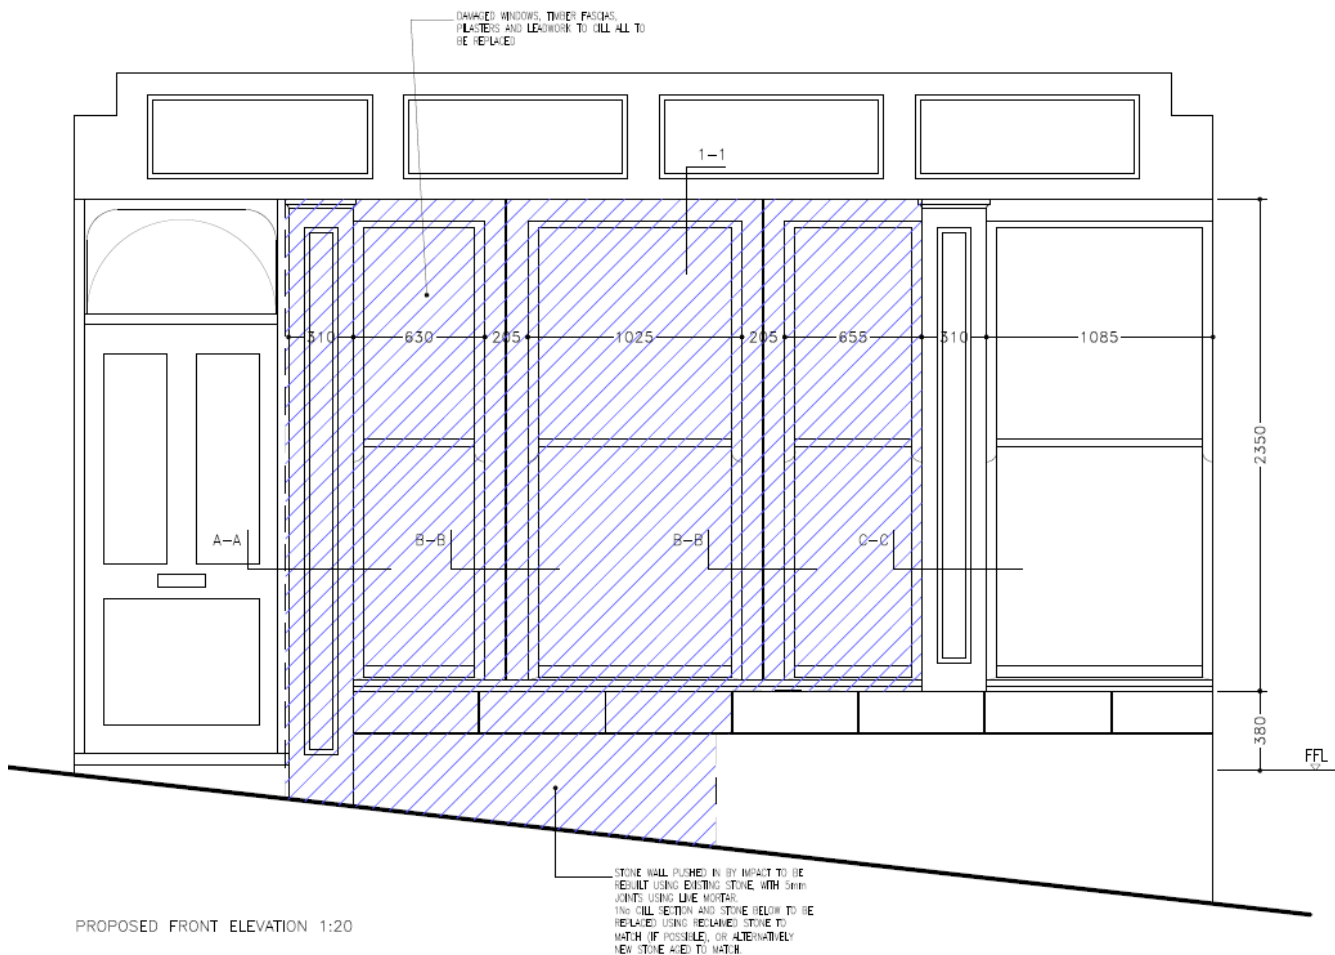
The drawing below shows the extent of replacement works required. The existing entrance door to the left and window to the far right of the drawing can be retained. The intention is for all details to exactly match the existing windows. The only proposed change is for double glazing rather than single glazing. This is our client's living room which is right on a busy road and which is heavily glazed. Having double glazing will make the room quieter as well as warmer.
