**6 Hall Bank, Buxton SK17 6EW**

**Replacement Windows to Front Elevation**

**Heritage Statement**

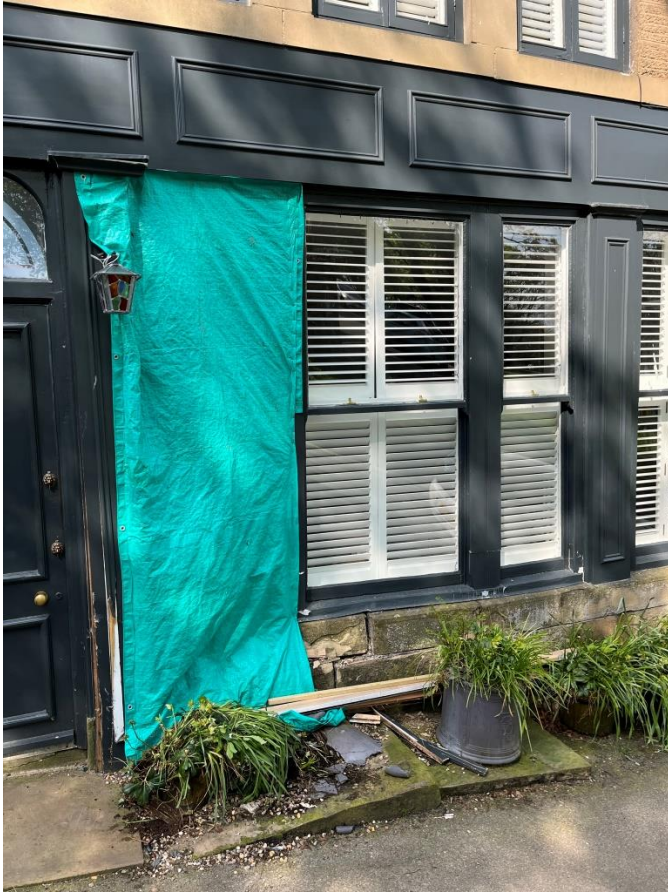
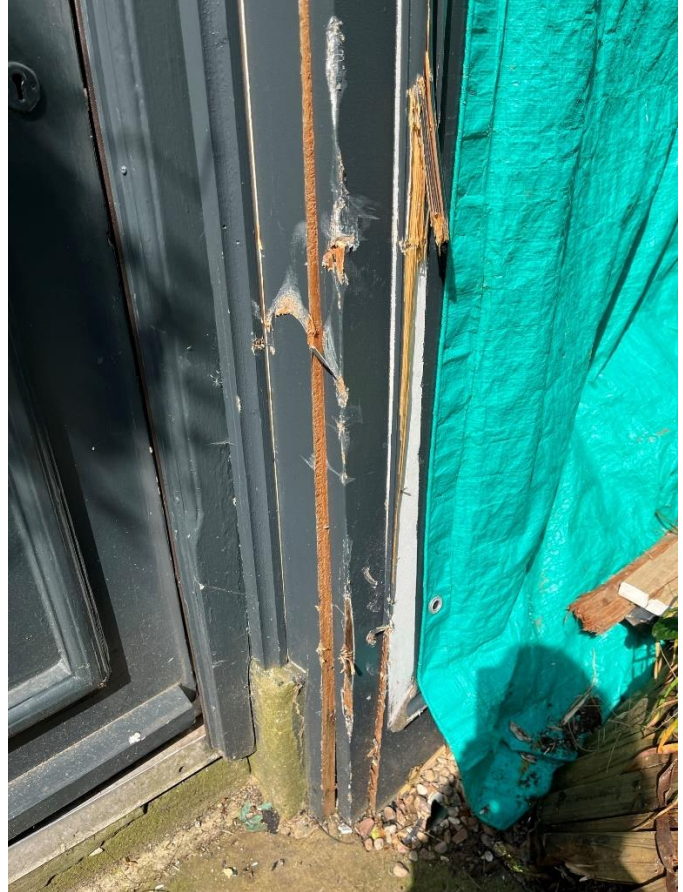
A car pulled out of the access opposite, didn't stop and crashed into the front of the building. This has damaged some of the windows and stonework below to the extent that they cannot be repaired. This application is to replace the damaged areas with construction to match the original.

This area of the building is shown on the photograph below. The left hand window of the tripartite sash and the stonework below have been extensively damaged, and the two windows to the right of this shown on the photograph have been pushed in and are connected to the left hand window. These also need to be replaced.

The drawing below shows the extent of replacement works required. The existing entrance door to the left and window to the far right of the drawing can be retained. The intention is for all details to exactly match the existing windows. The only proposed change is for double glazing rather than single glazing. This is our client's living room which is right on a busy road and which is heavily glazed. Having double glazing will make the room quieter as well as warmer.
