| Project: | | Client: | |
| The Cheshire Cheese<br>37-39 High Street<br>Buxton<br>SK17 6HA | | Everards of Leicestershire | |
| Outbuilding - Proposed Plans and Elevations | | | |
| 3838.PL04 | | A | |

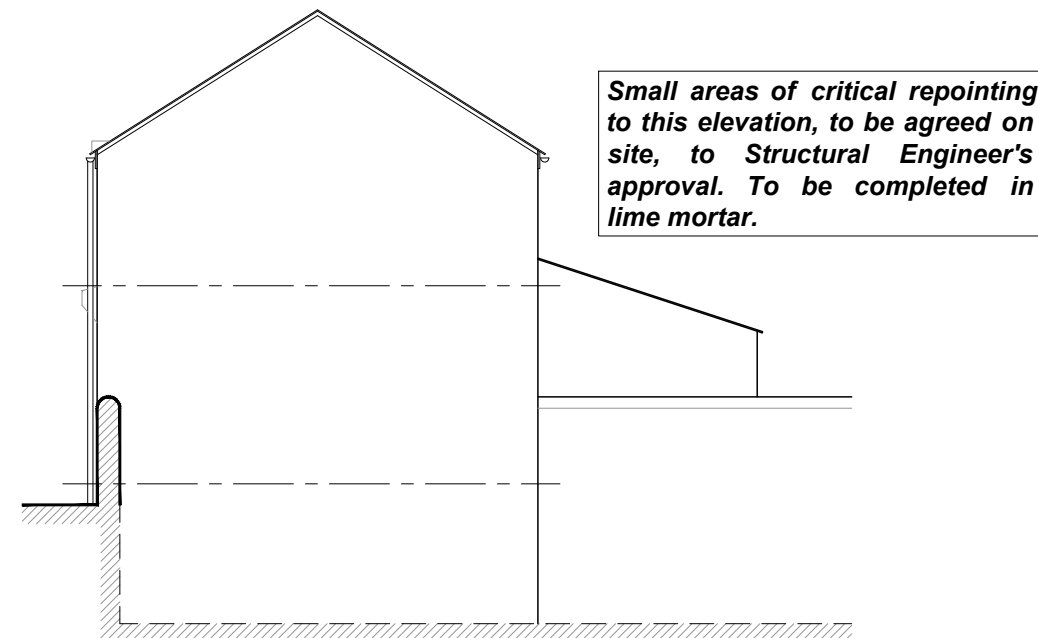
Front Elevation (SW facing)  
Scale 1:100

Small areas of critical repointing to this elevation, to be agreed on site, to Structural Engineer's approval. To be completed in lime mortar.

Remedial wall ties to be installed between the outer and inner skin of the whole front elevation to Structural Engineer's specification.

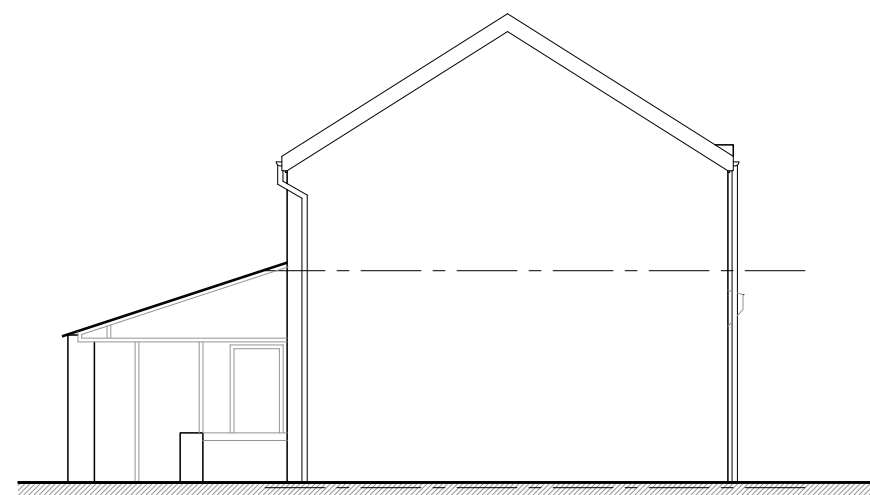
Rear Elevation (NE facing)  
Scale 1:100

Small areas of critical repointing to this elevation, to be agreed on site, to Structural Engineer's approval. To be completed in lime mortar.
