Re: Listed Building Consent at Laneside Cottage, Charley Lane SK23 6DY

Subject: Relaying stone slates and replacing decayed timbers and repointing chimneys.

# Roof Assessment at Laneside Cottage

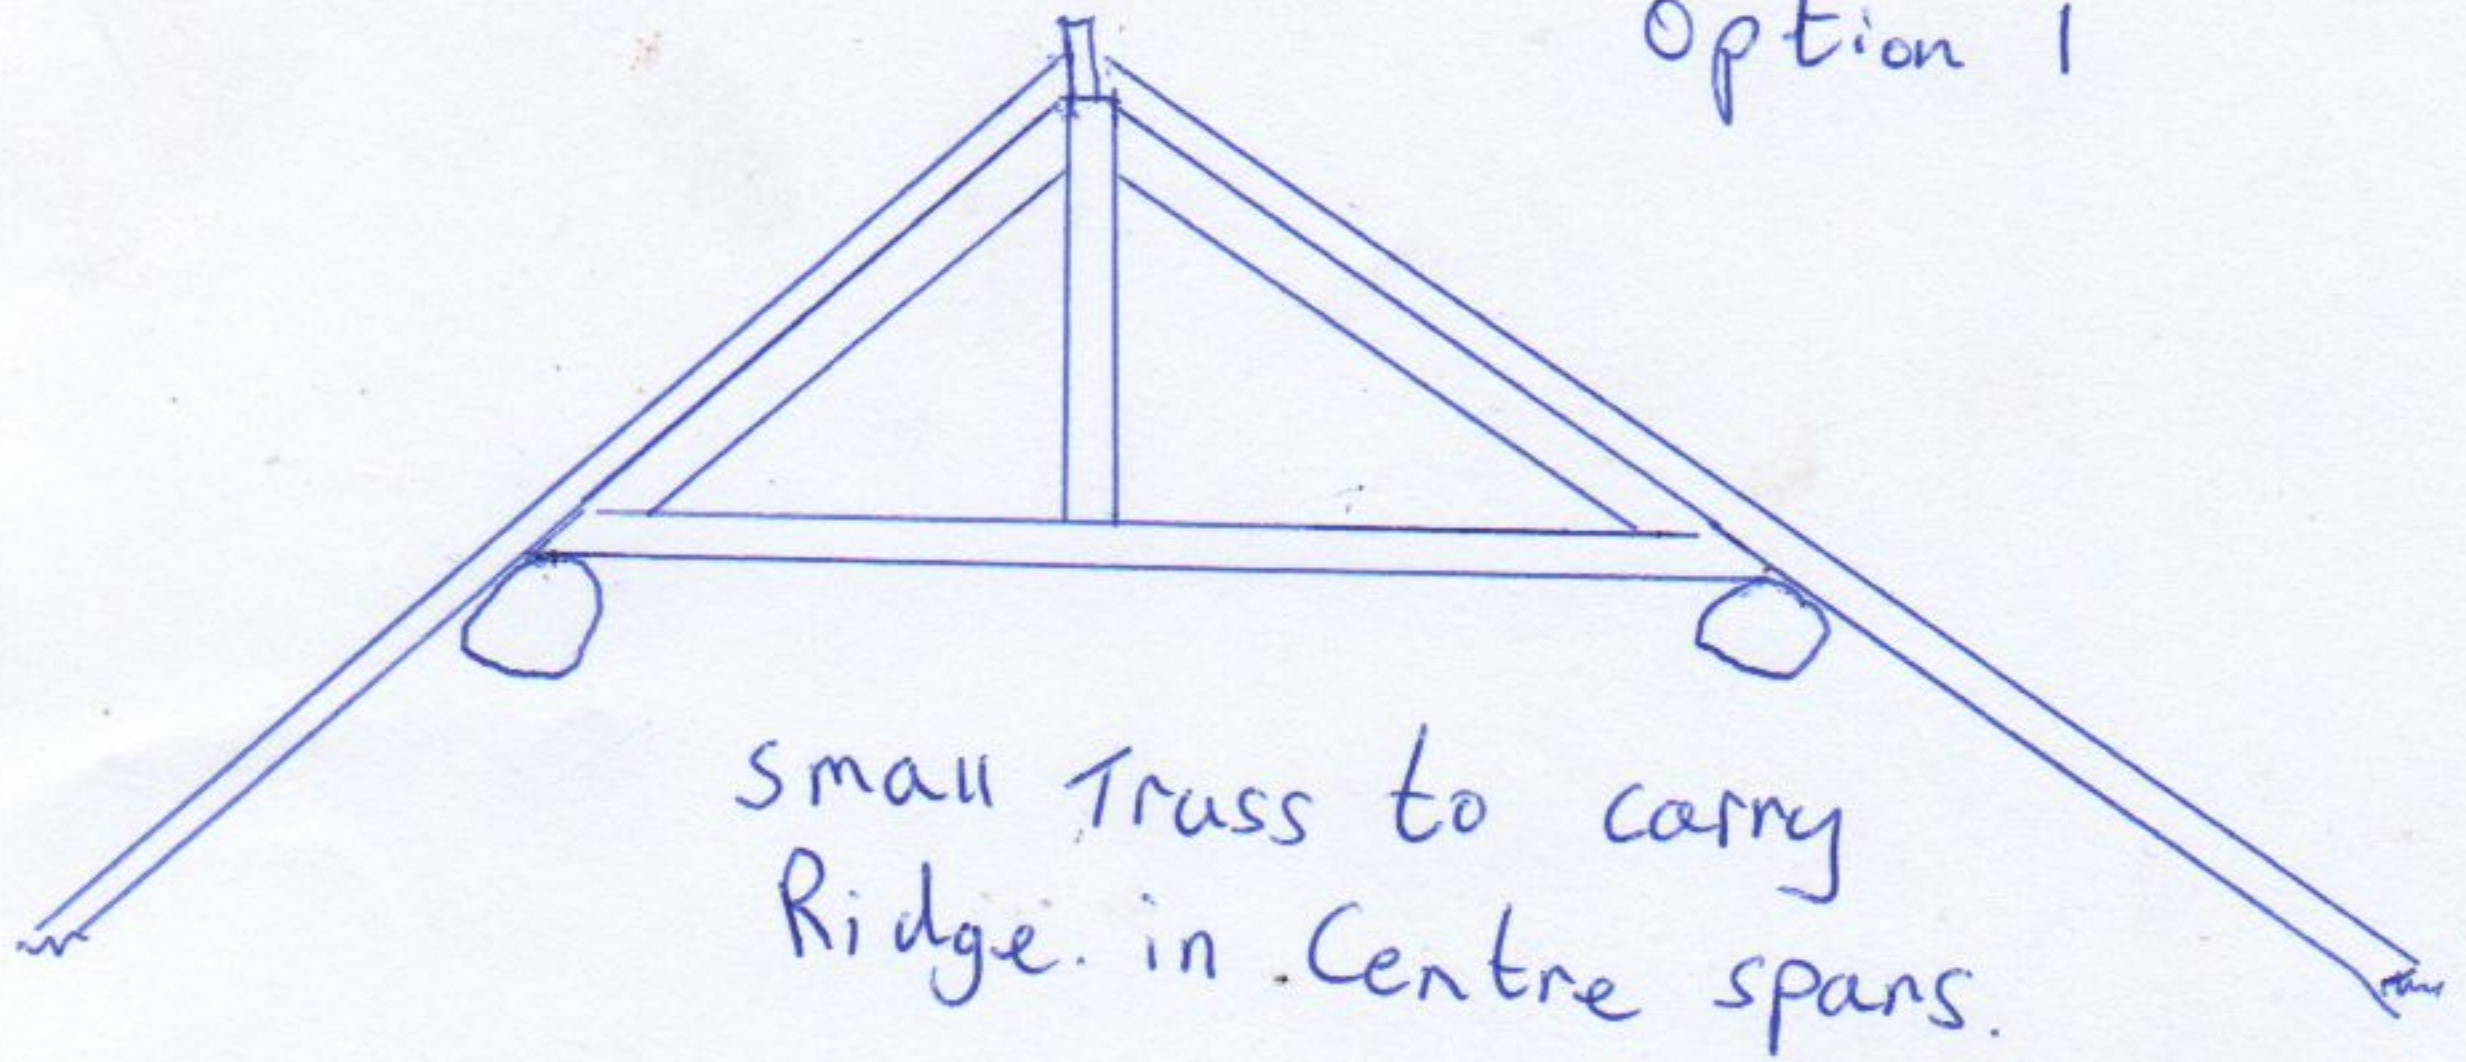
Not original ridge board

Ridge beam has been replaced with ridge board. This is inadequate, as a result sagging of the ridge.

Option 1 - Support sag of ridge board with two small trusses sat on upper purlins.
