# Heritage Impact Assessment

The purpose of this assessment is to ascertain the potential impact of repairing some of the principal timber beams at Ladyshawe House using metal flitching plates.

5.2 Summary of Proposals

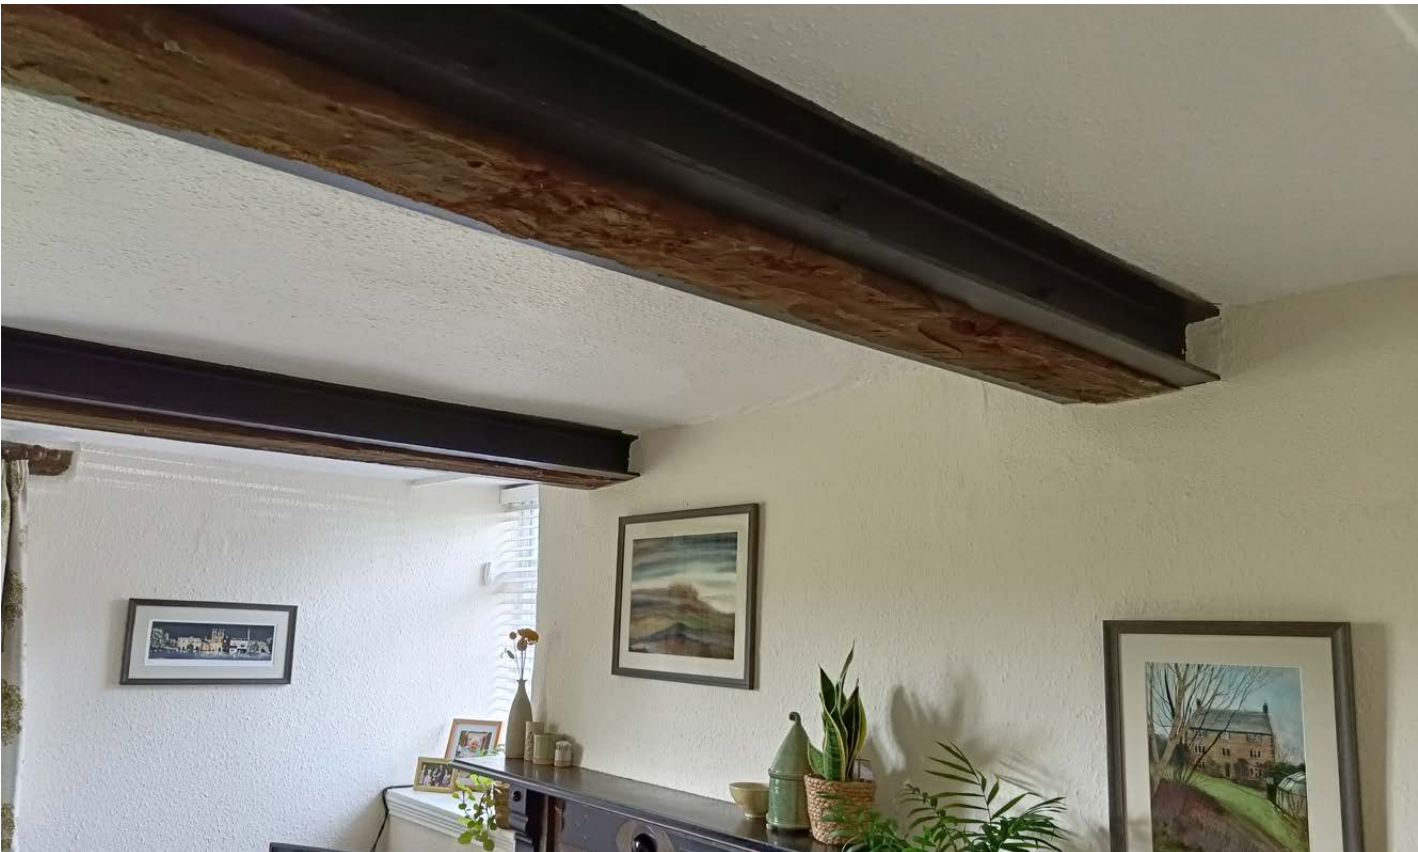
| Beam 7 | Possibly original 18th century | Beam flitched previously, application to regularise works |
| Beam 8 | Possibly original 18th century | Beam flitched previously, application to regularise works |

Figure 18 Beams 7 and 8 already flitched

Some of the primary beams in Ladyshawe House contain defects which are causing excessive deflection and are therefore not adequately supporting the floors. The proposed method of flitching the beams has been chosen to preserve original or historic timbers. Beams 7, 8, 11 and 12 are thought to be of the original 18th century date and the others are later, but generally historic. The original beams were hand sewn and have an age and patina that cannot and would not want to be replicated. Although repairs using flitching plates has quite a high visual impact, this is considered preferable to splice repairing the beams, which would involve the removal of original or historic fabric where it exists. A further advantage to this repair method is that the plates could be removed in the future (with adequate temporary propping) and a splice repair could still take place.

Beams 7, 8 and 12 were flitched almost 10 years ago when the current owner moved into Ladyshawe House. These beams had previously had metal brackets fitted, which on the advice of a structural engineer at the time, were not sufficient given the defects to the beams. The flitching method was therefore proposed and the building owner was unaware at the time that consent was required, but this later became apparent. Retrospective consent is therefore sought for the flitching plates applied to Beams 7, 8 and 12. The impact on the significance of Ladyshawe House in relation to these beams is the same as that for Beams 1, 2 and 3.

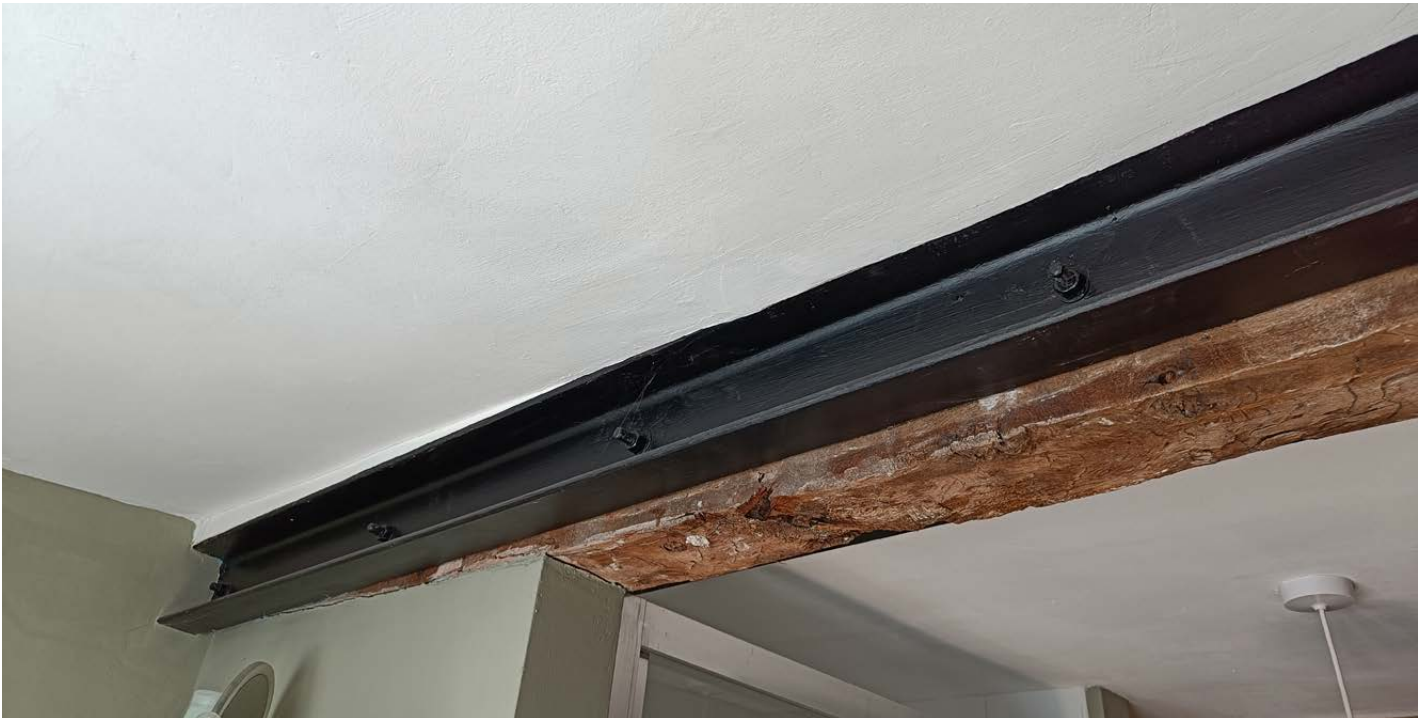
| Beam 12 | Possibly original 18th century | Beam flitched previously, application to regularise works |

Figure 19 Beam 12 already flitched

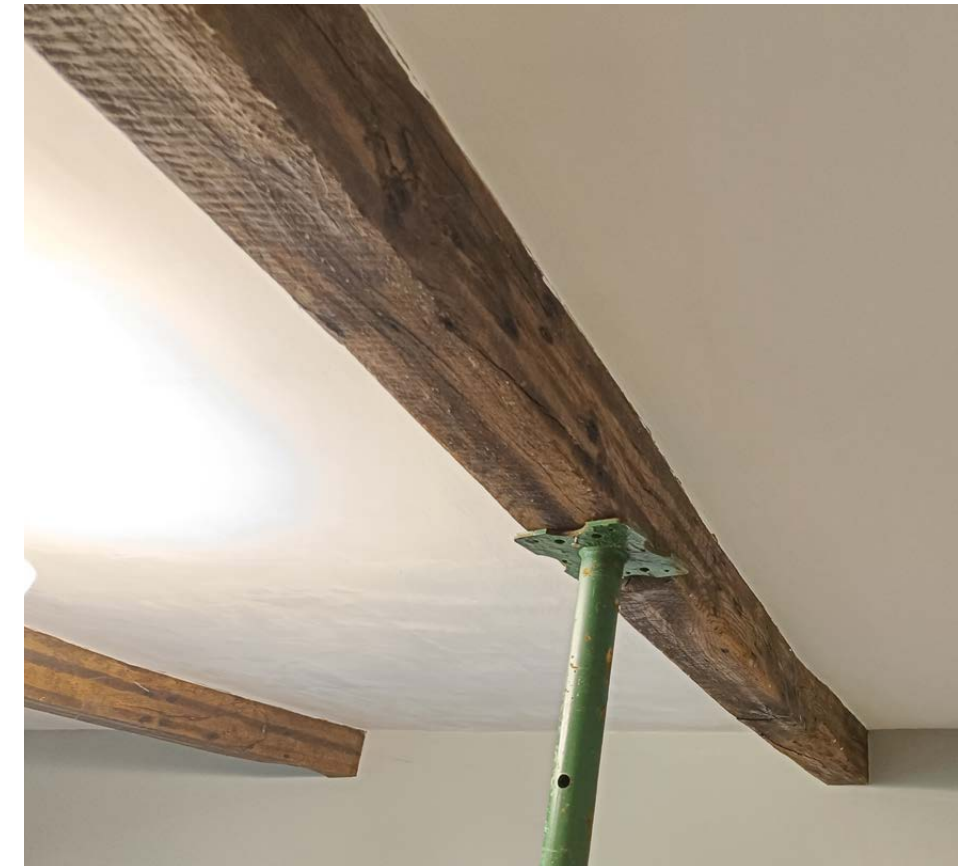
| Beam 1 | Historic, unlikely to be original | To be flitched |
| Beam 2 | Historic, unlikely to be original | To be flitched |

Figure 20 Beams 1 and 2 proposed to be flitched

The flitching plates would be fixed to either side of Beams 1,2, and 3, with the sections bearing on the masonry walls by 100mm. Creating this pocket causes loss of historic masonry in isolated areas of wall, but on balance this is much less than the percentage loss of timber that would be removed if a splice repair method was adopted. The proposed method of repair, combined with the ability to remove the flitching plates, is considered to cause a negligible level of less than substantial harm to the Grade II listed building, which is outweighed by preserving the structural integrity of the building, with minimal loss to original or historic fabric.

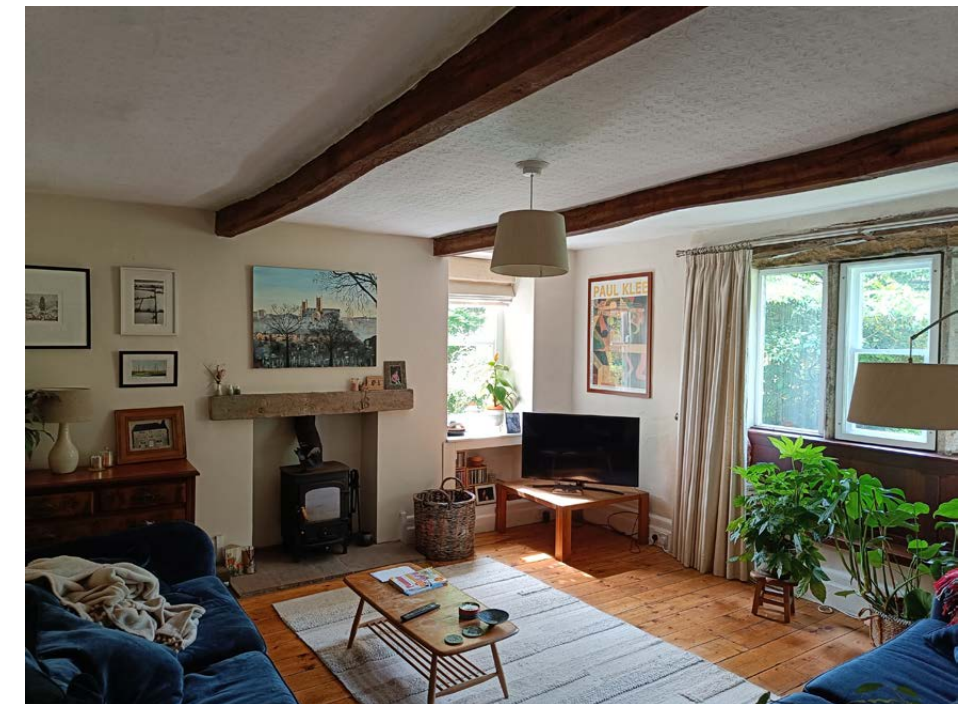
| Beam 3 | Historic, unlikely to be original | To be flitched |

Figure 21 Beam 3 (nearest window) proposed to be flitched
