RICHMOND CONSULTANTS

## CONDITION REPORT

### EXTERNAL WINDOWS & DOORS

1,3,5 and 8 Terrace Road  
Chapel En Le Frith  
SK23 9UZ

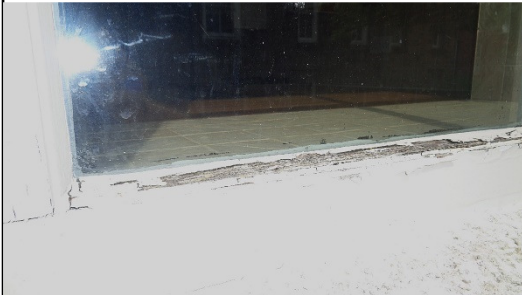
Photo 1

Remarks: Deterioration of the external glazing compound.  
Condition/Priority Rating: C2

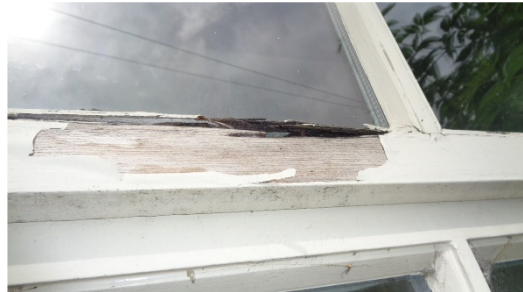
Photo 2

Remarks: Extensive decay to timber frames and deterioration of external finish.  
Condition/Priority Rating: C2

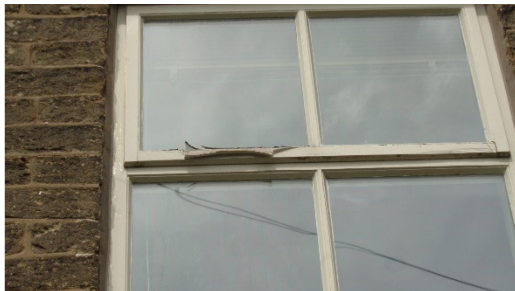
Photo 3

Remarks: Deterioration of external finishes and decay to timber frame.  
Condition/Priority Rating: C2

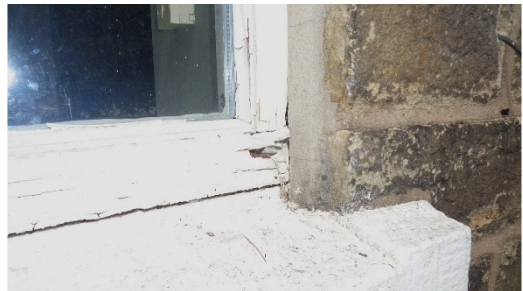
Photo 4

Remarks: Deterioration of external paint finish and timber decay to frame.  
Condition/Priority Rating: C2

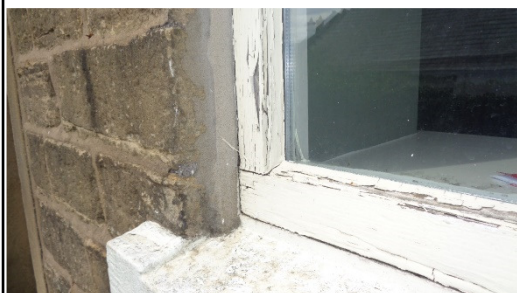
Photo 5

Remarks: Deterioration of external paint finish and timber decay to frame.  
Condition/Priority Rating: C2

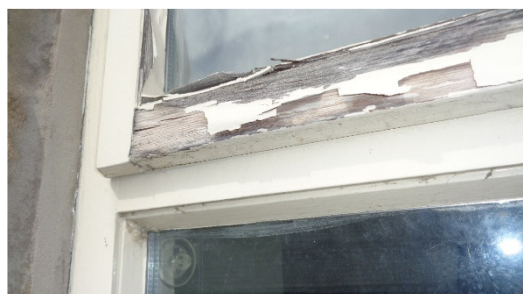
Photo 6

Remarks: Deterioration of external paint finish and timber decay to frame.  
Condition/Priority Rating: C2

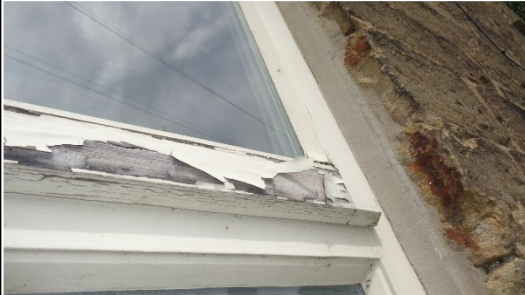
Photo 7

Remarks: Deterioration of external paint finish and severe timber decay to frame.  
Condition/Priority Rating: C2

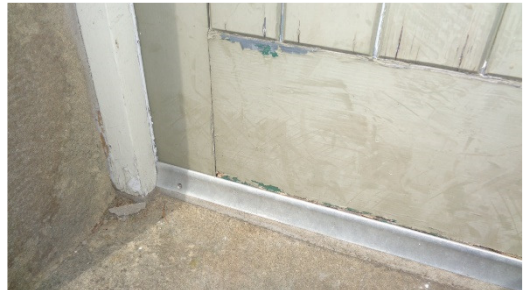
Photo 8

Remarks: Deterioration of external finish and timber decay to external doors.  
Condition/Priority Rating: C2

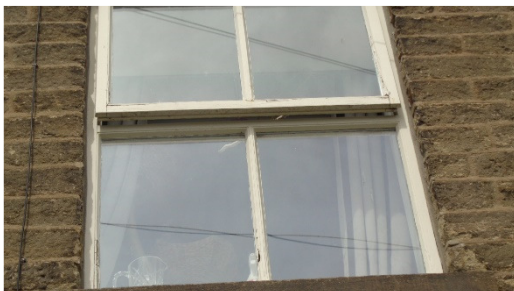
Photo 9

Remarks: Deterioration of external finish.  
Condition/Priority Rating: C2

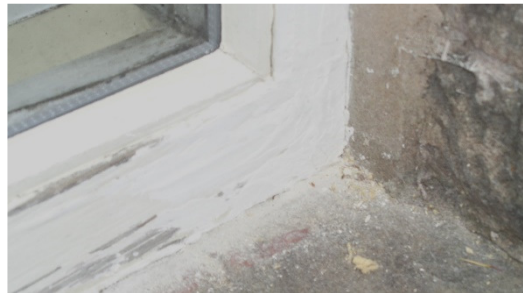
Photo 10

Remarks: Deterioration of external finish and integrity of window frame, tenants attempted repair.  
Condition/Priority Rating: C2

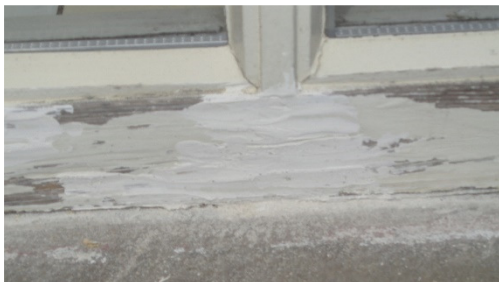
Photo 11

Remarks: Deterioration of external finish and integrity of window frame, tenants attempted repair.  
Condition/Priority Rating: C2

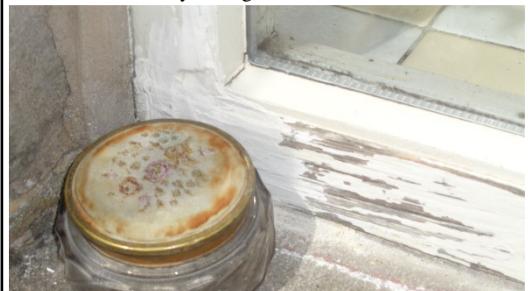
Photo 12

Remarks: Deterioration of external finish and integrity of window frame, tenants attempted repair.  
Condition/Priority Rating: C2

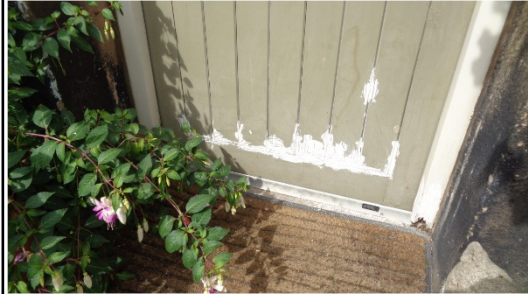
Photo 14

Remarks: Deterioration of external finish and timber decay to door frame.  
Condition/Priority Rating: C2

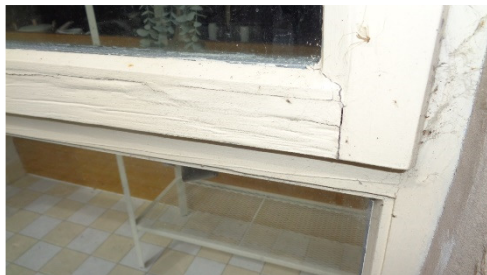
Photo 15

Remarks: Deterioration of external paint finish and timber decay to frame.  
Condition/Priority Rating: C2

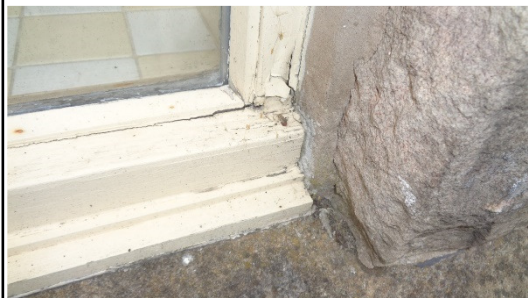
Photo 16

Remarks: Deterioration of external finish and timber decay to frame.  
Condition/Priority Rating: C2

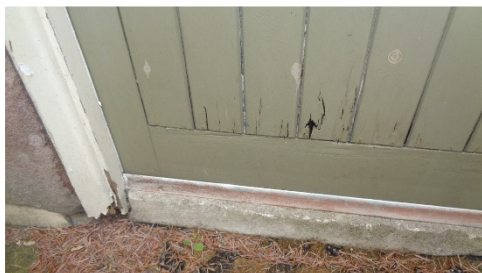
Photo 17

Remarks: Deterioration of external finish and timber decay to frame.  
Condition/Priority Rating: C

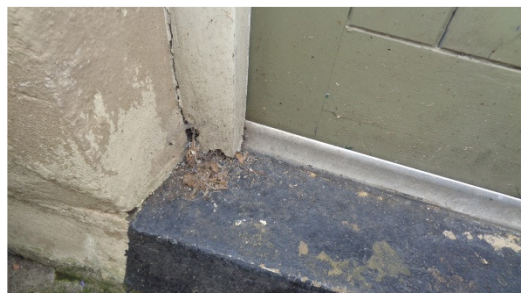
Photo 18

Remarks: Deterioration of external finish and timber decay to frame.  
Condition/Priority Rating: C2
