## Survey Report

**Agricultural Barns 1, 2, 3 and 4  
Ravens Leach Farm,  
Birch Vale**

September 2024

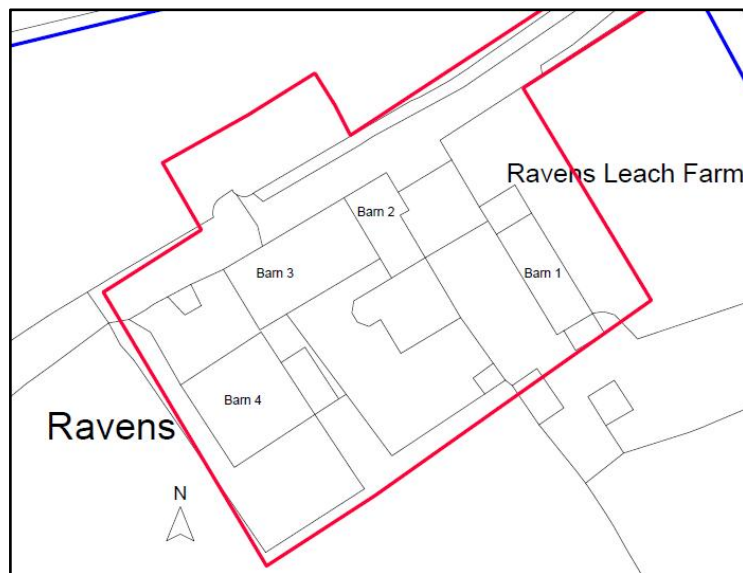
Figure 1: Location of Barns

For the purpose of this report Figure 1 identifies Barns 1 - 4.
