HPK/2025/0015 and HPK/2025/0016

**Proposed Internal Alterations at:**  
17 Broad Walk, Buxton SK17 6JR

# Your survey report

Flat 1., 17 Broad Walk, Buxton, Derbyshire, SK17 6JR

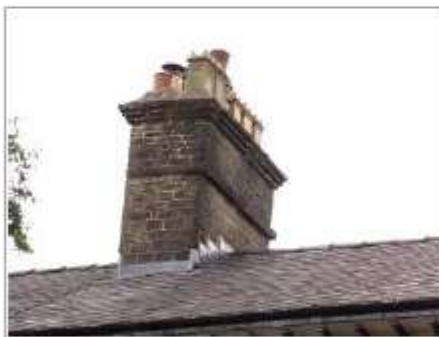
The left chimney of the building is shared with the neighbouring property. There are six flues and six chimney pots and there is a lead flashing at the join of the roof covering. The stone coping is eroded. This should be repaired soon. **2**

Shared chimney

Repair chimneys soon.

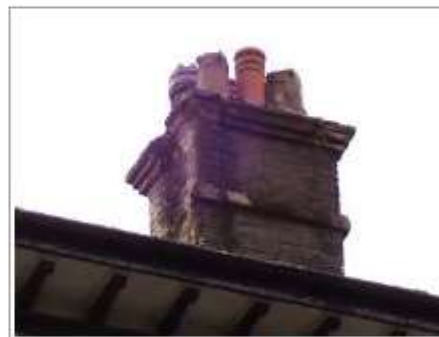
The right chimney is built of stone and has six flues and six chimney pots with a lead flashing at the join of the roof covering. There are gaps to the coving to the top right. Patch repairs have been carried out. Parts of the stone are eroded or missing on the left-hand side.

Left side of chimney

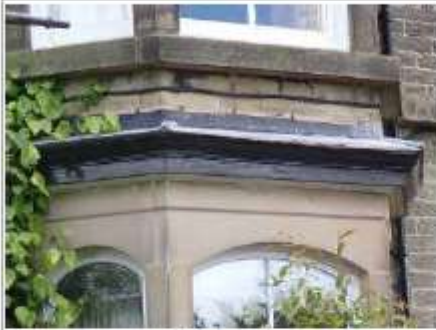
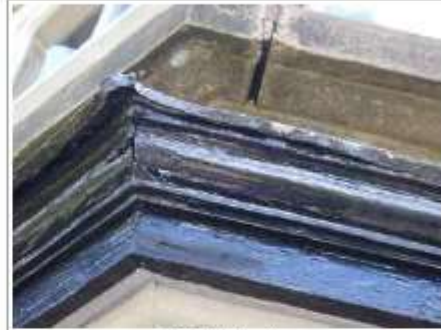
The left and right bays have lead coverings above the ground floor. The edges are painted. The edges have lifted revealing gaps where the nail fixings have fallen away.

Right bay roof

Right-deteriorating

This should be repaired soon.

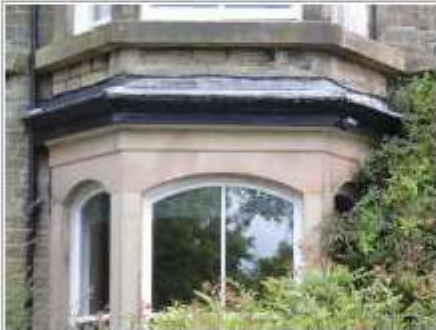
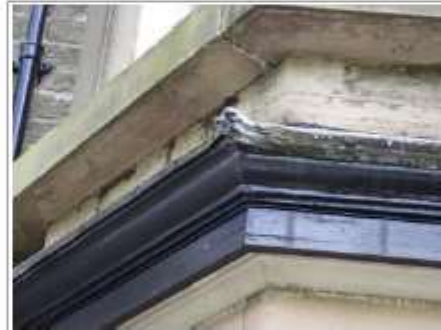
Left bay roof

Edges-deteriorating

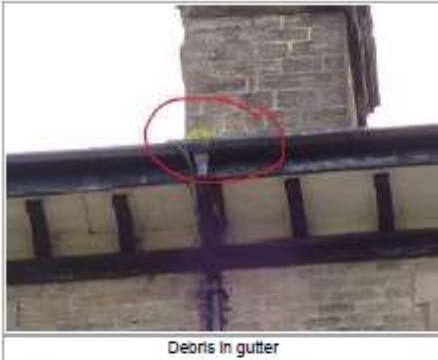
Debris in gutter

Repair external rainwater fittings soon.

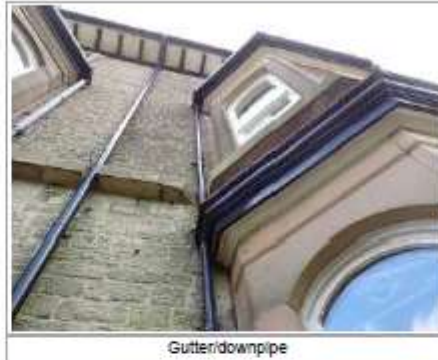
The rear main gutter has a uPVC gutter and downpipe. There is a cast-iron downpipe and this has peeling, flaking paintwork and is corroded and will need to be replaced.

Gutter/downpipe

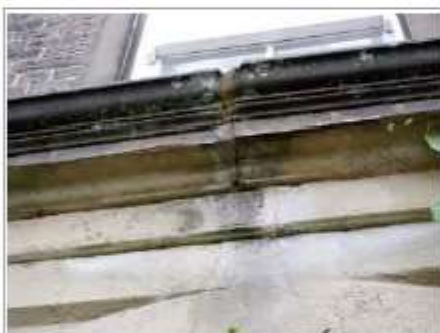
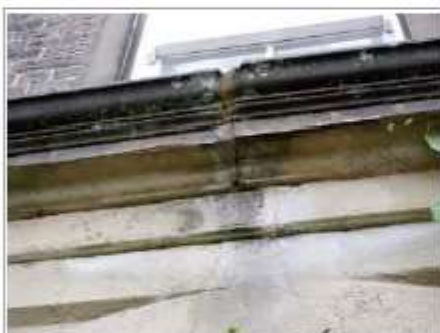
There is an eroded band course to the top left above the bay. There is an eroded arch above the front door and spalling, loose and cracked stonework which may fall.

Cracked-front door

Repairs are required soon.

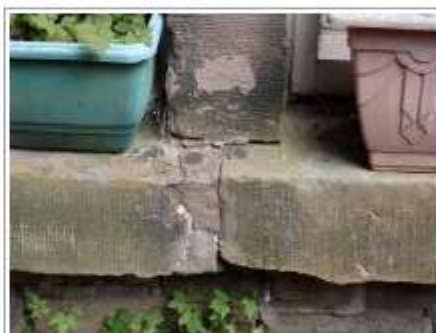
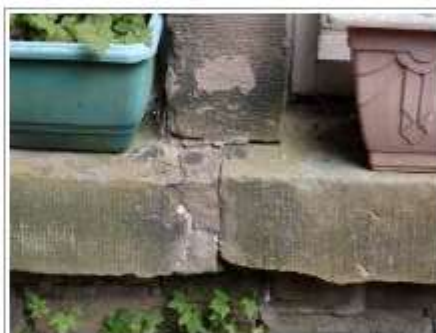
Eroded stonework

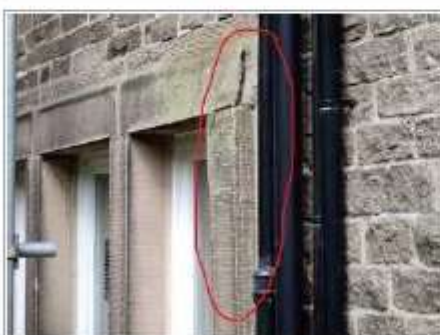
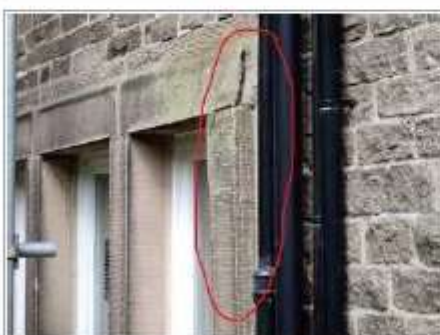
Side-split stonework

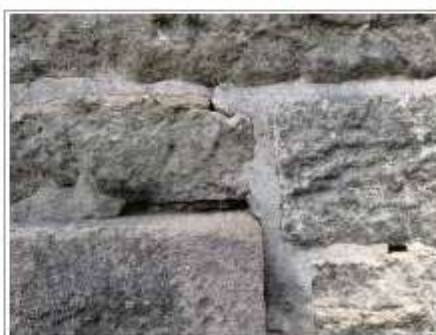
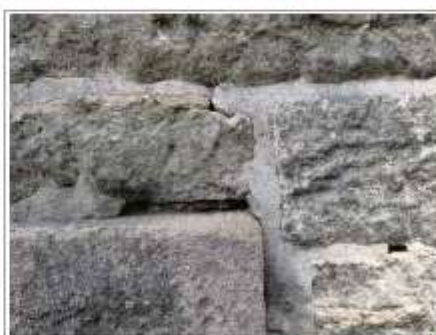
The ground floor left window has a cracked sill and needs repointing, and also the first floor left window. A cement repair has been carried out to a crack which has been poorly filled and this needs to be re-done with lime mortar.

Cement pointing

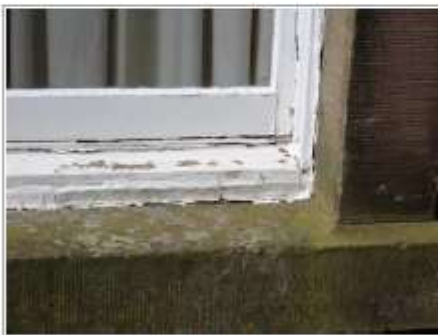
The ground floor centre side bedroom window is original. This has single glazing and rotted sills. The glass is cracked and the interior of the window box frame is damaged and needs overhauling. There is peeling, flaking paintwork outside.

Rotting timber frame

Overhaul and repair external windows soon.

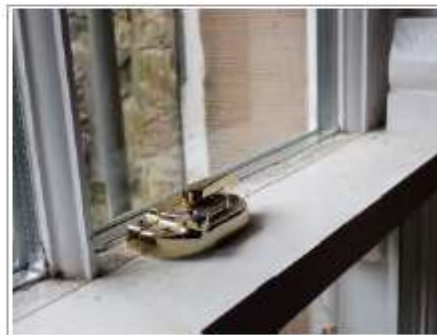
The kitchen window has a broken barrel.

Broken barrel

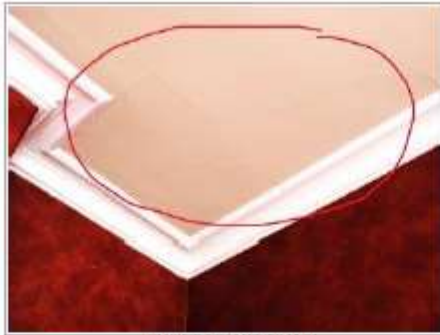
The ground floor right sitting room has a lath and plaster ceiling with coving. The ceiling is uneven, loose and cracked.

Cracked-right reception

Overhaul/repair/replace all ceilings now.

Lath and plaster ceilings are difficult to repair as large areas will be dislodged by the repair work itself. In these cases, complete replacement may be required.

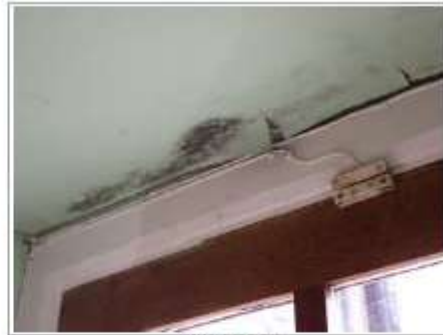
The hall ceiling is made from lath and plaster and is cracked.

Mould-hallway

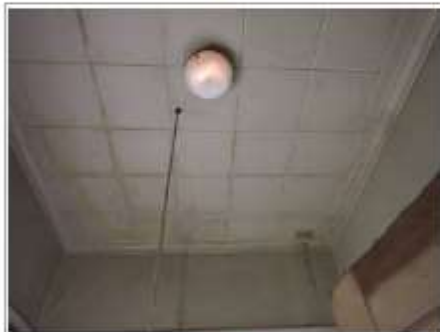
The shower room and W.C. ceiling have polystyrene tiles applied. These are a fire risk and can often mask poor ceilings.

Polystyrene tiles

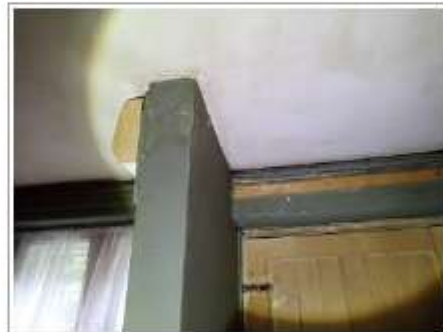
The utility room ceiling is plastered. This is undecorated and appears to have been replaced recently. This may have been carried out as a result of a leak from the flat above.

Utility ceiling

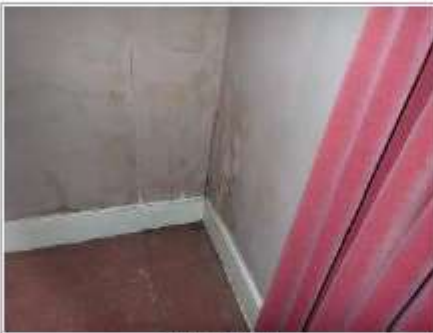
Bedroom Two rear left - Damp to rear wall, especially rear left corner, with low damp readings to the chimney.

Damp-bedroom

I recommend you arrange for a damp treatment specialist to carry out an inspection and prepare a report and estimate for treatment of the damp under long term guarantee.

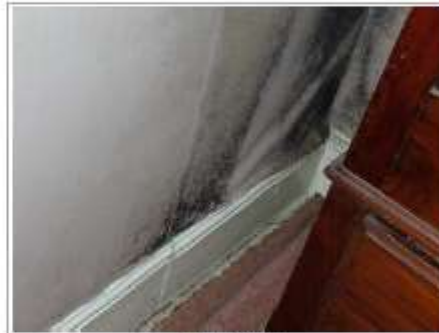
Bedroom rear right - Papered, mouldy and damp to front right, front left and to the window reveals.

Right bedroom

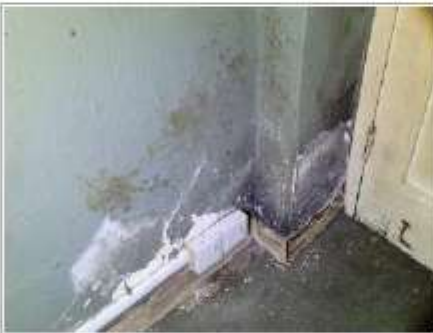
Mould and damp

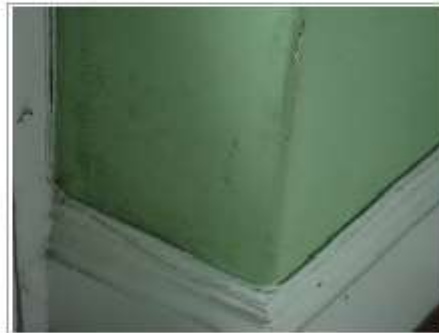
Vestibule - Loose and mouldy plaster either side of the entrance door.

Mould-vestibule

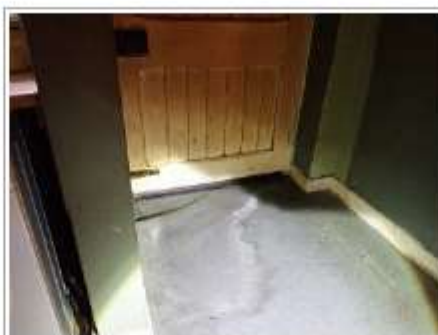
Water staining

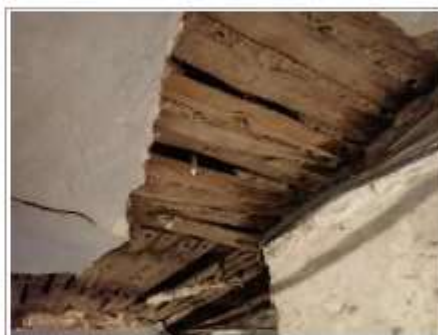
The cellar has a stone floor. The walls are made from stone and the ceiling is made from lath and plaster. This is general uneven and cracked with areas which have fallen down revealing the timber laths behind.

Cellar ceiling

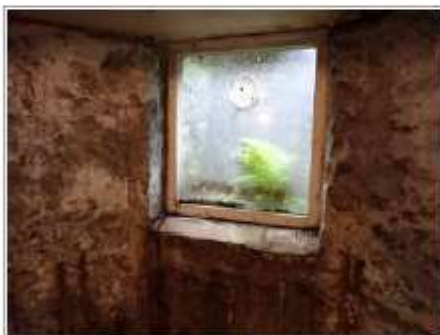
Timber wall shelving has been removed from the front left cellar area. The remaining supports show signs of woodworm rot and decay.

Rotting frames

I recommend you improve the ventilation to the cellar and remove any rotted woodworm and rot

infested timber, for example old door frames etc., to prevent a spread of rot and decay elsewhere.

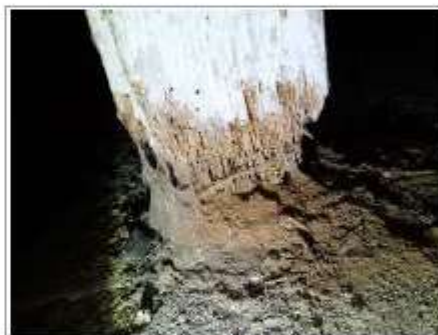
Wood rot

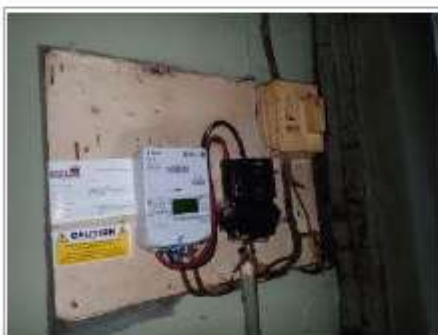
There is a mains electricity supply. The meter and consumer unit are located in the utility room. The meter and consumer unit are located at height. In order to rear the meter and adjust the fuses it will be necessary to use portable steps. This is a safety hazard as there is risk of falls from height. (see **Section I3 Risks**).

Meter-utility

You should arrange for a suitably qualified person to carry out inspection of the electrical installation system now. Although I do not know the full extent of the repair works necessary, it seems likely that a complete rewire may be required.

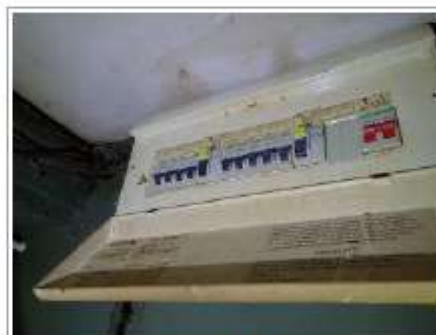
Consumer unit-utility

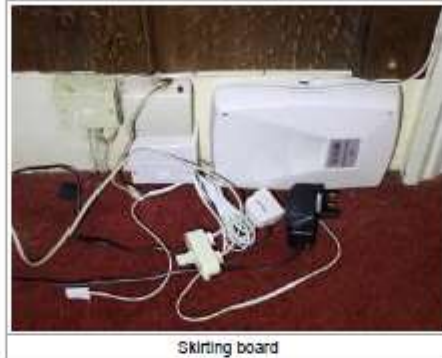
The wiring in the property, as well as the sockets and switches, is regarded as being dated. For example, there are surface power points some of which are mounted on skirting boards, some inset and there are exposed wires to appliances throughout the property. Also, the electrical installation is not covered by a current inspection and testing certificate and the plastic consumer unit is mounted on a timber board. These are all safety hazards (see **Section I3 Risks**).

Skirting board

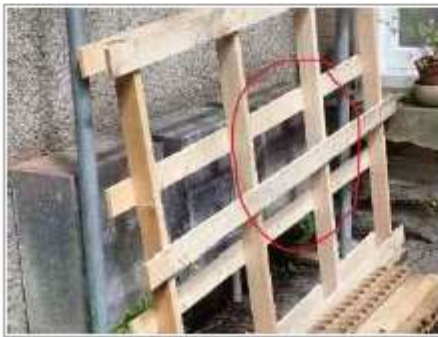
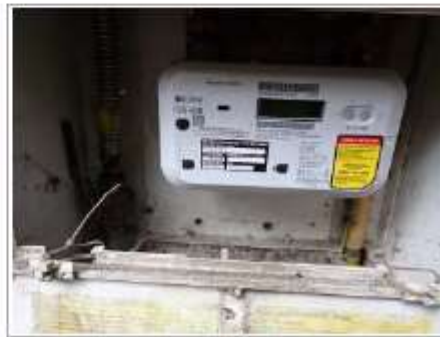
The gas meter is contained in an external meter cabinet to the rear of the main building. The door of the cabinet is broken. The gas supply system is not covered by a current inspection and testing certificate and this is a safety hazard (see Section I3 Risks).

Meter location

Meter-side wall

You should arrange for a suitably qualified person to carry out an inspection of the gas installation system now.

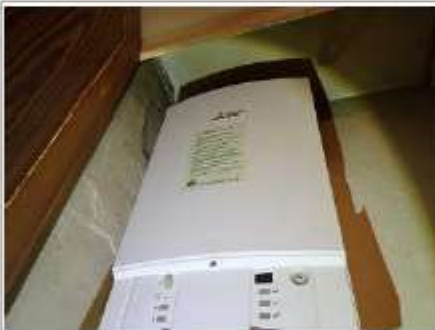
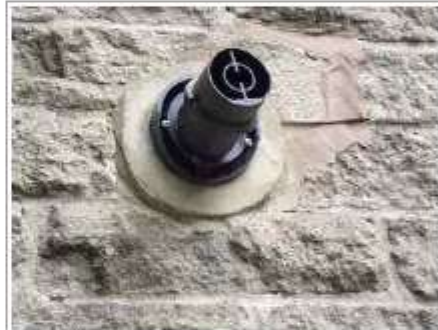
I saw no evidence of any service conducted on this appliance over the last 12 months. This is a safety hazard (see Section I3 Risks).

Gas fired boiler

Gas boiler

You should arrange for a suitably qualified person to carry out a service of the boiler and general appraisal.
