# **Design, Access and Heritage Statement**

*November 2018*

**Repairs and partial rebuilding of the external envelope  
at 3 and 5 Laneside Road, New Mills SK22 4LX**

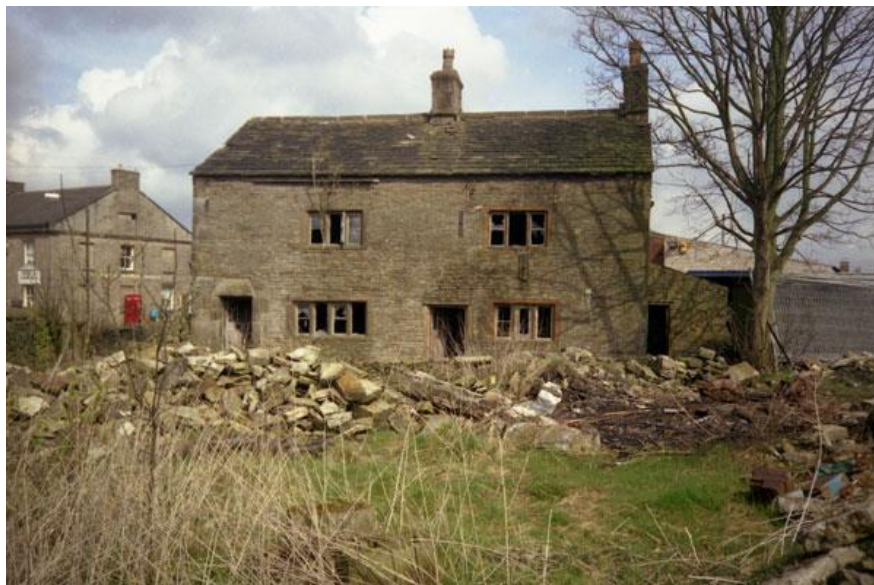
**Figure 1: 3 and 5 Laneside Road Circa 1970**

Figure 1 (above) shows the front (South) elevation of the property Circa 1970. This shows a lean-to addition to the property (date of construction unknown) on the east side elevation which has been removed (date unknown).

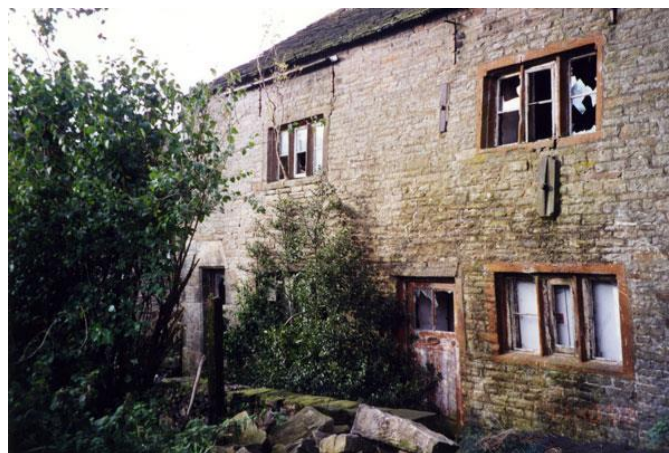
**Figure 2: Front Elevation (Part) Circa 1990**

Figure 2 shows the front (South) elevation of the property Circa 1990. The door in the photograph is unlikely to be the original. The windows appear to be painted timber casement with a single central horizontal glazing bar. The condition of the front wall is similar to that currently.

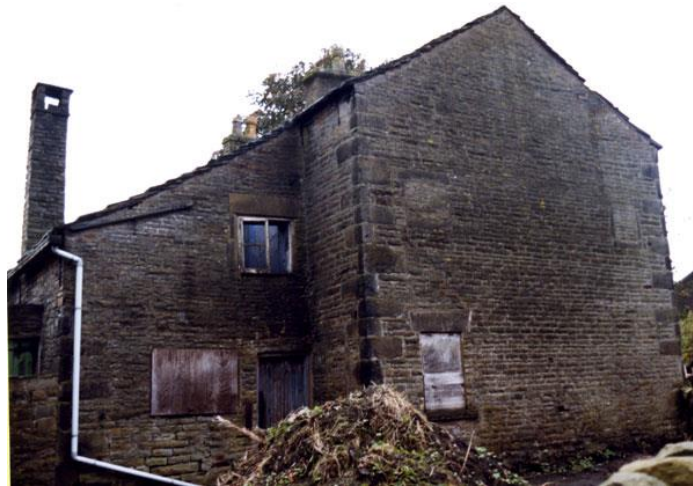
**Figure 3: Side (West) elevation Circa 1990**

Figure 3 shows the side (West) elevation of the property Circa 1990. There are 2 first floor window opening which have been blocked up.

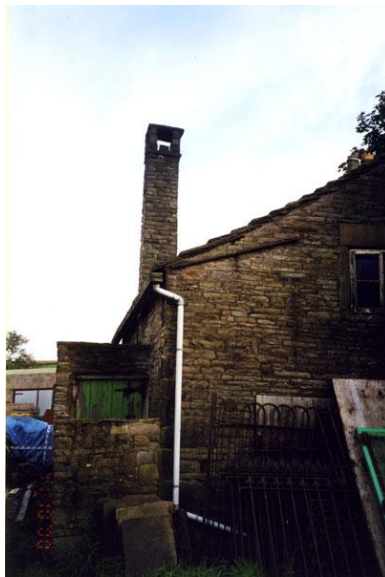
**Figure 4: Side (West) elevation Circa 1990**

Figure 4 shows the side (West) elevation of the property Circa 1990. There is a small extension addition to the rear (date unknown) which has been removed (date unknown). There is a chimney stack to the rear (probably original) which has been removed (date unknown).

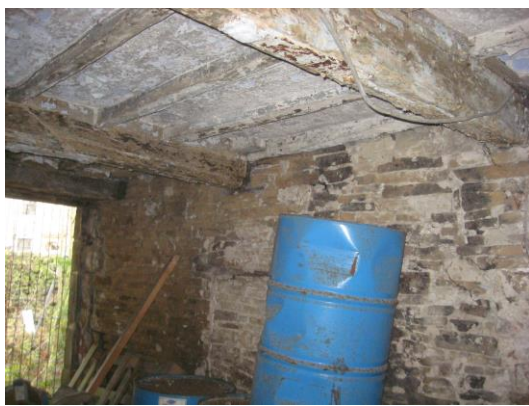
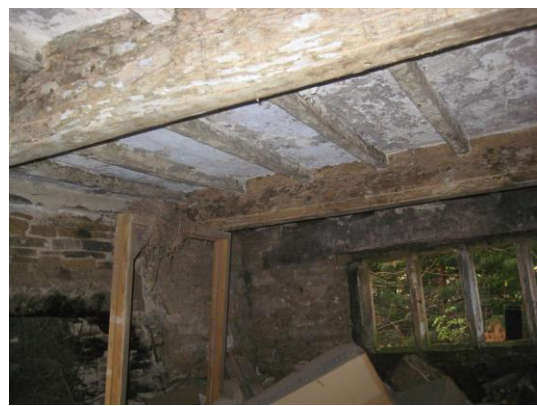
Figure 17 and 18: Existing First Floor Structure over Room 2 (there is no first floor structure over room 1 (assumed to have collapsed))

- First floor timbers over Room 2 - The existing timbers will be reused and any repairs/replacement timbers required will be on a like for like basis.
- First floor timbers over Room 1 – The first floor structure timbers will replicate those over room 2
- Internal Staircases – new timber staircases to the assumed design of the original
- Doors to be mortice & Tennon joint frame ledged in timber & painted.
- Windows made from Accoya softwood to existing design painted, with no trickle vent, 14mm heritage double glazing fixed with putty.
- Rainwater, gutters & downpipes in black painted cast aluminium.
