## Ground Investigation Report

Proposed Residential Development

Land off Nunsfield Road, Buxton

Document no.: STQ4642M-R03-Rev\_A

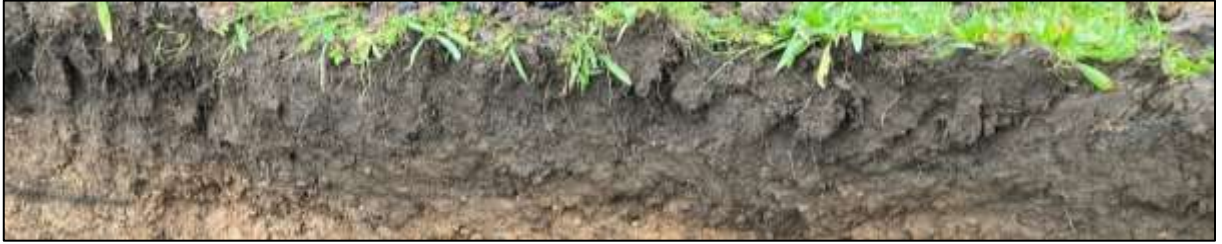
Figure 6-A: Topsoil encountered within TP104

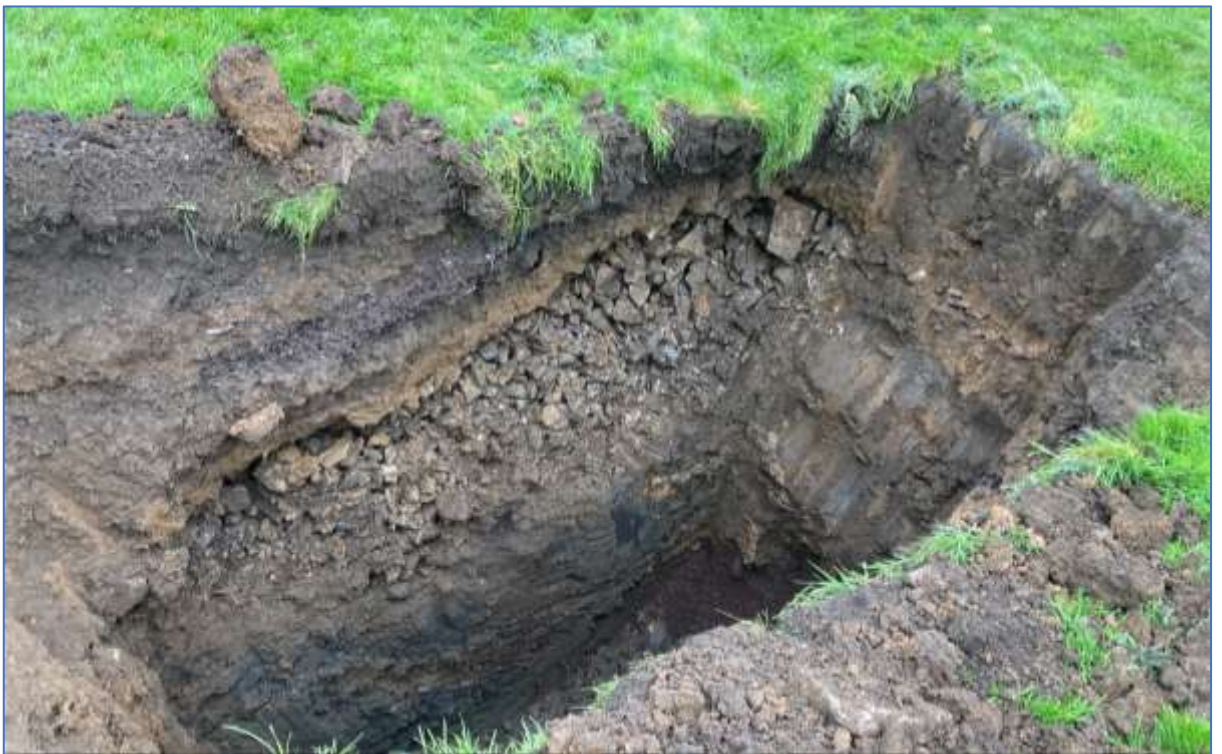
6.3.1 Made Ground outside of the former Hogshaw Refuse Tip and Access Road was observed locally across the site within TP108A, TP108C (north of site), and TP119 (central northern part of site). Such deposits typically comprised reworked natural soils (clays and cobbles) and some gravels of anthropogenic material including metal, glass, clinker and ceramic.

Figure 6-B: Made Ground encountered in TP108A

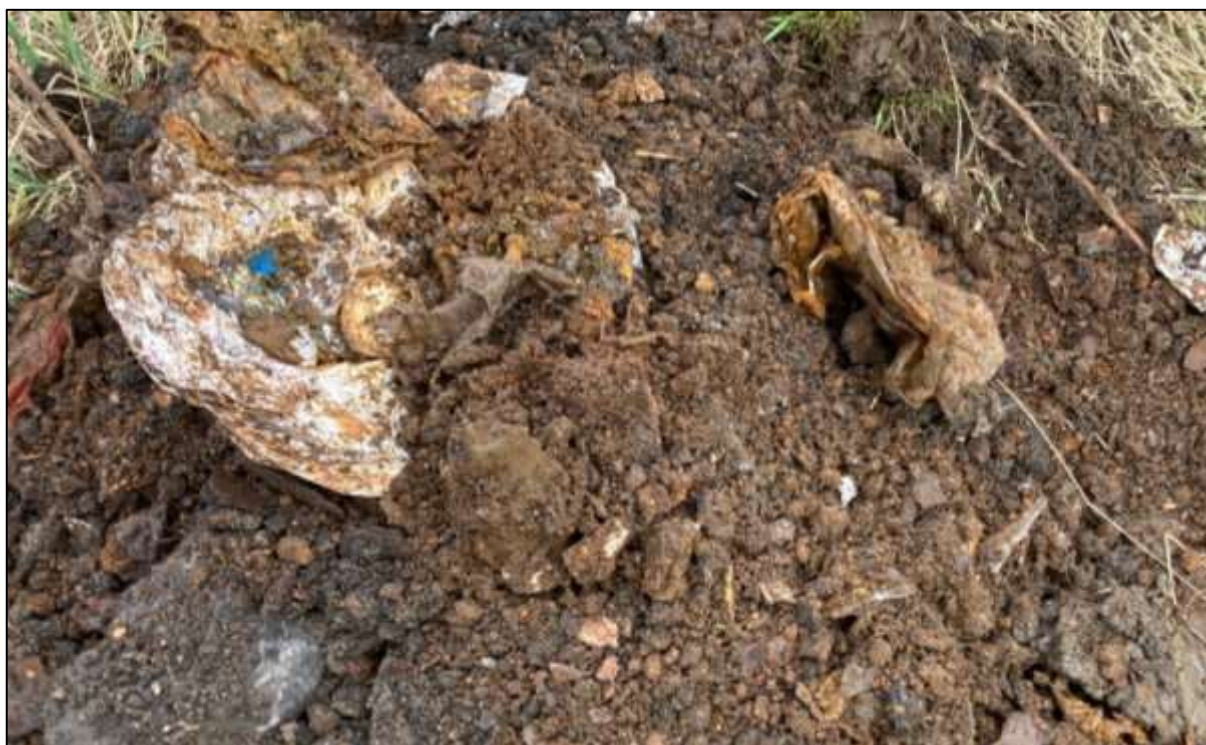
6.4.1 Made Ground encountered within the area of the proposed drainage basin (former Hogshaw Refuse Tip) was observed to a depth >5.84m bgl.

6.4.2 The Made Ground observed as both a cohesive and granular material with gravels consisting of brick, plastic, concrete, glass, clinker, slag, with frequent fragments of metal, wood, plastic, wire, paper, timber tiles and fabric.

*Figure 6-C: Typical Made Ground observed within the area of the proposed drainage basin*

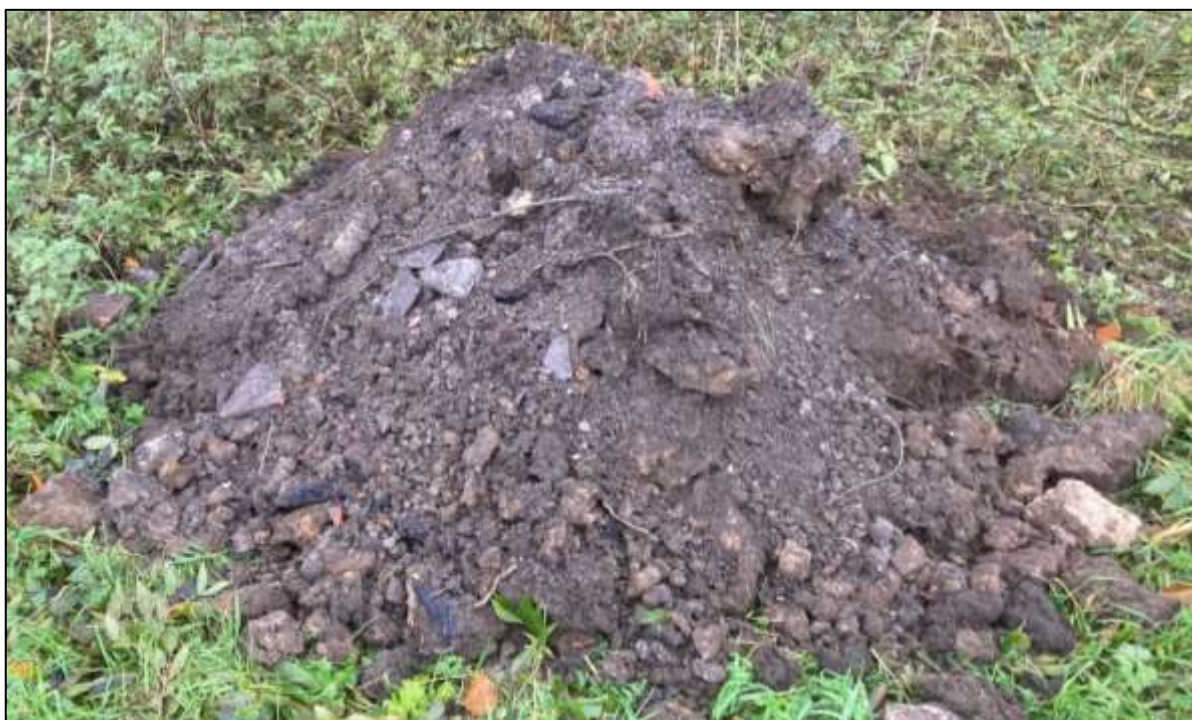
- 6.5.1 Made Ground within the area of the proposed access road (former Russia Mere) was observed to a depth of 0.5m to >5.45m bgl.
- 6.5.2 The Made Ground was observed as both a cohesive reworked natural soils and granular material, with the latter containing gravels and cobbles of brick, slate, asphalt and ceramic with fragments of metal and glass.
- 6.5.3 In areas adjacent to the access road redline boundary currently under consideration (former DTS102 and DTS18), deep deposits of suspected reworked Bee Low Limestone were encountered. These were not however present within the area of access road.
- 6.5.4 A photograph of the granular Made Ground encountered in the area of the proposed access road is presented below.

Figure 6-D: Made Ground observed within the area of the proposed access road

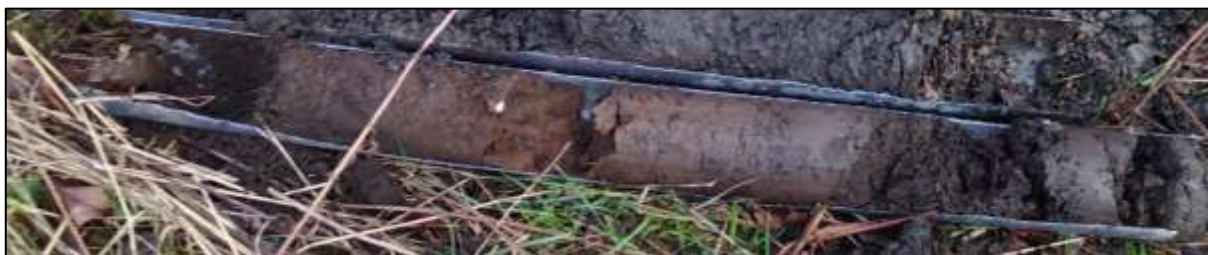
- 6.6.1 The Weathered Bowland Shale Formation was encountered within the west and southwest of the site. The depth of the underlying unweathered bedrock was recorded between depths of 2.2m and >5.38m bgl.
- 6.6.2 The weathered deposits of the Bowland Shale Formation were typically observed as a stiff brown slightly silty clay and sandy clayey gravel, with gravel comprising mudstone and shale.
- 6.6.3 A photograph of the Weathered Bowland Shale Formation encountered is presented below.

Figure 6-E: Weathered Bowland Shale Formation deposits encountered in DTS10

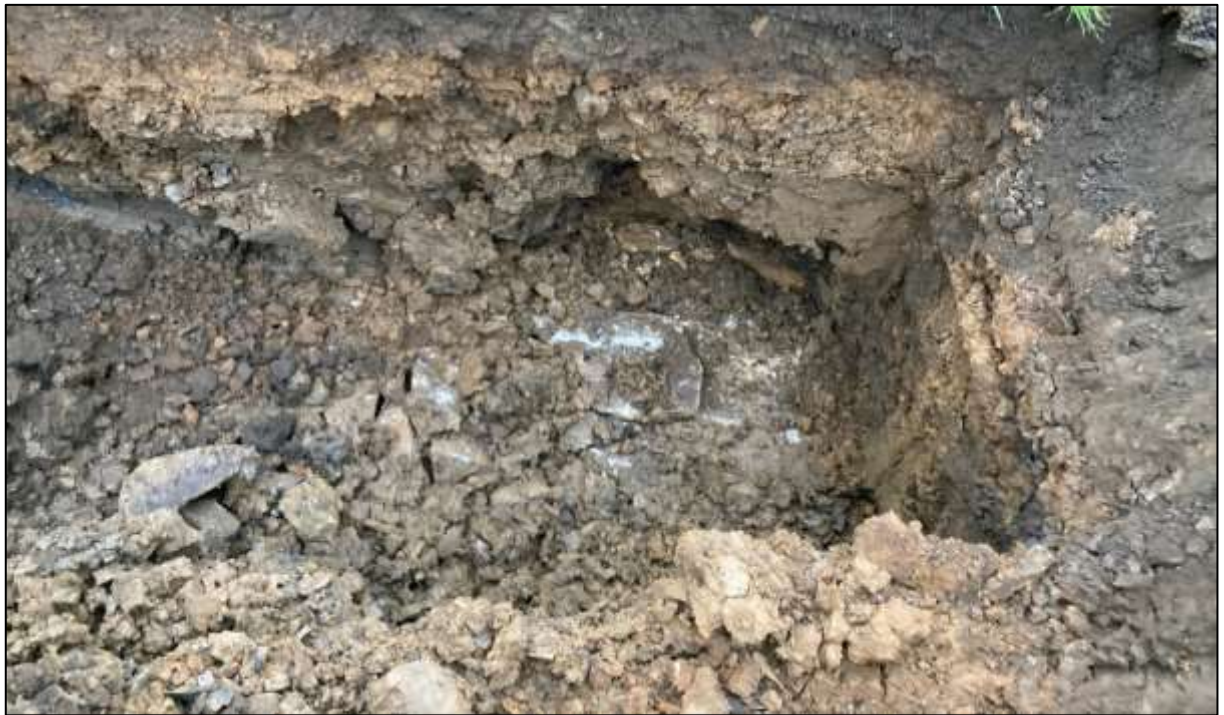
- 6.7.1 The Weathered Eyam Limestone Formation was encountered in most exploratory holes with the exception of those in the northwest (basin area) and southeast of the site (access road). The thickness of the underlying unweathered bedrock was recorded between 0.4m and 5.38m bgl.
- 6.7.2 The weathered deposits of the Eyam Limestone Formation were typically observed as a soft to firm brown clay at shallow depths with gravels and cobbles of limestone and sandstone at depth.
- 6.7.3 A photograph of the Weathered Eyam Limestone Formation encountered is presented below.

*Figure 6-F: Weathered Eyam Limestone Formation deposits*

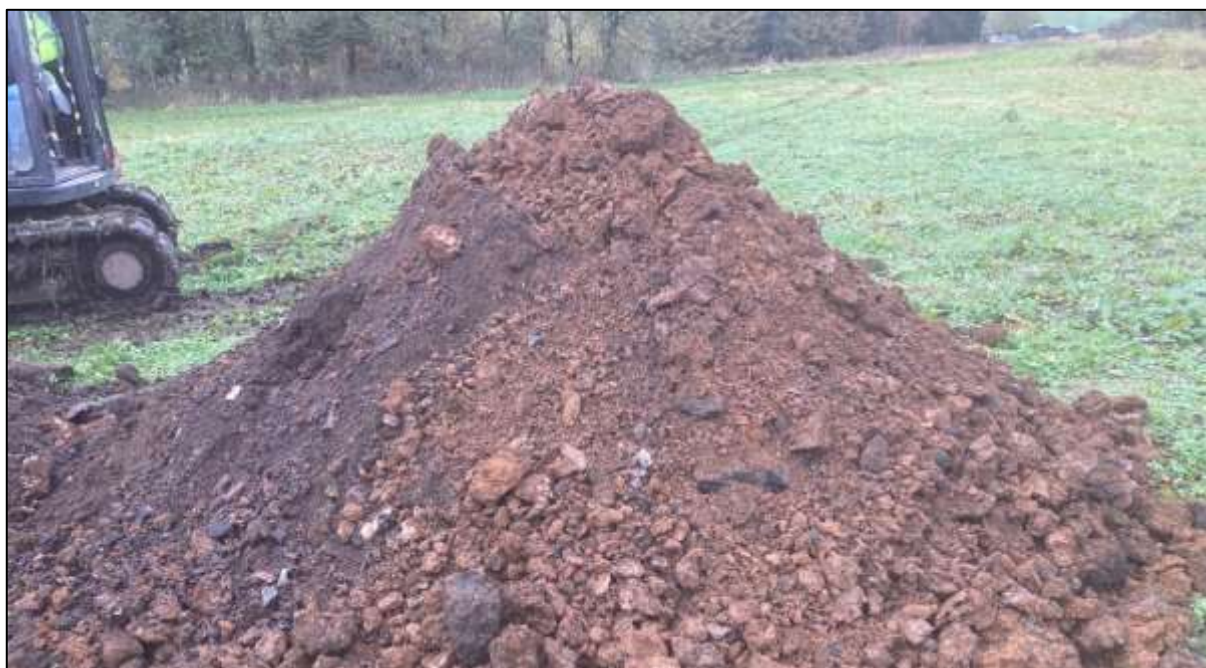
- 6.8.1 The Bee Low Limestone Formation was encountered only locally within the southeast of site (within DTS13, TP08, TP13, TP101, TP102 and TP118). The depth of the underlying unweathered bedrock was recorded between 1.0m and >5.45m bgl.
- 6.8.2 The weathered deposits of the Bee Low Limestone Formation were typically observed as stiff orangish brown sandy clay or medium dense orangish brown clayey very silty very gravelly sand, with gravels of limestone and mudstone. Locally the Weathered Bee Low Limestone Formation was observed as a limestone gravel at depth.
- 6.8.3 A photograph of the Weathered Bee Low Formation encountered is presented below.

Figure 6-G: Weathered Bee Low Formation deposits

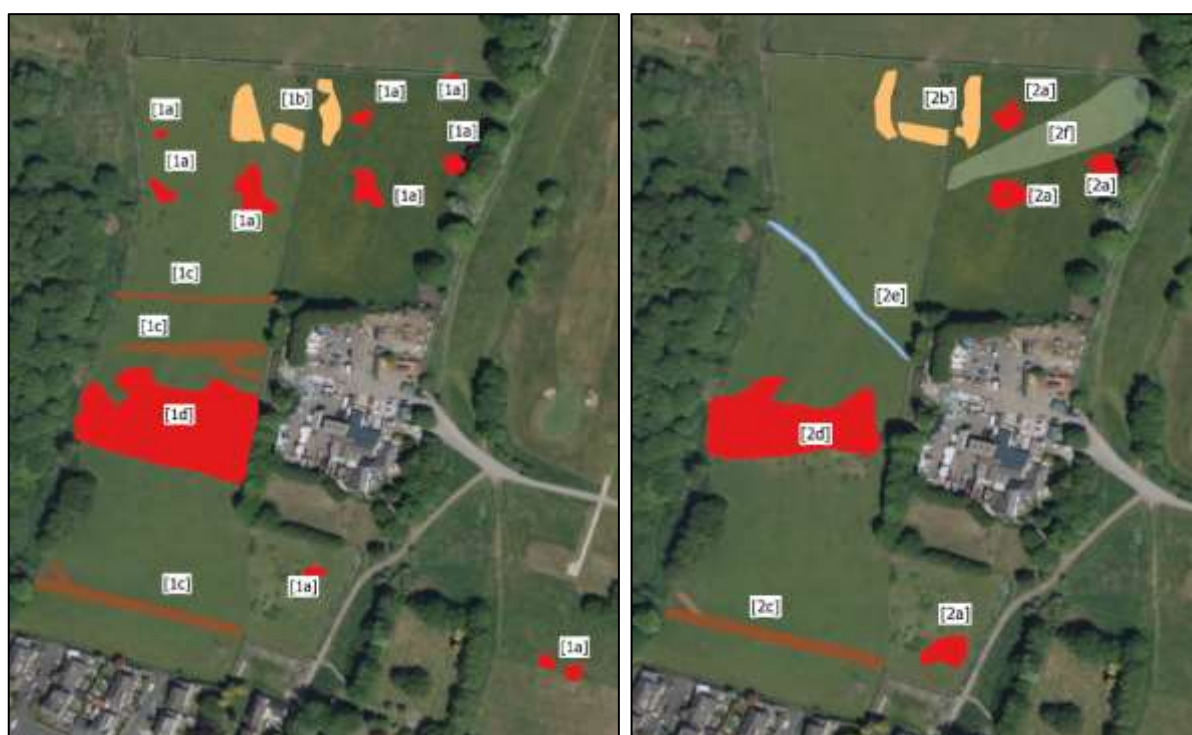
Figure 7-A: GPR responses 1a-1d (0.4-0.6m bgl) and 2a-2f (0.8-1.0m bgl)

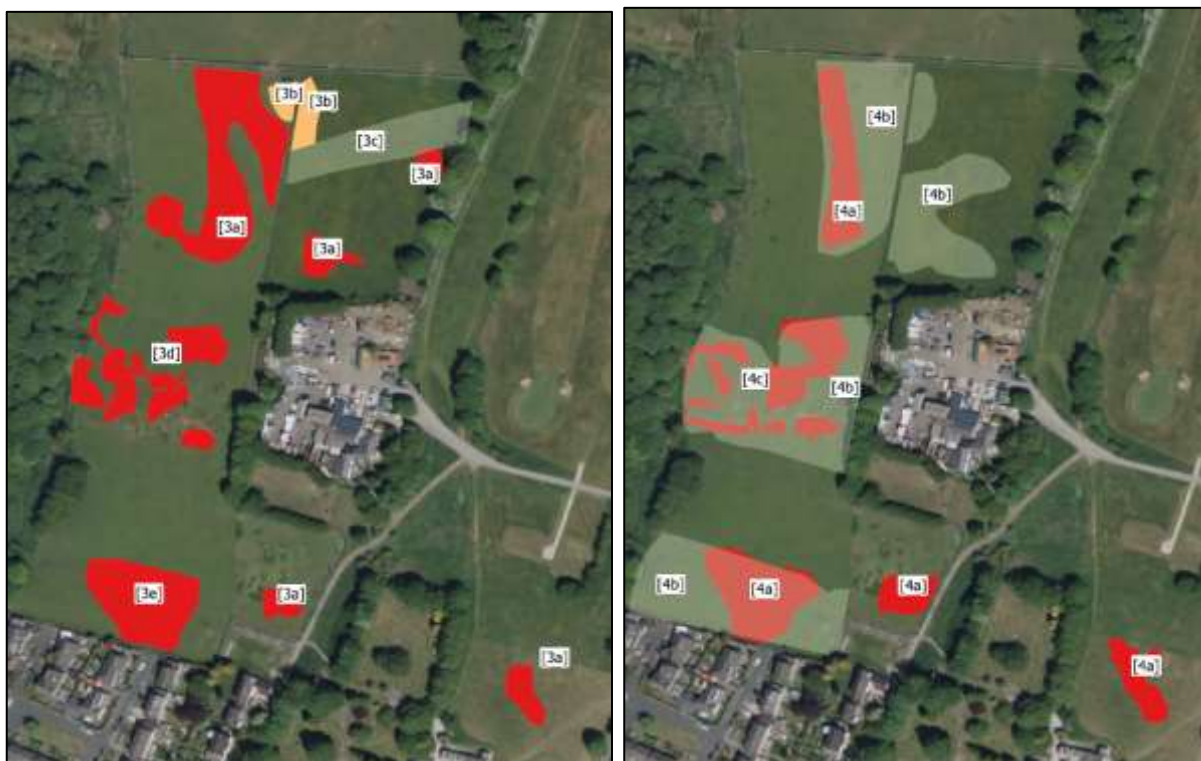
| Response(s) | Depth (m bgl) | Description |
|---|---|---|
| 4b | 2.0-2.2 | Responses from this depth range provide a more significant contrast and it is possible that the variations presented are related to natural variations in material. For this reason, wide areas of response have been identified, and it is possible that the natural variations in material properties at this depth are responsible for the contrasts that are being observed, rather than voiding. It is at these depths where weathered materials typically transition into bedrock and/or different geology. |
| 4c | | Relates to response associated with 1d/2d/3d. However, are more rectilinear at this depth and could be anthropogenic in origin. |

Figure 7-B: GPR responses 3a-3d (1.4-1.6m bgl) and 4a-4c (2.0-2.2m bgl)
