Eagle Parade Conduit  
Eagle Parade  
Buxton  
Derbyshire  
SK17 6EQ

EXISTING  
COMPONENT ANALYSIS  
DETAIL PLANS 01 & 02

24233-E-042C

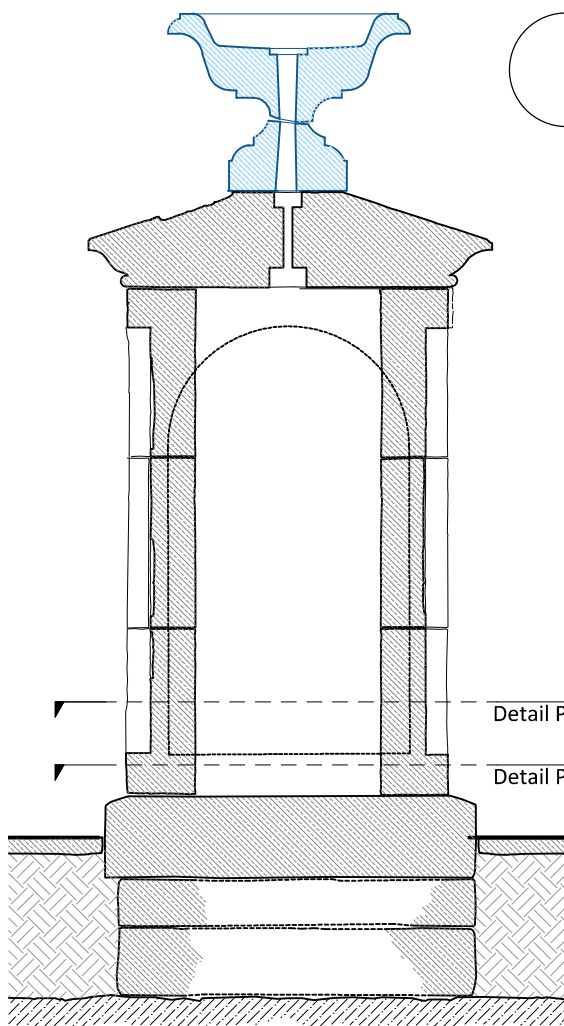
Structural displacement to the west of  
Cenotaph south facade lower panel [C2] of at  
least 20mm. (Type A defect)

Cementous mortar pointing (D1 Defect) to  
fill structural displacement gaps >10mm  
between east facade Cavendish panel and  
Cenotaph south facade panel [C2]

Approximate location of 20th/21st  
century engineering brick to the rear  
of lower tap hole panel [2D]. Observed  
via 16.04.26 endoscope survey.

Severe cracking >10mm (Type B defect)  
through full depth of lower Cenotaph  
west facade central panel [D2].

Cementous mortar pointing (D1  
Defect) to fill structural displacement  
gaps >10mm between east facade  
Cavendish panel and Cenotaph North  
facade panel [B2]

Severe cracking (Type B defect) at the lower  
northeast corner of the Cavendish frame [2A]  
resulting in a 22mm displacement north as  
indicated.

Structural displacement resulting in northeast  
corner of Cavendish Motif panel [2A] & [3A]  
moving east at least 15mm. (Type A defect)

20th/21st century engineering brick  
- refer also to above left note. Refer  
also to Bench Architects drawing  
-E-049 for photographic record.
