Eagle Parade Conduit  
Eagle Parade  
Buxton  
Derbyshire  
SK17 6EQ

EXISTING  
COMPONENT ANALYSIS  
DETAIL PLAN 05 & 06

24233-E-044B

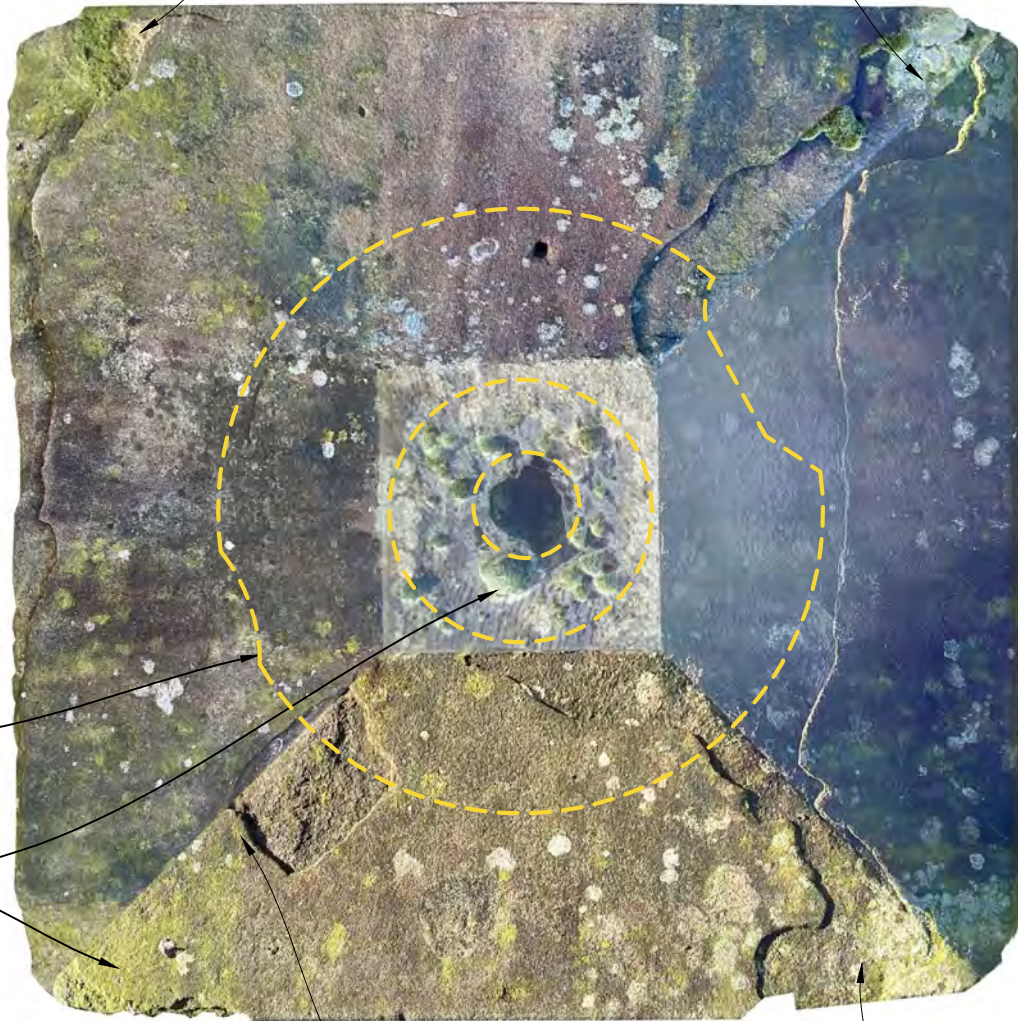
Detail Plan 06 -  
Photographic record of  
Cornice from above.  
(1:10)

Examples of surface deterioration spalling  
less than & greater than 10mm (Type C1 &  
C2 defects) to the cornice [5] resulting in  
loss of ashlar fabric .

Outline above of original Urn and  
Pedestal (currently in storage)

Outline of Cenotaph  
below Cornice [5]

Extent of surface deterioration  
spalling less than & greater  
than 10mm (Type C1 & C2  
defects) to the cornice [5]  
resulting in loss of ashlar fabric  
as indicated.

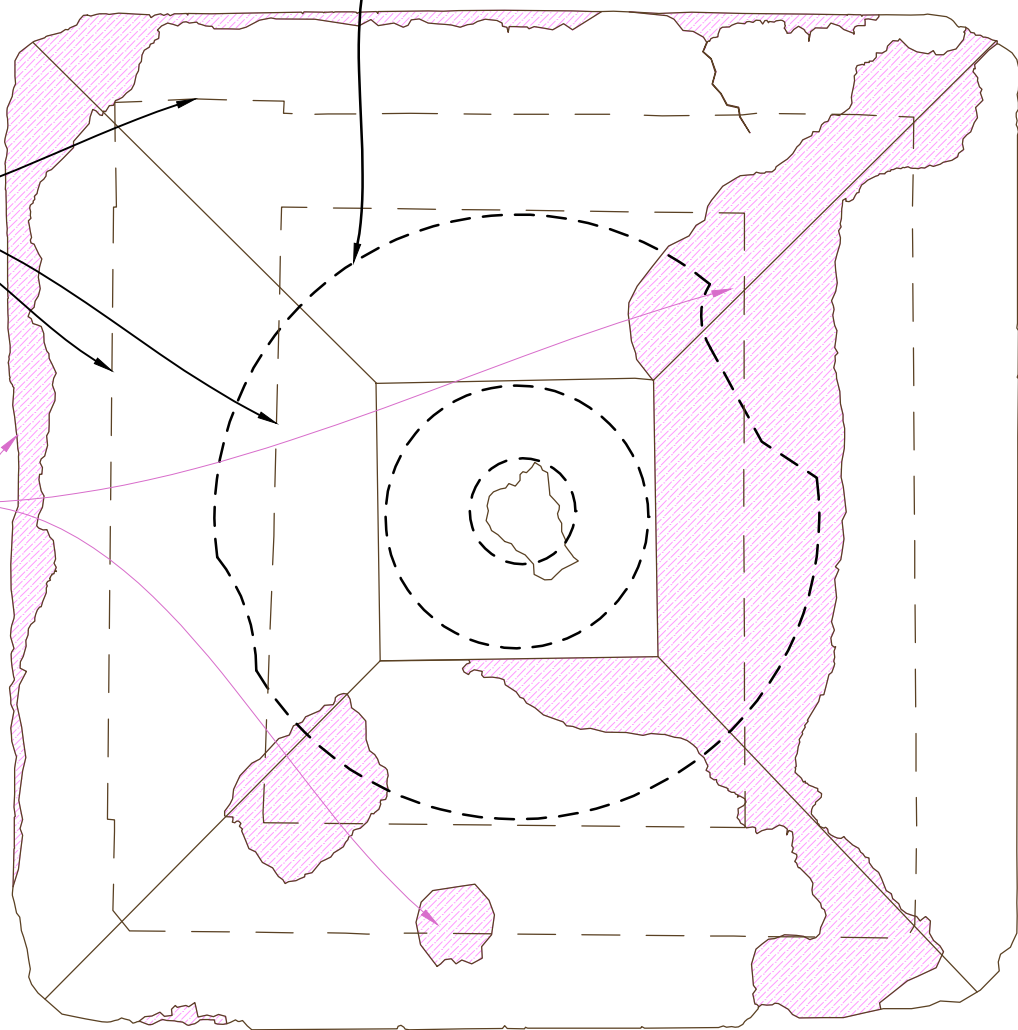
Detail Plan 05 (1:10)

Outline (in yellow) of  
original Urn and Pedestal  
above.

Current microbiological  
growth.

Examples of surface deterioration spalling less  
than & greater than 10mm (Type C1 & C2  
defects) to the cornice [5] resulting in loss of  
ashlar fabric .
