Eagle Parade Conduit  
Eagle Parade  
Buxton  
Derbyshire  
SK17 6EQ

Buxton Civic Association

EAST ELEVATION - CENOTAPH  
CONDITION SURVEY (2 OF 2)

24233-E-037B

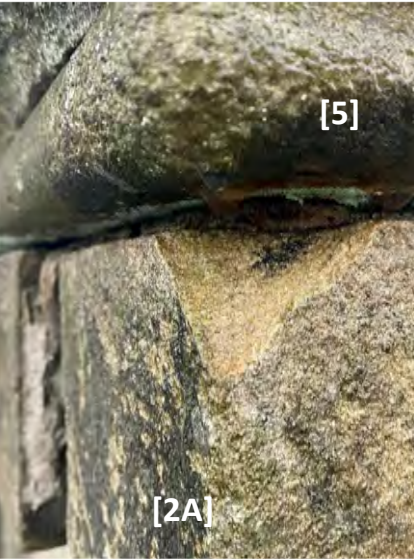
Loss of surface at top southeast corner of panel [2A]

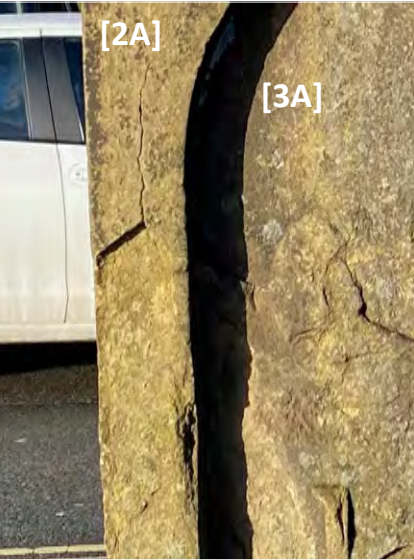
(above & above right) Cracking <10mm (Type B defect) to Cavendish Motif frame and above arch section [2A] and Severe surface deterioration >10mm spalling (Type C1 defect)

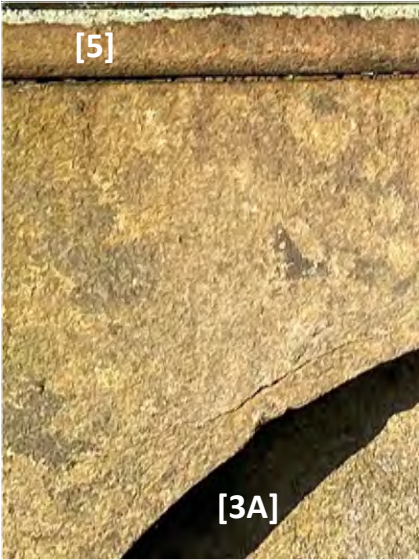
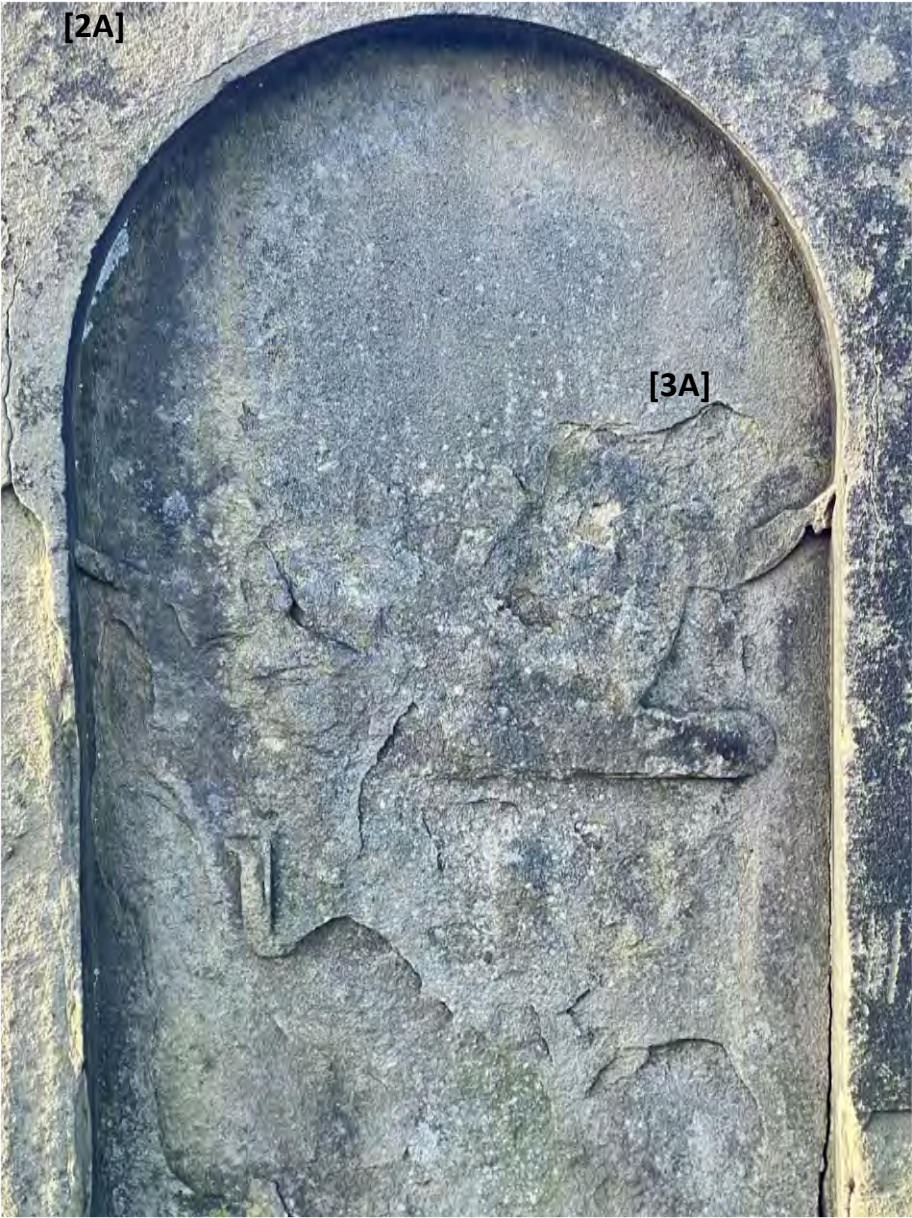
Cavendish Motif [3A] - refer to above right note.

The Cavendish coiled serpent motif [3A] and the 1840 date have experienced significant erosion up to 75mm deep, rendering them unrecognizable. The ashlar has delaminated and fragmented into small pieces, subsequently powdering. This deterioration is attributed to the expansion of clay within the argillaceous sandstone and recurrent freeze-thaw salt crystallization occurring within the stone's surface pores.

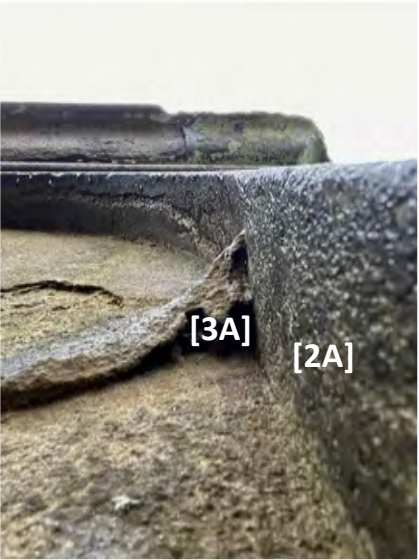
Detail of decay to the Cavendish coiled serpent motif [3A]

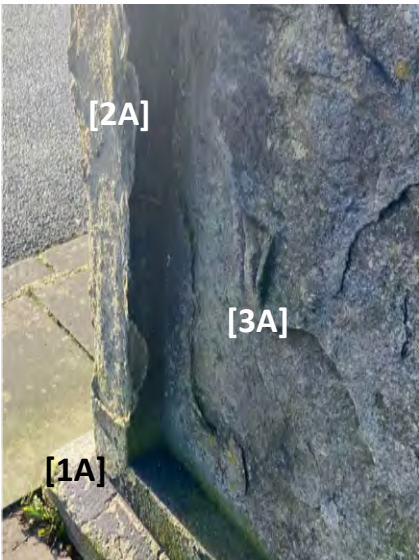
Extent and depth of surface loss to Cavendish Motif [3A] and lower SE corner of Cenotaph frame [2A]

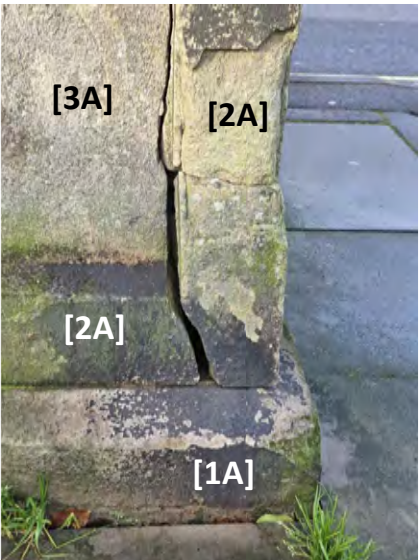
Detachment of lower NE corner of Cenotaph frame [2A] over Plinth [1A] abutment

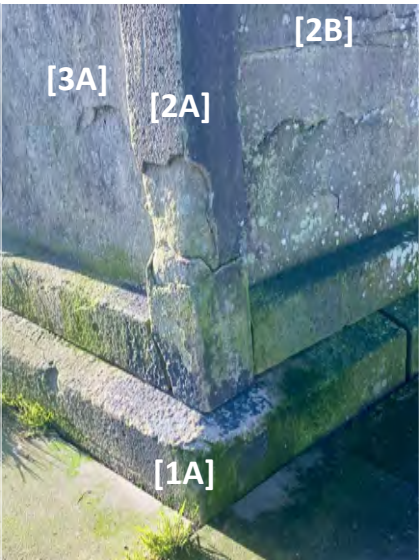
Extent and depth of surface loss to lower NE corner of Cenotaph frame [2A]
